Inspection Report

Property Address:
42381 Sultan Ave
Palm Desert CA 92211

Dominguez Property Inspections, LLC

Date: 3/27/2024	Time: 10:00 AM	Report ID: 014 - 2024
Property: 42381 Sultan Ave Palm Desert CA 92211	Customer: Sample Repor #2 Sample Report #2	Real Estate Professional: Danny Schmitz Keller Williams

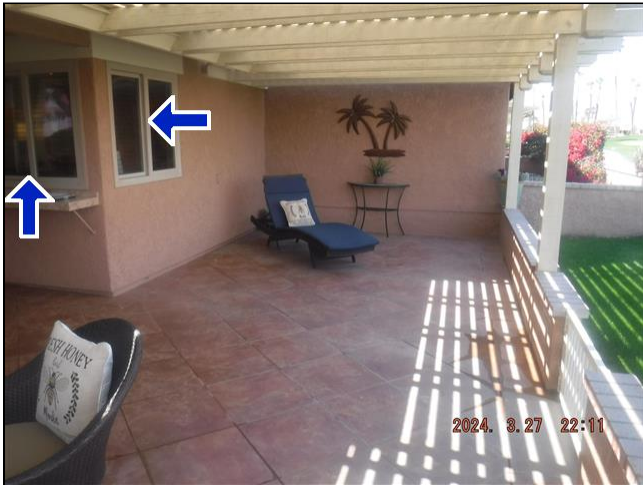
1.2 Noted the screen(s) are missing at various window(s) locations at the back of the home. Window screens help pest management. This is a maintenance issue. Recommend to install window screen(s) as recommended, by a qualified person and company.

1.2 Item 1(Picture) Windows missing screens

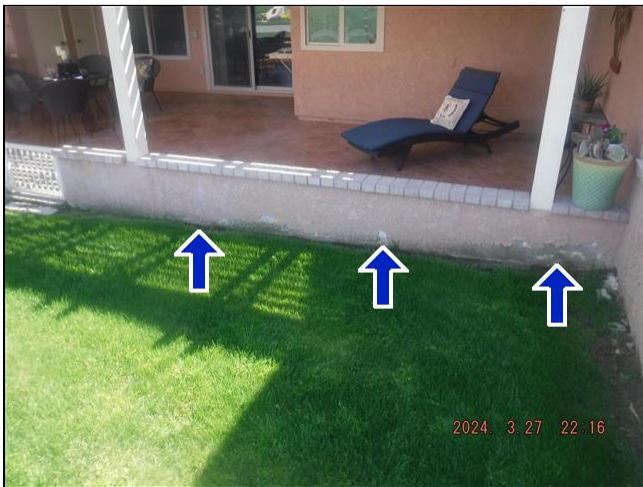
1.4 The block wall stucco coating is failing (peeling) at the patio back of home. This is a maintenance issue and is for your information. Further deterioration may occur if not repaired. Recommend a licensed general contractor further evaluate and repair or replace as needed.

1.4 Item 1(Picture) Patio block wall

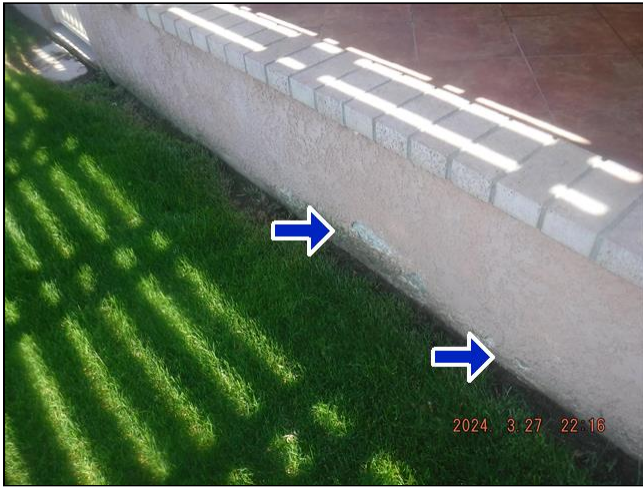
1.4 Item 3(Picture) Stucco coating peeling

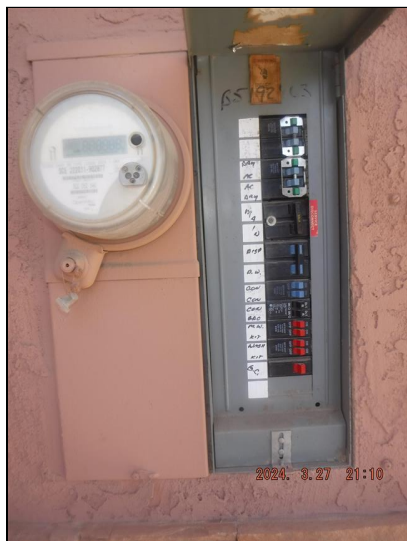
⚠️ (2) Noted the potential issue(s) discovered in the panel such as missing AFCI (Arc Fault Circuit Interrupters) breakers, and any other problems that an electrical contractor may discover while performing repairs needs correcting. An arc fault circuit interrupter is designed to detect a dangerous electrical arc and promptly interrupt the circuit before a fire can ignites. When an arc fault occurs, it creates a sharp spike and drop that is easily detectible by an AFCI electrical breaker. Not having AFCI breakers in a panels can be a safety issue.

2.1 Item 1(Picture) No AFCI breakers in panel

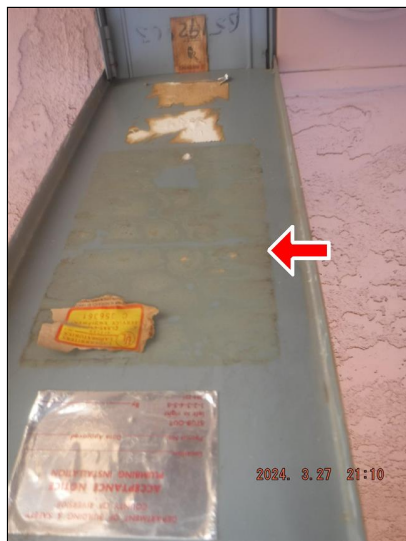
Note, the panel manufactures label (sticker) is missing and or damaged. Its important for the electrical panel boxes to have the label for maintenance and or emergency purposes. A license electrical contractor should evaluate panel

2.1 Item 2(Picture) Missing panel label

to determine brand and label that is needed. Recommend a licensed electrical contractor inspect further and correct as needed.

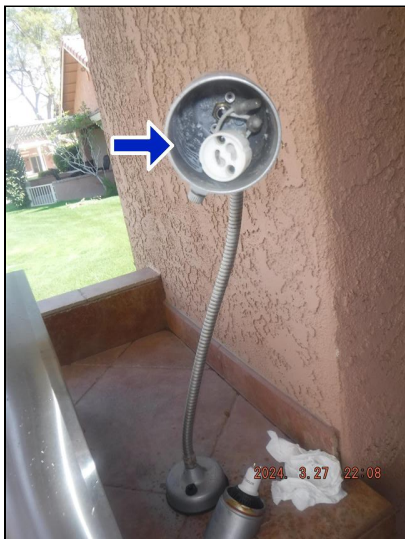
2.6 The light fixture did not work when tested at the patio right side of bar-bee-que unit. I recommend to change bulb first, then re-test. Recommend a license electrical contractor further evaluate and repair or replace as needed.

2.6 Item 1(Picture) BBQ light fixture

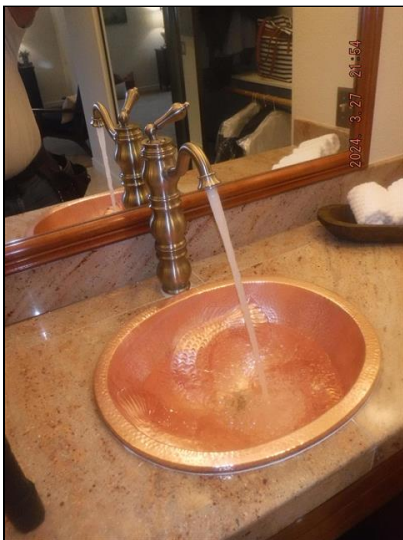
(2) The plumbing sink drains slowly at the master bathroom. A cause of a slow drain can range from a simple cleaning at stop valve or at the trap under sink. Sometimes the drain can be partially clogged down the line. I am unable to determine the cause of the slow drain. Recommend a license plumbing contractor further evaluate and repair or replace as needed.

3.0 Item 1(Picture) Master bathroom sink

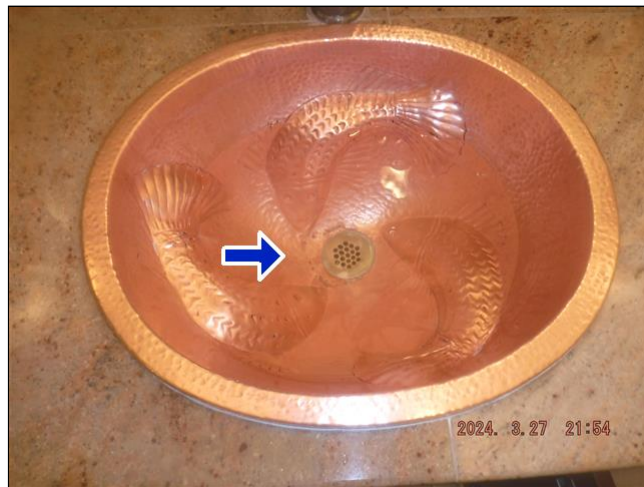
3.0 Item 2(Picture) Sink drains slow

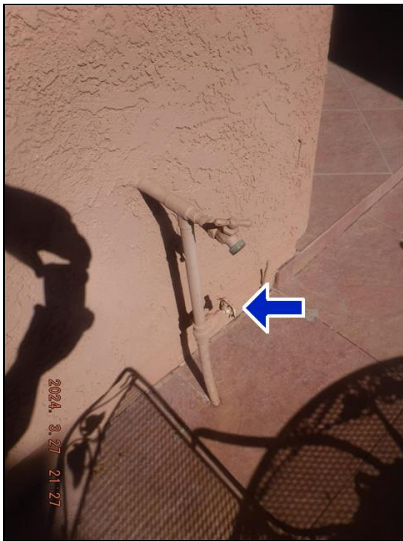
(2) Noted the quick water shut off valve did not work when tested at the front courtyard. Valve should be repaired or replaced for quick water shut off access. This is not up to today's plumbing standards. Recommend a license plumbing contractor further evaluate and repair or replace as needed.

3.2 Item 2(Picture) Water shut off valve

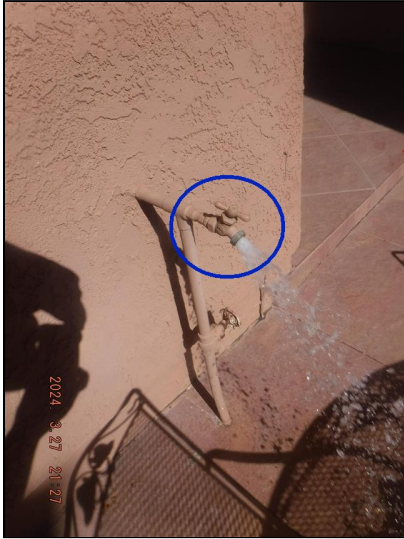
(2) Noted the hose bib/spigot(s) is/are missing a anti-siphon valve at the front and back of home. Anti-siphon valve(s) on hose bib/spigot(s) are required to prevent water from backflow into the home, this can possibly cause

3.3 Item 1(Picture) Plumbing hose bib (front of home)

cross-contamination of the water supply. Installation of anti-siphon valves is a small repair. Recommend a license plumbing contractor further evaluate and repair, replace or advise as needed.

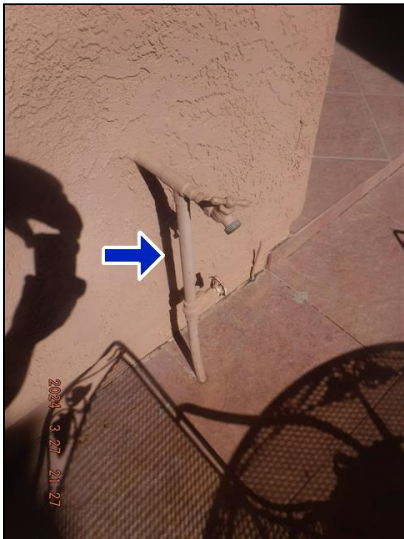
3.5 Note, there is NO water pressure regulator currently installed on the main water line for the home. Without a water pressure regulator you can't adjust the water pressure to a recommended range. Recommend a license plumbing contractor further evaluate and repair or install as needed.

3.5 Item 1(Picture) Main water line

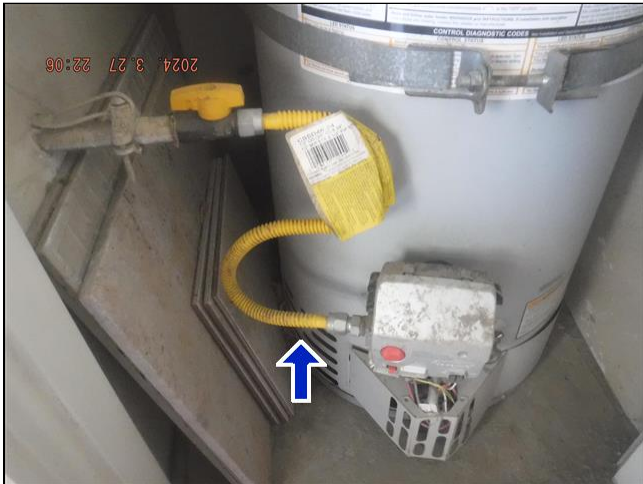
(2) Note: Sediment traps are missing on the gas line(s) for the furnace unit(s) and water heater unit(s). Sediment traps may have not been required at the time of construction, recommend to install as recommended by today's plumbing standards. Missing sediments straps may prevent, and or void manufacturers and or home warranties. According to the 2016 California Plumbing Code (CPC), sediment traps are required for all gas appliances except: illuminating appliances, ranges, clothes dryers, decorative appliances for installation in vented fireplaces, gas fireplaces, and outdoor grills. Those are quite a few exceptions. Recommend a license plumbing contractor further evaluate and repair or advise as required.

3.7 Item 1(Picture) Water heater gas line

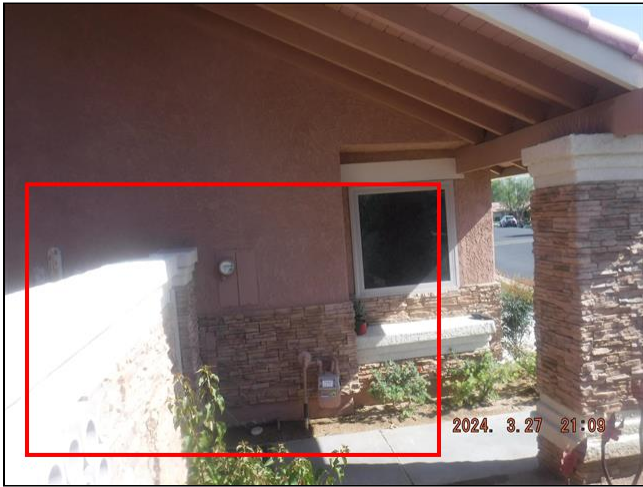
+ (2) Noted a possible gas odor/smell was detected near, or around the gas meter location at the time of inspection. If a gas leak is present, this can be a safety issue. Recommend a license plumbing contractor or gas company technician further evaluate and repair, replace or advise as needed.

3.8 Item 2(Picture) Location of gas odor detected

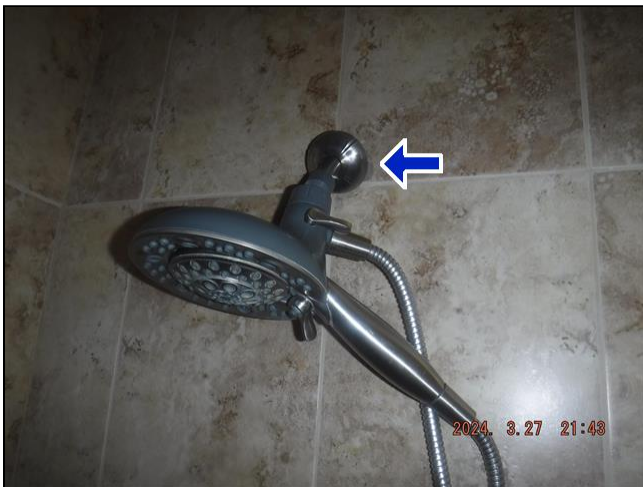
3.10 Noted the shower plumbing fixture(s) (shower head and valve) are loose at the wall, and or not properly sealed/ water proofed with silicone/caulking at the guest bathroom. This can allow moisture to seep/penetrate behind wall causing water damage or mold growth. This is a maintenances issue. Recommend a plumbing contractor or a qualified person evaluate further and repair as needed.

3.10 Item 1(Picture) Guest bath shower head

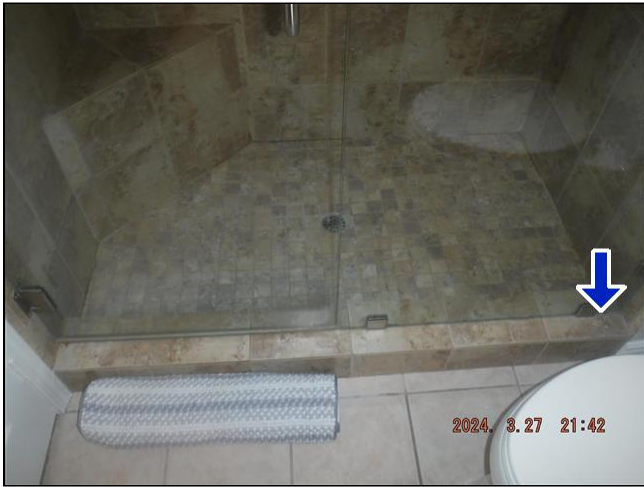
3.11 Noted the bathroom shower stall leaks at the threshold in the guest bathroom. Leaking shower stalls can cause major water damage and mold growth if not repaired. This is a maintenance issue. Recommend a license plumbing or general contractor further evaluate and repair or replace as needed.

3.11 Item 1(Picture) Location of shower stall leak

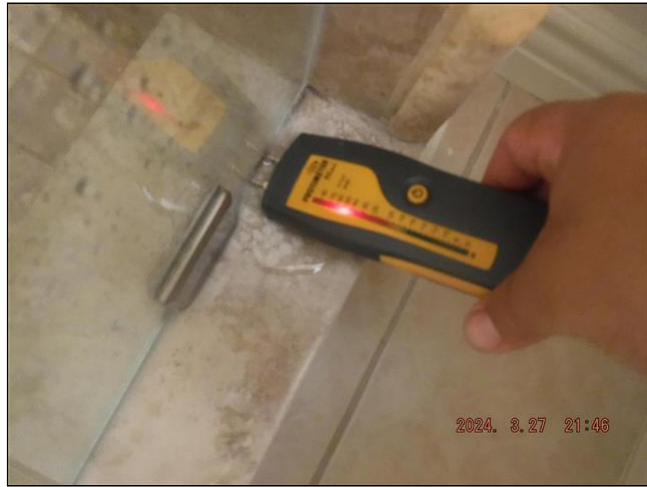
3.11 Item 2(Picture) Shower stall leak

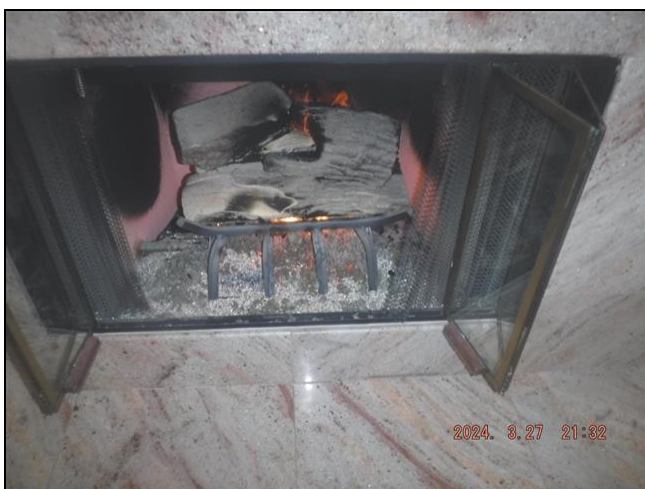
The fireplace unit is missing a C-Clamp at the flue damper inside the firebox. Although the C-Clamp is commonly removed so that the flue damper may be closed. It is recommended that the C-Clamp be installed per the Gas Company in order to keep the flue damper open at all times for safety. Recommend to install c-clamp on damper. A qualified person should correct as needed.

4.6 Item 1(Picture) Fireplace Unit

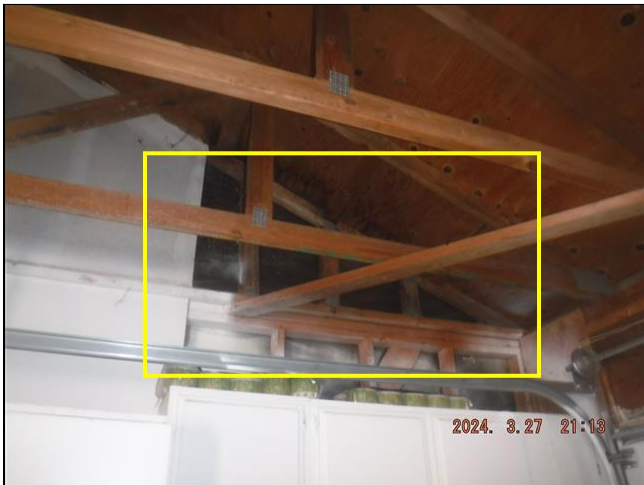
5.0 Noted water stains were observed at the garage ceiling on the right side. Stains were viewed on the sub roof (plywood sheathing and joists). Due to recent dry weather, was unable to determine if these stains are from a previous or correct leak (plumbing or roof). Stains were dry at the time of inspection. Recommend a license general or roof contractor further evaluate and repair or advise as desired.

5.0 Item 1(Picture) Location of ceiling water stains

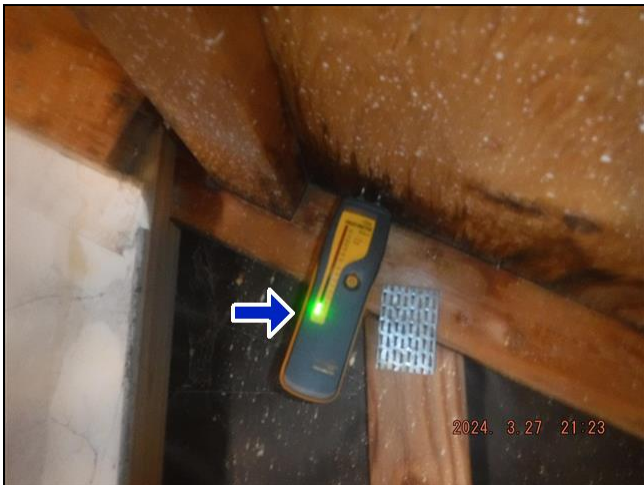
5.0 Item 3(Picture) Moisture meter (device) indicated dry surface

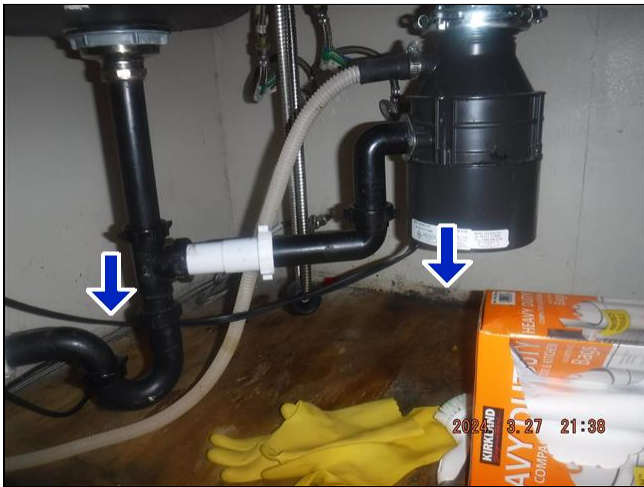
or is not a health concern. No leaks present at the time of inspection at this location. However, moisture stains were present in the area possibly from a previous leak (The only way to determine if this black substance is or is not a health concern, is to obtain surface samples, and have a lab analysis them). If this is a concern you may contact us for a re-evaluation and testing, or contact a certified mold inspector for further evaluation.

6.1 Item 1(Picture) Location of black substance

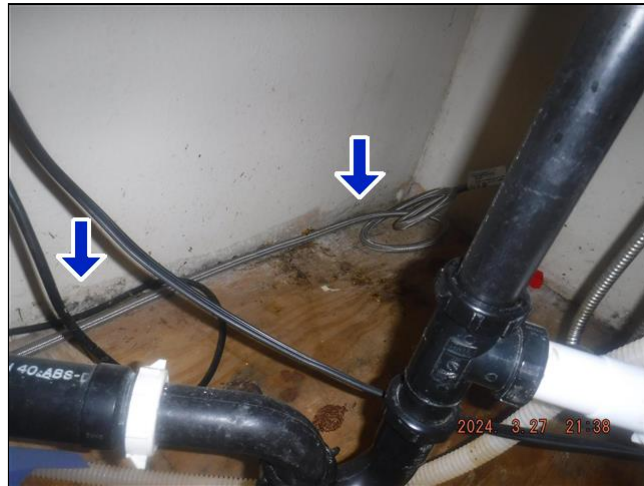
6.1 Item 4(Picture) Black substance on wall

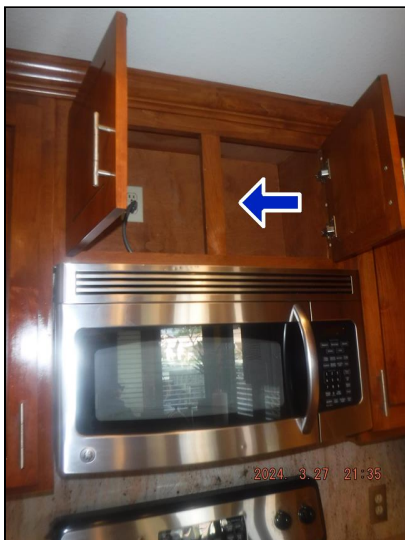
7.4 The range hood fan is missing a vent pipe, and does not appear to vent/exhaust to the outside. It's is recommended to vent the air to the outdoors than to recirculate it into the room. A vented hood that removes steam, smoke, heat, and cooking odors is the best way to keep your kitchen clean, since it gets rid of grease particles that would otherwise accumulate on your walls and cabinets. This is just a recommendation. Recommend a qualified person further evaluate and repair or replace as needed.

7.4 Item 1(Picture) No vent pipe for exhaust fan

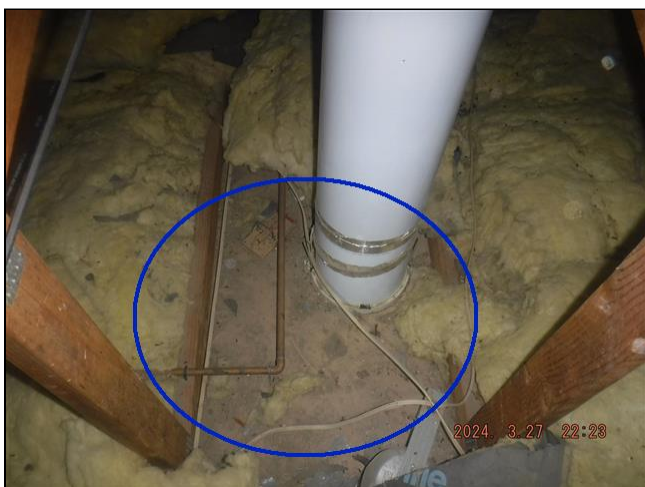
(2) Signs of pest intrusion (rodent, insect, etc...) was noted in the attic at the time of inspection. Rodent droppings were discovered at various locations of the attic. Unable to determine if this pest issue is a previous or present issue. This is for your information. Recommend a license pest control company further evaluate and repair or advise as desires.

8.4 Item 1(Picture) Rodent droppings

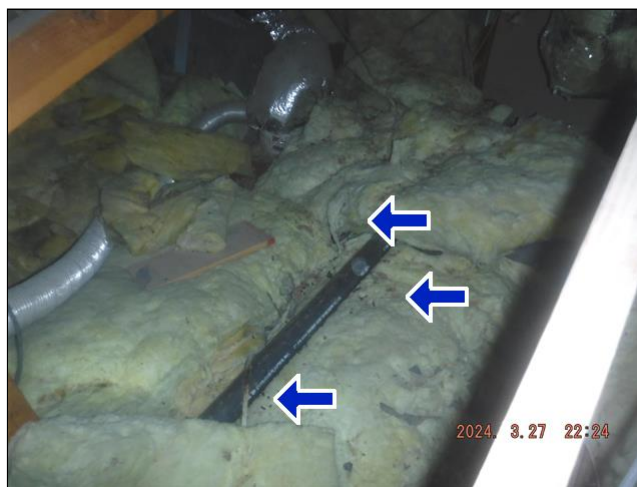
8.4 Item 2(Picture) Rodent droppings

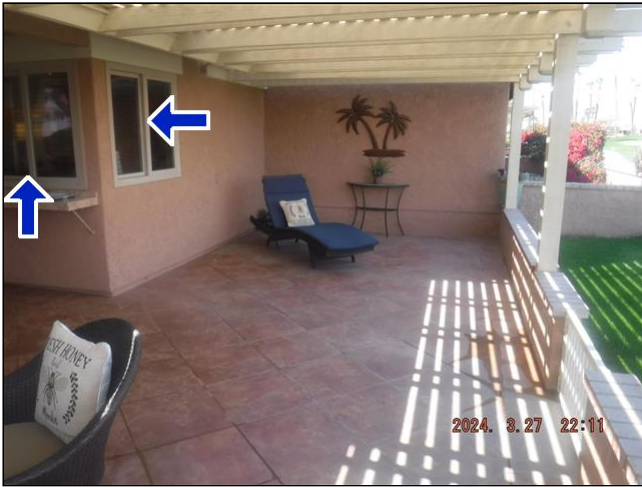
Noted the screen(s) are missing at various window(s) locations at the back of the home. Window screens help pest management. This is a maintenance issue. Recommend to install window screen(s) as recommended, by a qualified person and company.

1.2 Item 1(Picture) Windows missing screens

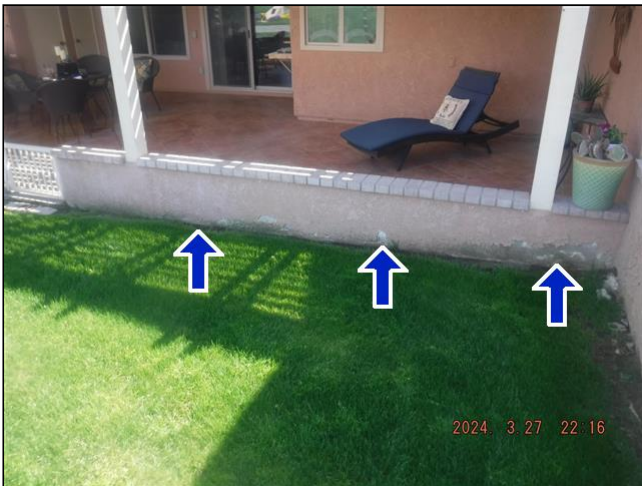
The block wall stucco coating is failing (peeling) at the patio back of home. This is a maintenance issue and is for your information. Further deterioration may occur if not repaired. Recommend a licensed general contractor further evaluate and repair or replace as needed.

1.4 Item 1(Picture) Patio block wall

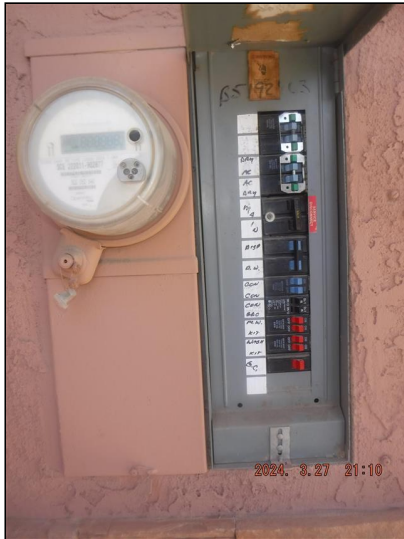
2.1 Item 1(Picture) No AFCI breakers in panel

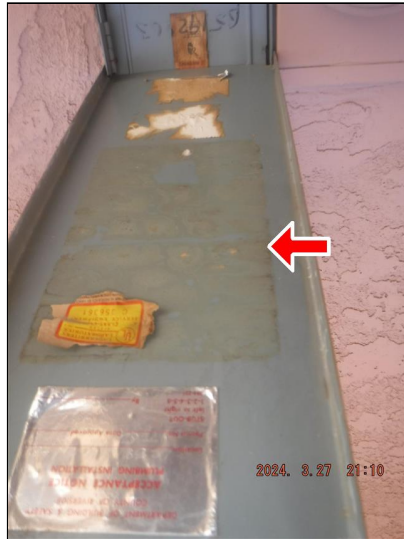
Note, the panel manufactures label (sticker) is missing and or damaged. Its important for the electrical panel boxes to have the label for maintenance and or emergency purposes. A license electrical contractor should evaluate panel to determine brand and label that is needed. Recommend a licensed electrical contractor inspect further and correct as needed.

2.1 Item 2(Picture) Missing panel label

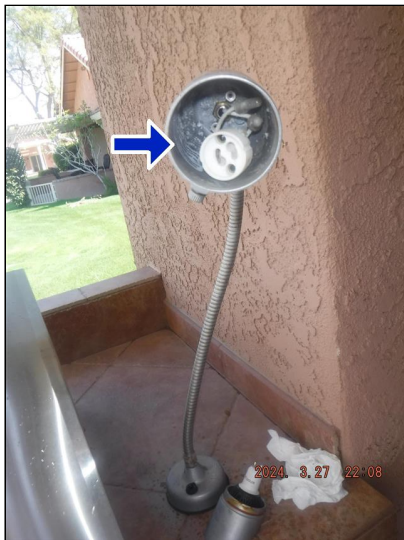
The light fixture did not work when tested at the patio right side of bar-bee-que unit. I recommend to change bulb first, then re-test. Recommend a license electrical contractor further evaluate and repair or replace as needed.

2.6 Item 1(Picture) BBQ light fixture

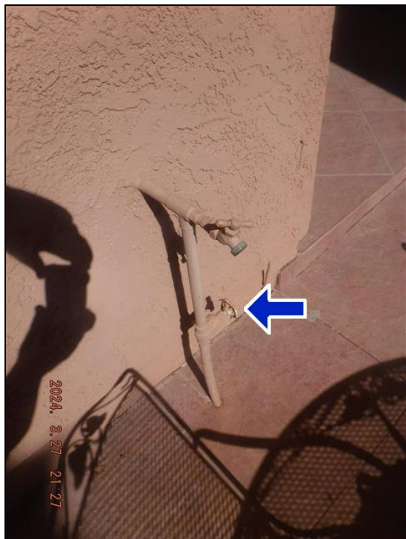
(2) Noted the quick water shut off valve did not work when tested at the front courtyard. Valve should be repaired or replaced for quick water shut off access. This is not up to today's plumbing standards. Recommend a license plumbing contractor further evaluate and repair or replace as needed.

3.2 Item 2(Picture) Water shut off valve

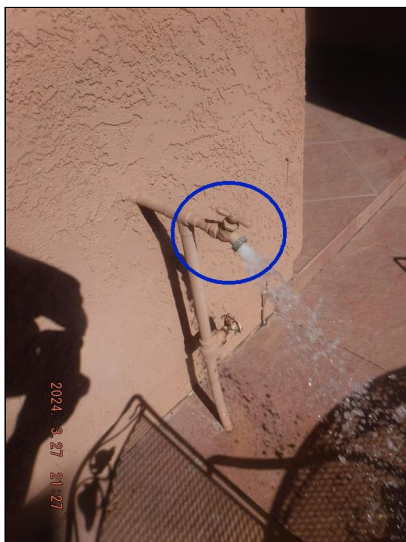
(2) Noted the hose bib/spigot(s) is/are missing a anti-siphon valve at the front and back of home. Anti-siphon valve(s) on hose bib/spigot(s) are required to prevent water from backflow into the home, this can possibly cause cross-contamination of the water supply. Installation of anti-siphon valves is a small repair. Recommend a license plumbing contractor further evaluate and repair, replace or advise as needed.

3.3 Item 1(Picture) Plumbing hose bib (front of home)

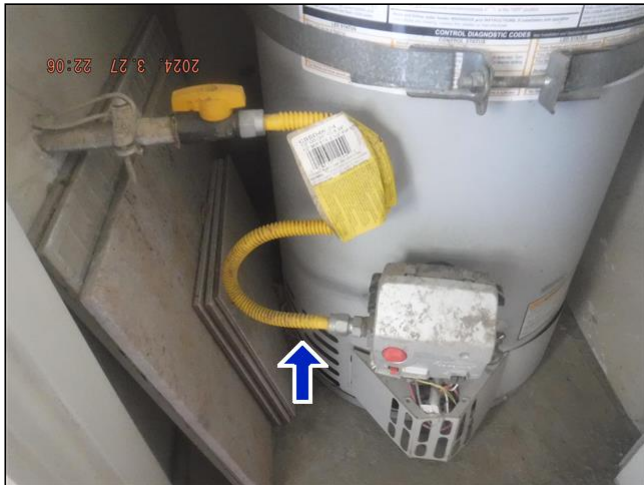
vented fireplaces, gas fireplaces, and outdoor grills. Those are quite a few exceptions. Recommend a license plumbing contractor further evaluate and repair or advise as required.

3.7 Item 1(Picture) Water heater gas line

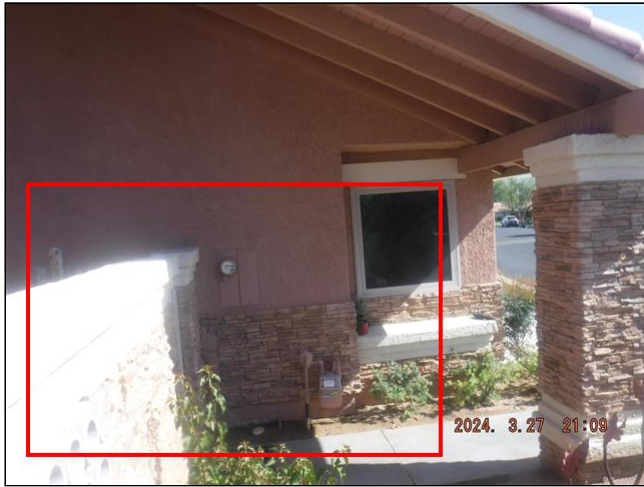
3.8 Item 2(Picture) Location of gas odor detected

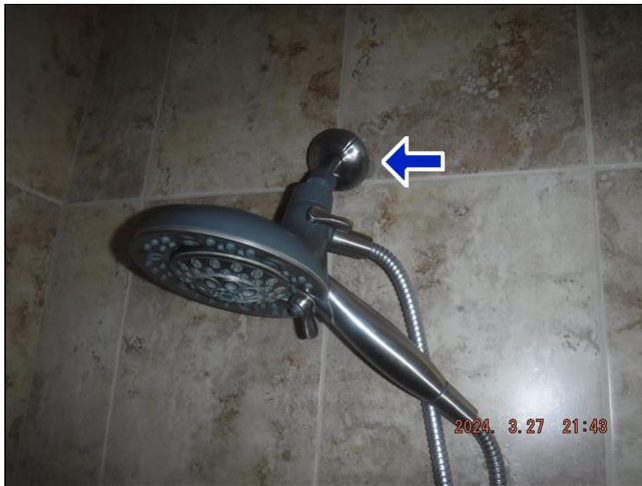
3.10 Item 1(Picture) Guest bath shower head

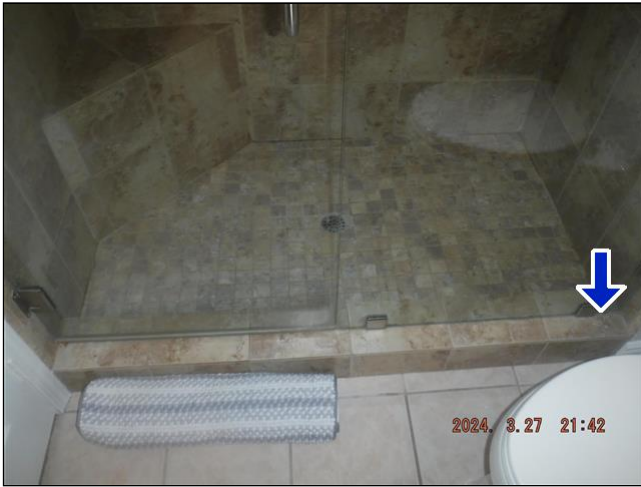
3.11 Item 1(Picture) Location of shower stall leak

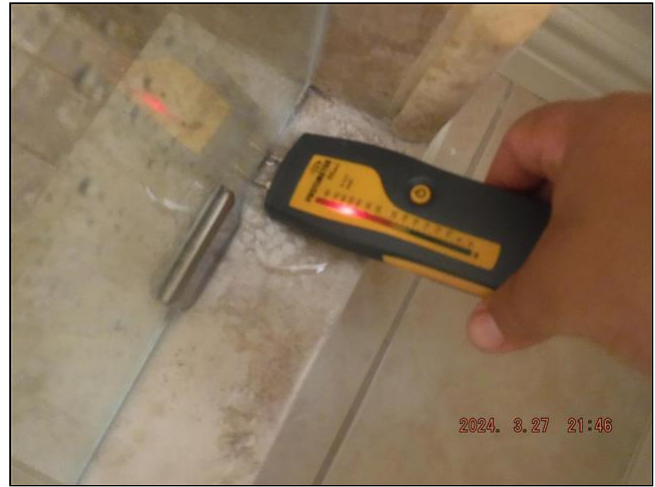
3.11 Item 2(Picture) Shower stall leak

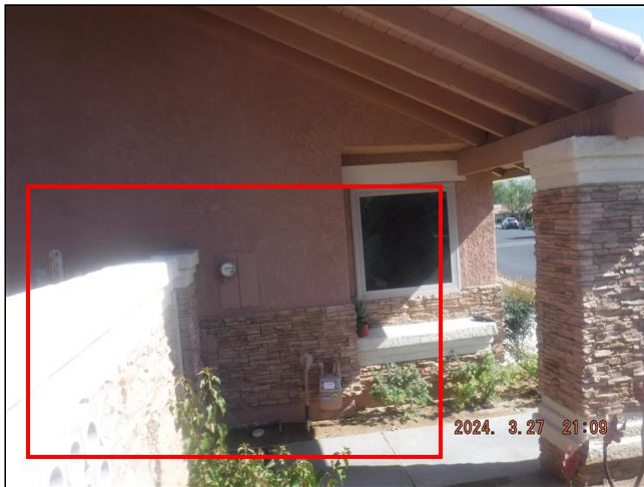
3.8 Item 2(Picture) Location of gas odor detected

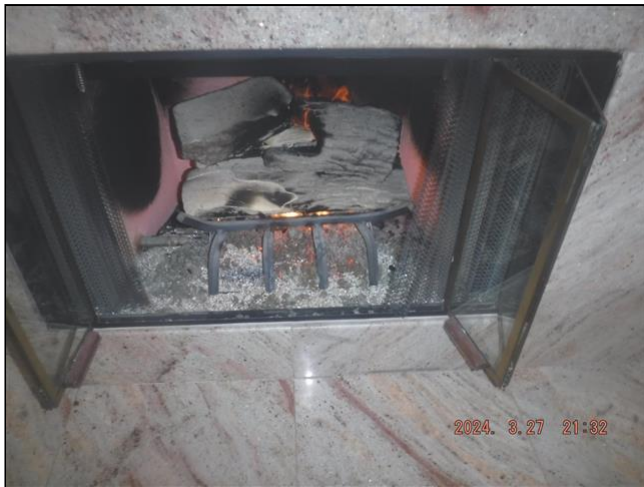
per the Gas Company in order to keep the flue damper open at all times for safety. Recommend to install c-clamp on damper. A qualified person should correct as needed.

4.6 Item 1(Picture) Fireplace Unit

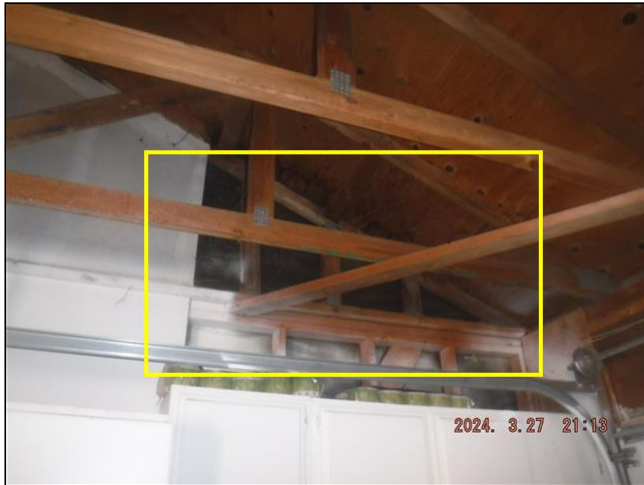
5.0 Item 1(Picture) Location of ceiling water stains

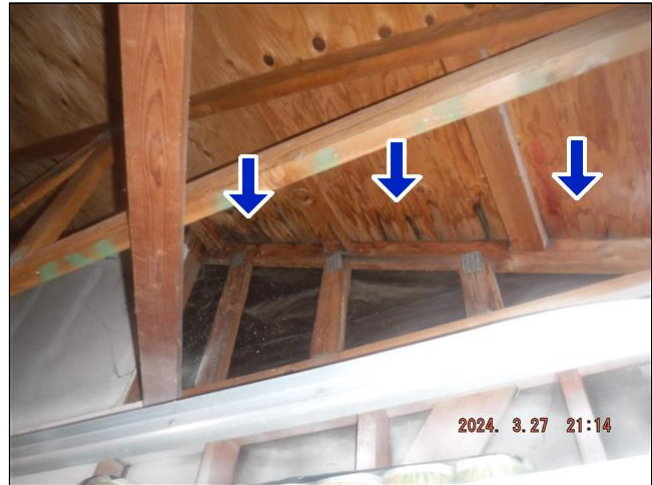
5.0 Item 2(Picture) Stained plywood sheathing

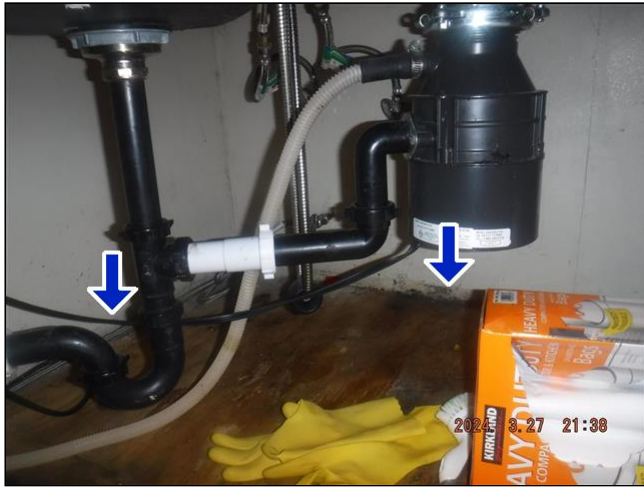
6.1 Item 1(Picture) Location of black substance

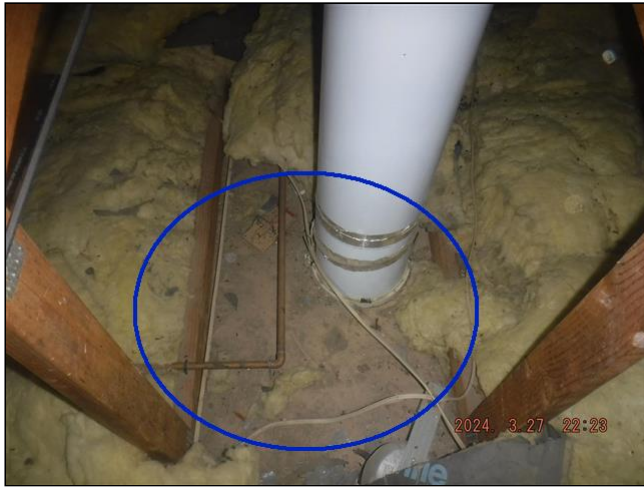
8.4 Item 1(Picture) Rodent droppings

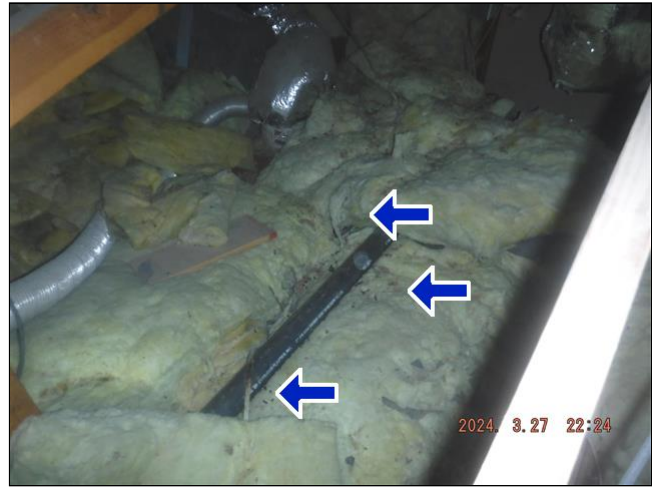
8.4 Item 2(Picture) Rodent droppings
