Inspection Report

Sample Report #1

Property Address:
715 El Placer Rd
Palm Springs CA 92264

Dominguez Property Inspections, LLC

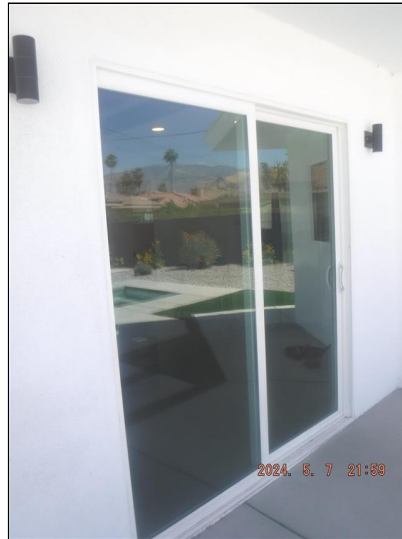
1.1 Item 2(Picture) Screen door missing

1.1 (1) Note, the sliding glass door(s) are missing the screen(s) at the back of the home. Screen doors help with pest management. This is for your information. Recommend to install door screen(s) as recommended, by a qualified person and company.

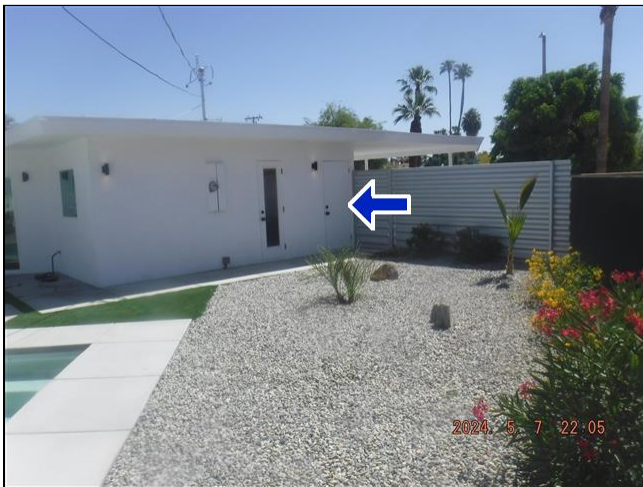
(2) Note: The exterior door on the left side of the home was locked at the time of inspection. Possible washer and dryer units location. Unable to locate key to unlock, therefore was not able to visually inspect the interior condition of this area or components.

1.1 Item 3(Picture) Location of lock door

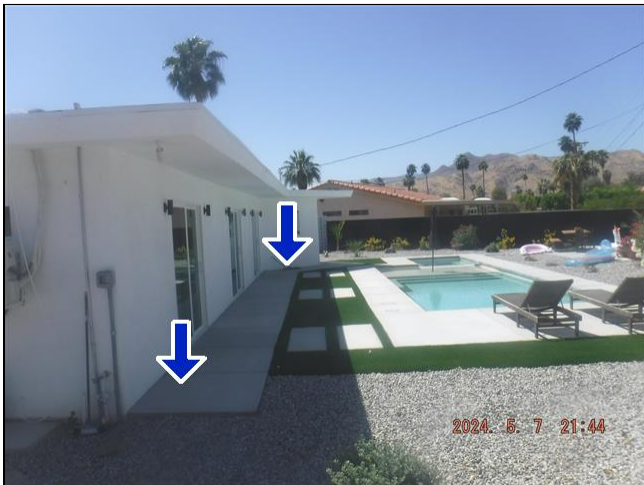
1.4 Noted the exterior concrete slab/walkway height, and slope at the front and back of the home perimeter can cause water ponding, water and or termite intrusion. Recommend the slab have a clearance of at least 3 inches and slope away from the home. Recommend a license general or landscape contractor further evaluate and repair or advise as desired.

1.4 Item 1(Picture) Walkway slab slope back of home

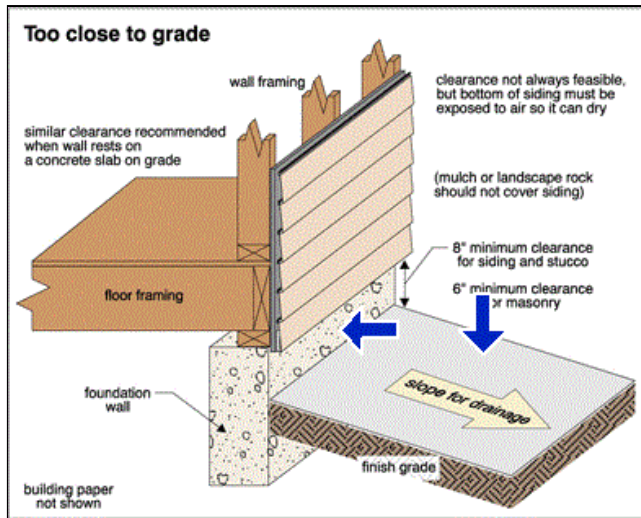
1.4 Item 4(Picture) Example of proper sloping slab

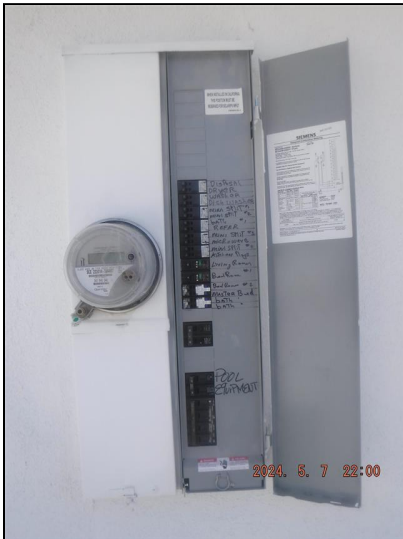
2.3 Item 1(Picture) Main electrical shut off (at panel)

2.3 The MAIN electrical panel box is located at the left side front of home. Main electrical disconnect.

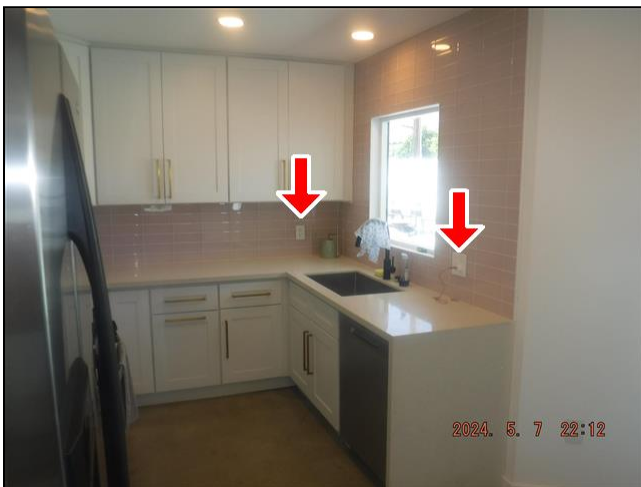
+ 2.5 Noted the GFCI (ground fault circuit interrupter) protected electrical outlet(s) is not present in the kitchen. Some of these style outlet(s) may have not been required at the time of construction, however we recommend to update to current electrical standards for safety. A GFCI electrical outlet(s) should be installed within 6 feet of interior plumbing fixtures. Recommend a license electrical contractor further evaluate and correct as required.

2.5 Item 1(Picture) No GFCI electrical outlet

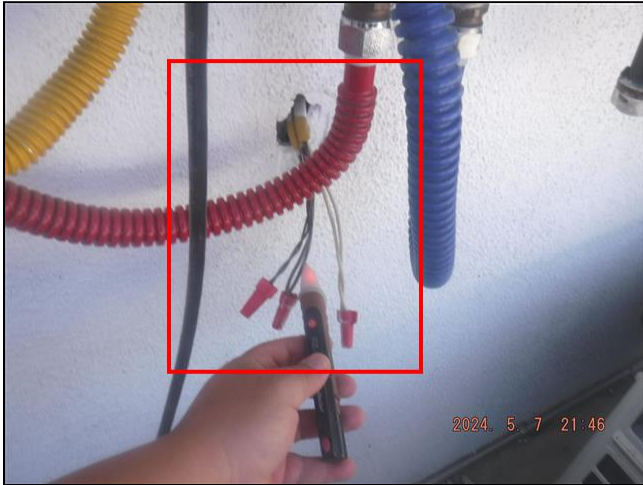
+ 2.6 (1) Noted expose(ed) electrical wiring (open splice) within reach was observed at the exterior right side of the home.

2.6 Item 1(Picture) Exposed electrical wiring (right of home)

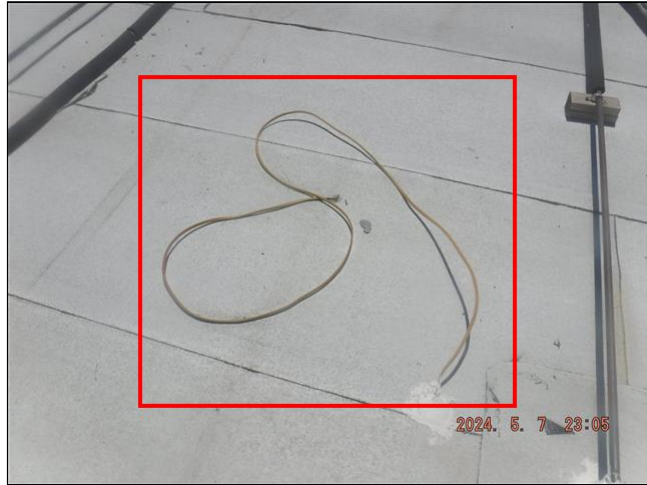
2.6 Item 2(Picture) Exposed electrical wiring (roof)

The grounding wire at the right side of the home is exposed and not properly connected or concealed. Exposed electrical wiring can be a safety issue if not corrected. Recommend a license electrical contractor further evaluate and repair or correct as needed.

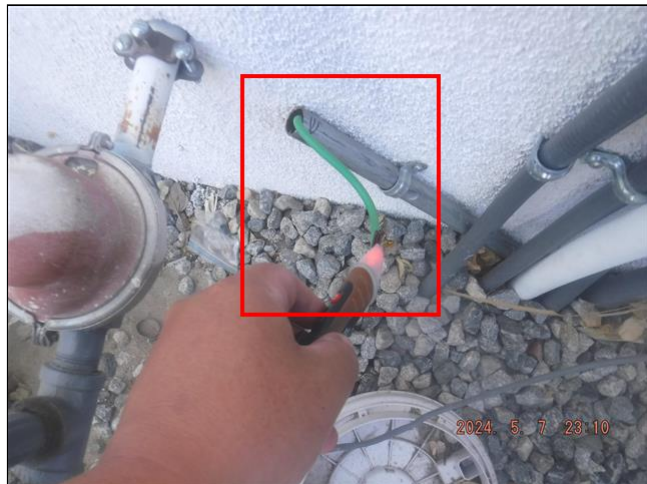
2.6 Item 4(Picture) Grounding wire at right side of home

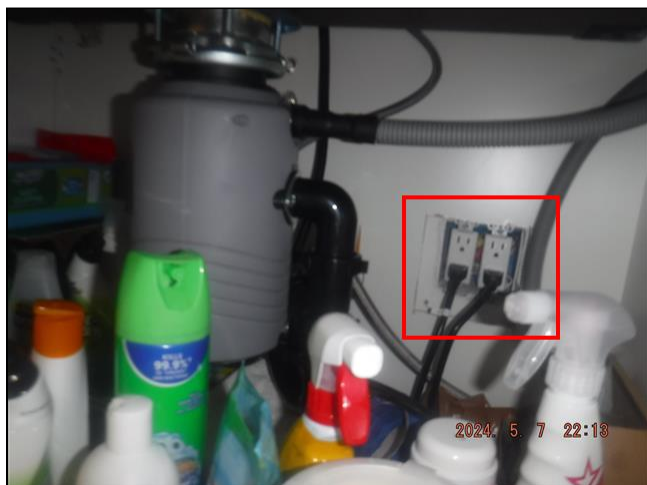
⊕ (2) Noted the electrical outlet(s) is missing a cover plate in the kitchen under the sink. Exposed wiring is considered unsafe until repaired or concealed. Cover plate should be installed. Recommend a license electrical contractor further evaluate and repair or replace as needed.

2.6 Item 5(Picture) Electrical outlet under kitchen sink

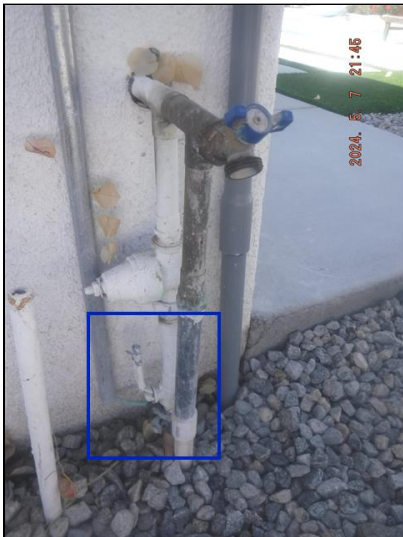
3.2 Item 1(Picture) Quick access water shut off valve location

3.2 The home quick access water shut off valve is located at the back right side of the home. Note: This valve will ONLY shut off the water supply going into home/dwelling. This is for your information.

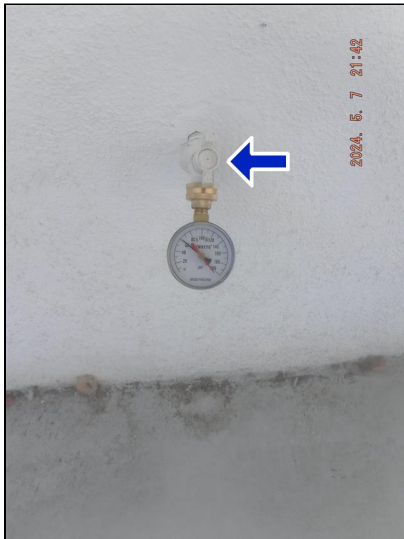
3.3 Item 1(Picture) Hose bib/ spigot (front of home)

(2) Noted the hose bib/spigot(s) are missing a anti-siphon valve at the front, back and sides of home. Anti-siphon valve(s) on hose bib/spigot(s) are required to prevent water from back flowing into the home, this can possibly cause cross-contamination of the water supply. Installation of anti-siphon valves is a small repair. Recommend a license plumbing contractor further evaluate and repair, replace or advise as needed.

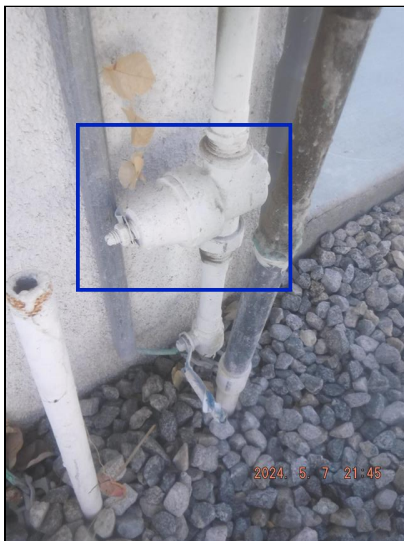
3.5 Item 1(Picture) Water pressure regulator location

3.5 Water pressure regulator is not part of a standard home inspection. The pressure regulator is shown for location purposes only.

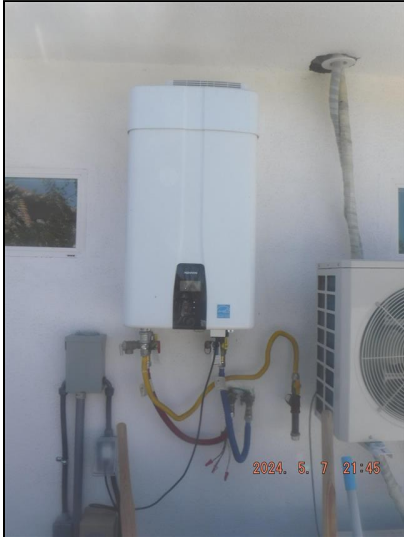
3.6 Item 1(Picture) Water Heater Unit

3.6 (1) Noted the water heater unit was operational at the time of inspection. Unit condition appeared new. Recommend a qualified license plumbing contractor repair, and or maintenance as/when needed.

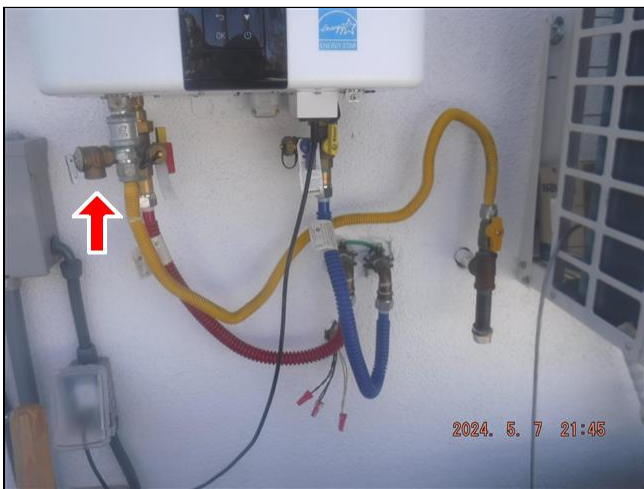
+ (2) Noted the T & P (Temperature and Pressure) release valve for the water heater does not have a qualified discharge pipe. This is a safety issue. A discharge pipe should be installed and it should extend to within 6 inches of the floor. (PVC is not approved for hot water use). Discharge pipe should be of copper, galvanize or a rated (high temperature) piping material. Recommend a license plumbing contractor further evaluate and repair as required.

3.6 Item 2(Picture) T&P valve missing discharge pipe

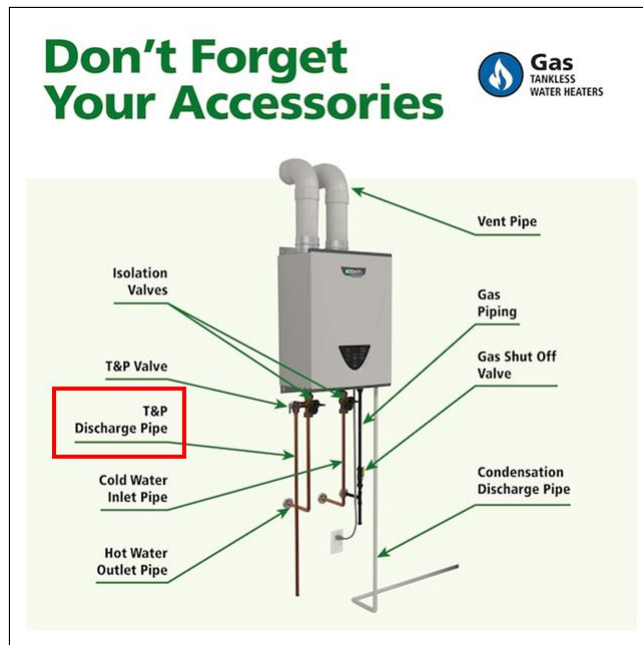
3.6 Item 3(Picture) Example of water heater with discharge pipe

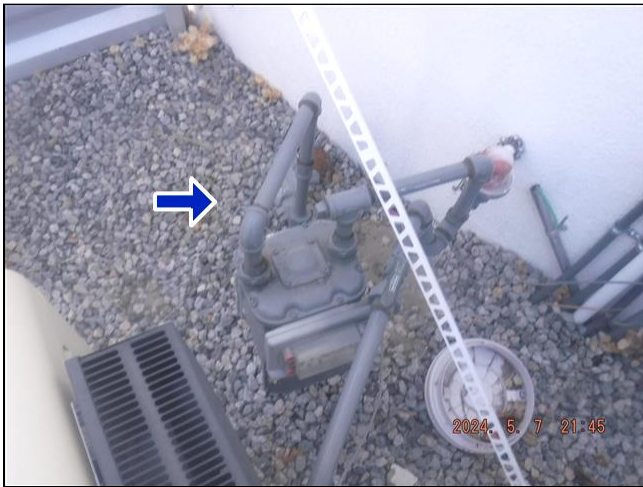
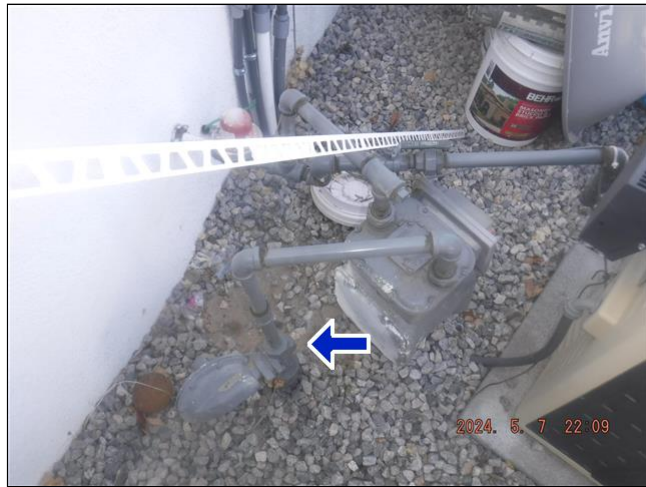
Gas meter is a public utility component and therefore inspected for leaks only.

3.8 Item 1(Picture) Main Gas Shut Off (At Meter)

3.8 Item 2(Picture) Main Gas Shut Off (At Meter)

Recommend to store a qualified wrench, and or tool near the gas shut off valve for quick shut off access.

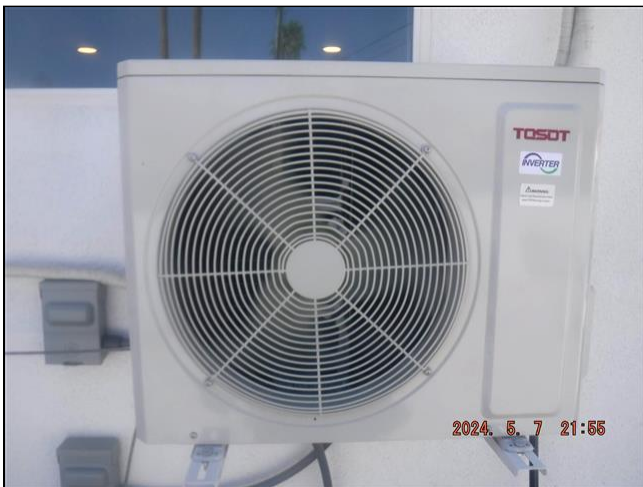
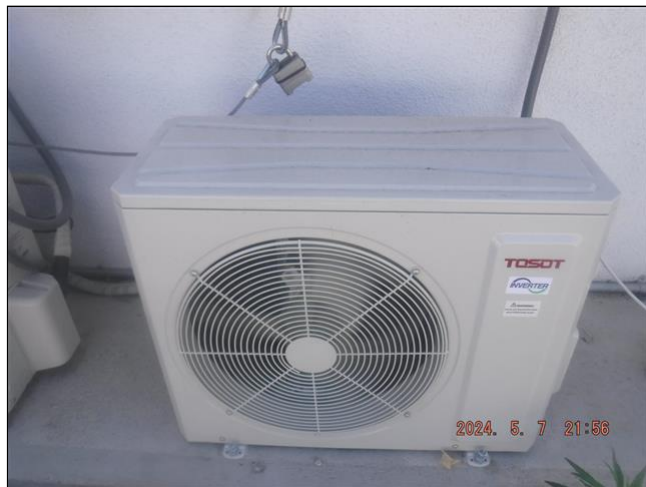
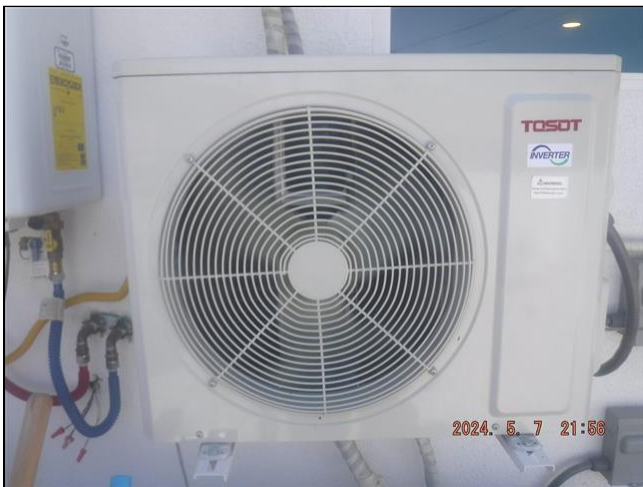
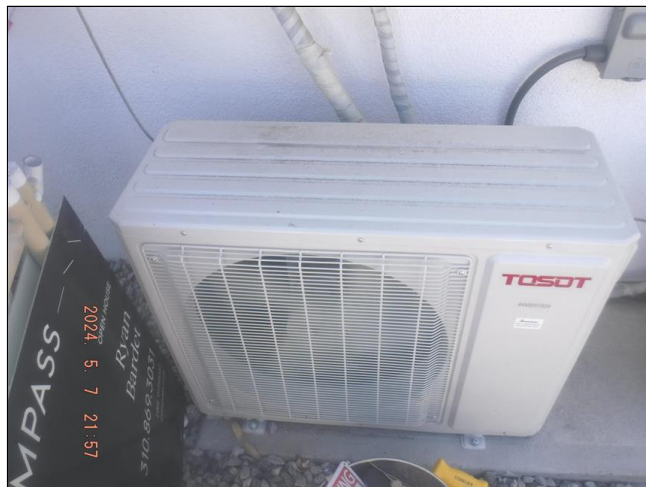
Note, three units are 1 tons, and one unit is a 2 ton.

4.0 Item 1(Picture) Mini air conditioning unit

4.0 Item 2(Picture) Mini air conditioning unit 2

4.0 Item 3(Picture) Mini air conditioning unit 3

4.0 Item 4(Picture) Mini air conditioning unit 4

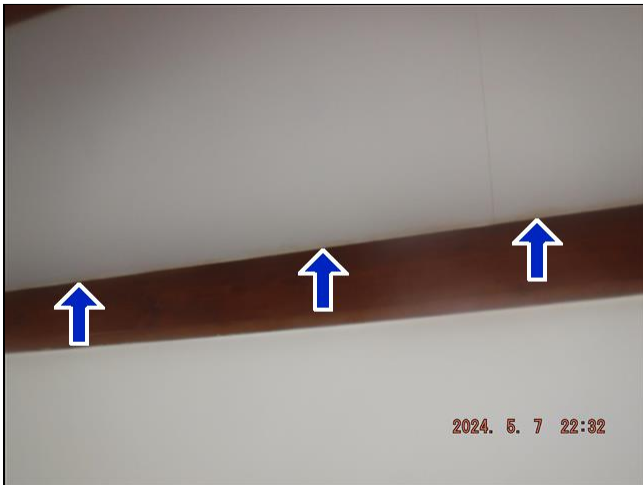
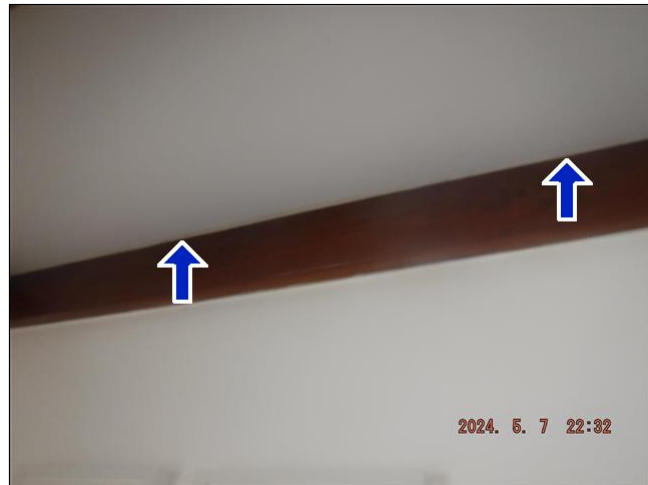
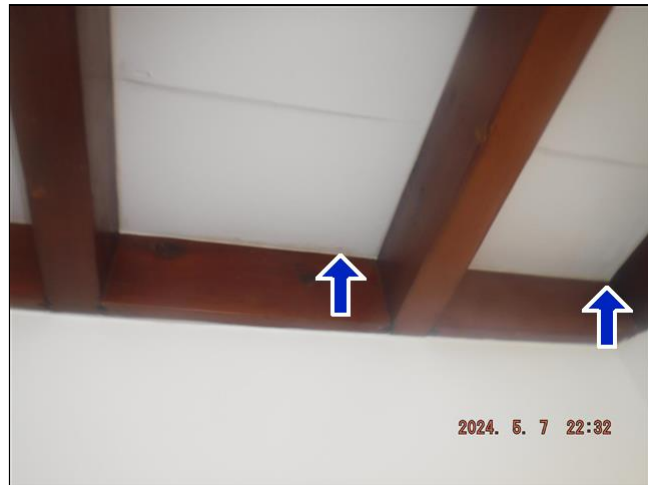
5.0 Noted the paneling on the ceiling revealed minor light moisture stains on the edges possibly indicating a leak did, or still may exists at the living room. Due to recent dry weather, I was unable to determine if this stain(s) are from a current or previous leak. Stains were dry at the time of inspection. Recommend a license general contractor further evaluate and repair or replace as needed.

5.0 Item 1(Picture) Ceiling stains

5.0 Item 2(Picture) Ceiling stains

5.0 Item 4(Picture) Ceiling stains

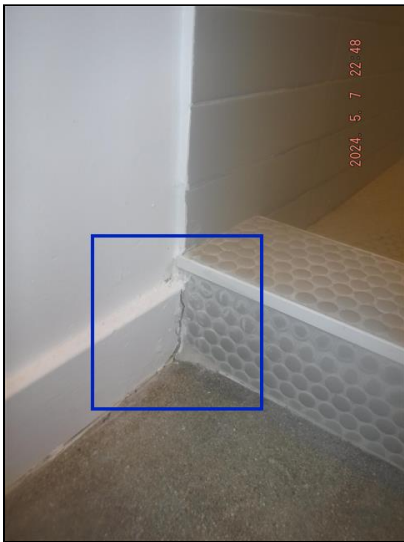
5.1 Item 1(Picture) Signs of water damage on wall

5.1 Noted the drywall/baseboard appears to have signs of minor water damage (drywall is peeling, wrapping, and or stained) at the guest bathroom side of shower stall. Unable to determine the source of water damage. This could have occurred from water seeping out of the shower pan when being used. This needs repairing to avoid further deterioration/damage. Recommend installing glass barrier or door to prevent continued damaged. Recommend a license contractor further evaluate and repair or replace as needed.

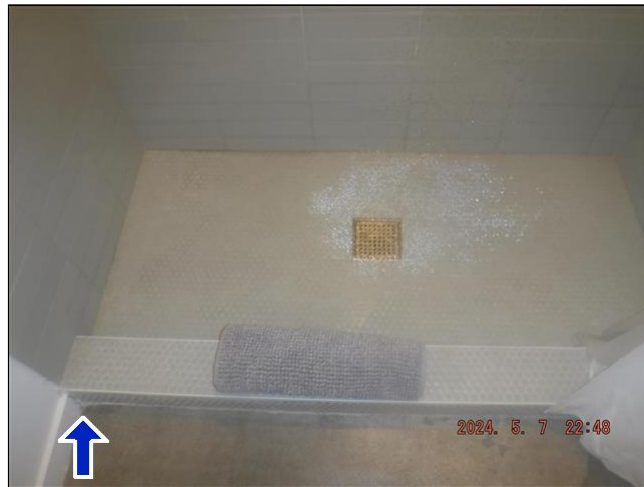
5.1 Item 2(Picture) Signs of water damage on wall

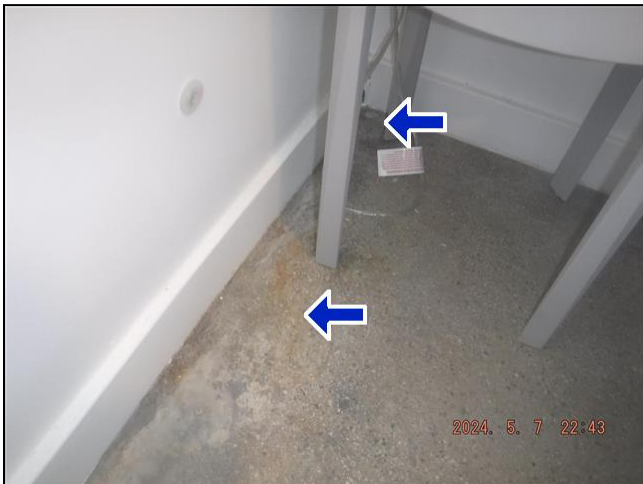
5.2 Item 1(Picture) Stained slab floor (guest bedroom)

5.2 Noted the concrete slab floor is stained at the living room, guest and master bedrooms. Unable to determine source of these stains.

The baseboard on the wall is wrapping, and or caulking at the seams is failing around the stained flooring. Recommend to monitor these areas during heavy rain fall for water intrusion. Recommend a license general contractor further evaluate and repair or replace as needed.

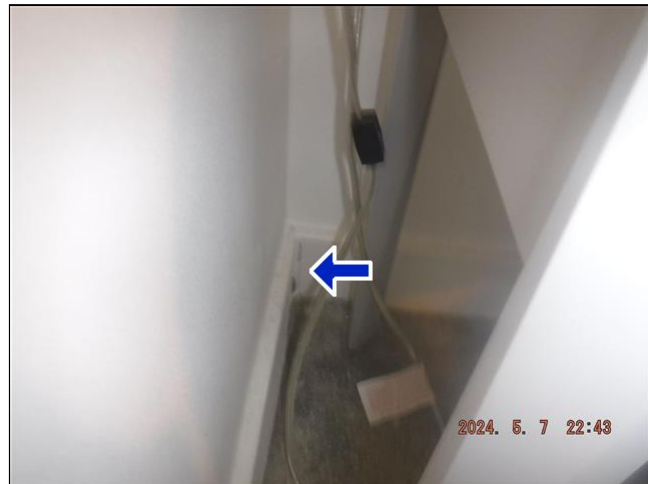
5.2 Item 2(Picture) Baseboard caulking failing

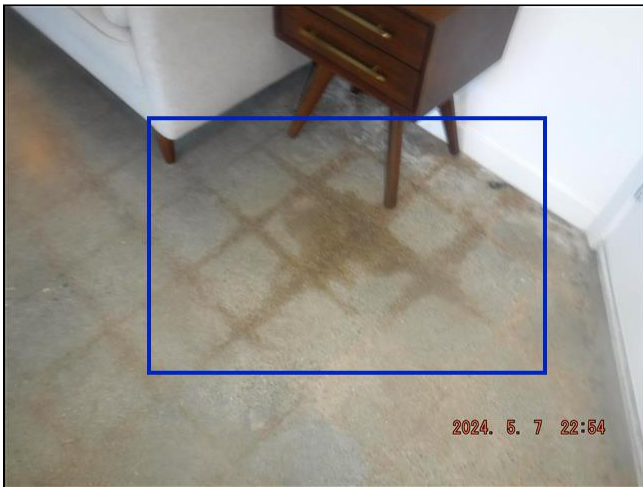
5.2 Item 5(Picture) Stained slab floor (living room)

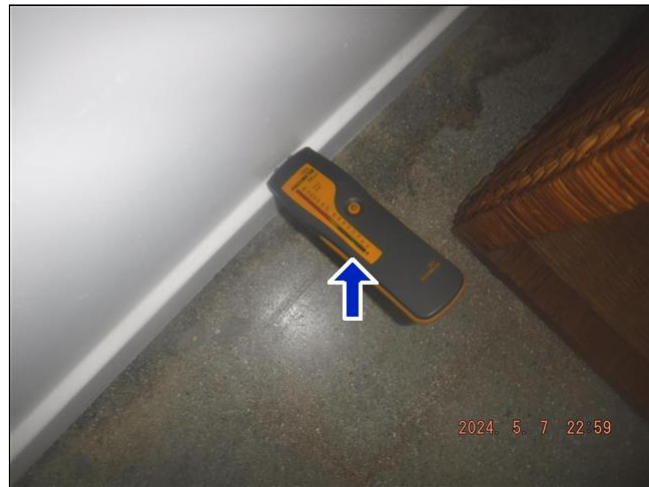
5.2 Item 6(Picture) Moisture meter (device) indicated dry surface

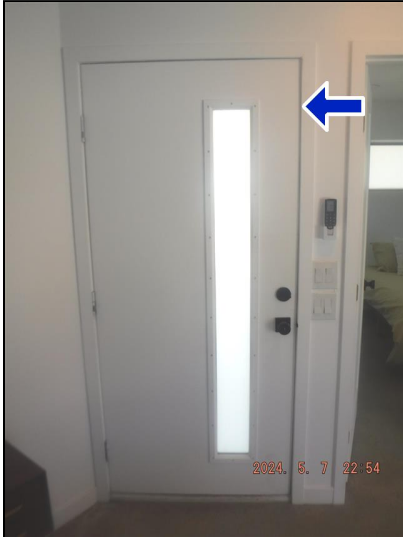
5.4 Item 1(Picture) Main entry door

5.4 (1) Noted the main entry door rubs at top when closing at the living room. Door may need adjustment or replacement. Recommend a license general contractor further evaluate and repair or replace as needed.

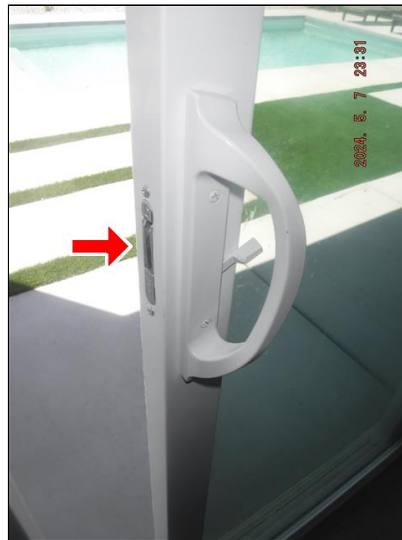
5.4 Item 4(Picture) Door did not lock properly

+ (2) Noted the sliding glass door(s) did not lock securely when tested at the living room. Door(s), and or sliders should lock for safety. Recommend a window/door specialist/contractor further evaluate and repair or replace as needed.

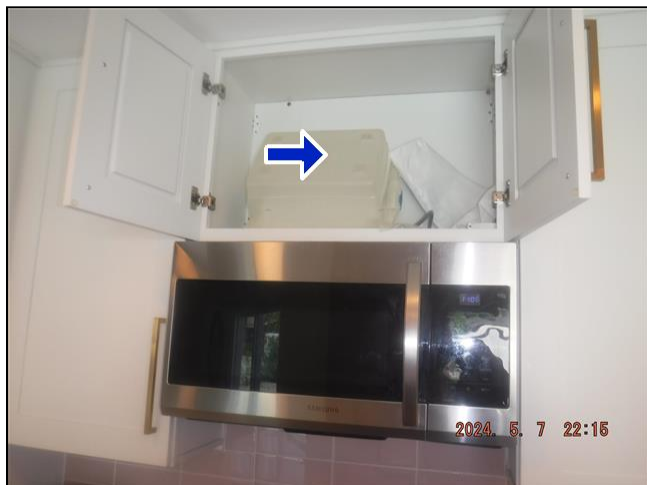
6.4 The range hood fan is integrated into the microwave and is missing a vent pipe. Range hood fan did not appear to vent/exhaust to the outside. It's recommended to vent the air to the outdoors than to recirculate it into the room. A vented hood that removes steam, smoke, heat, and cooking odors is the best way to keep your kitchen clean, since it gets rid of grease particles that would otherwise accumulate on your walls and cabinets. This is just a recommendation. Recommend a qualified person further evaluate and repair or replace as needed.

6.4 Item 1(Picture) Range hood fan not vent outdoors

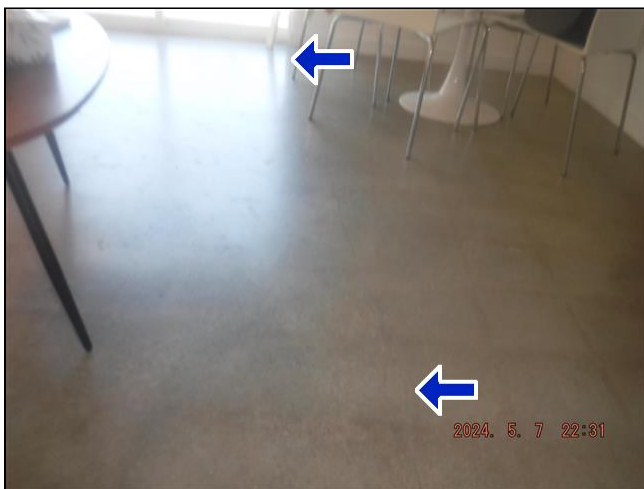
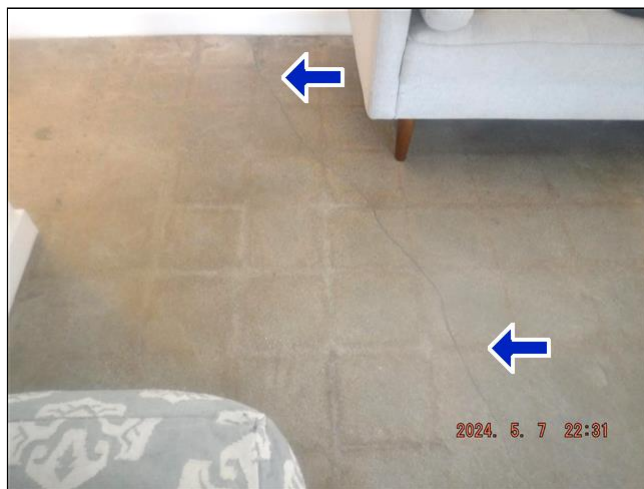
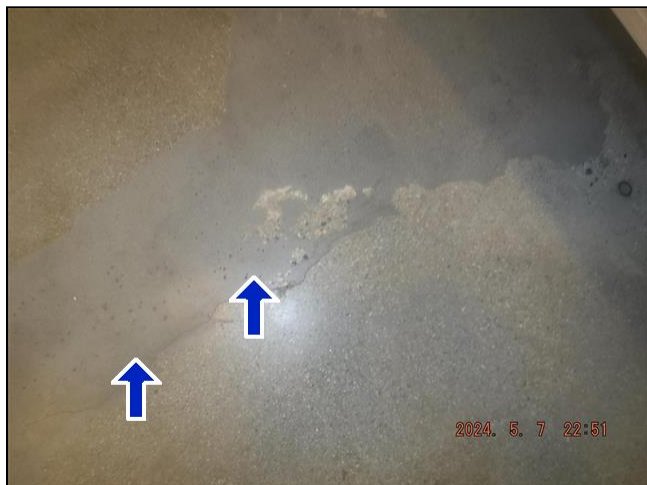
7.0 Noted a few settlement crack(s) were observed on the concrete slab (foundation) at the living room and master bathroom. Crack(s) can be a simple to a complex issue, settlements cracks are common. Recommend crack(s) sealed as needed to minimize further deterioration. If this is a concern to buyer recommend a structural engineer further evaluate and advise as desired. Recommend a license contractor repair or advise as desired.

7.0 Item 1(Picture) Slab crack (living room)

7.0 Item 2(Picture) Slab crack (living room)

7.0 Item 3(Picture) Slab crack (master bath)

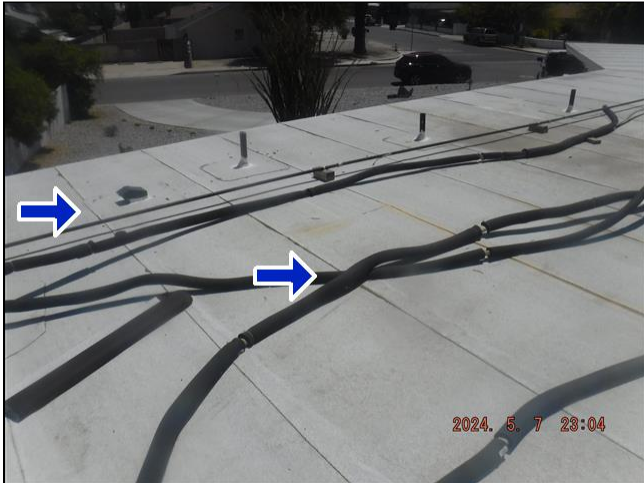
9.0 Item 1(Picture) Roll seams

(2) Noted the asphalt rolls sealant at the seams appears to be failing at various locations of the roof. I am unable to determine if this current condition of the sealant will continue to fail. Improper sealant can lead to leaks if not corrected. Recommend a license roof contractor further evaluate and repair or replace as needed.

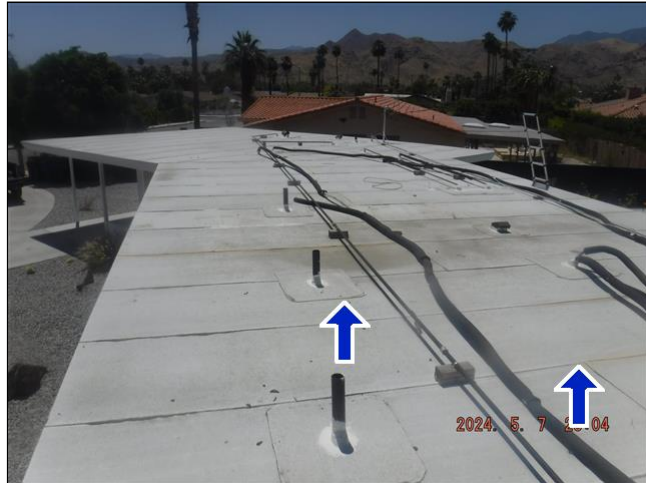
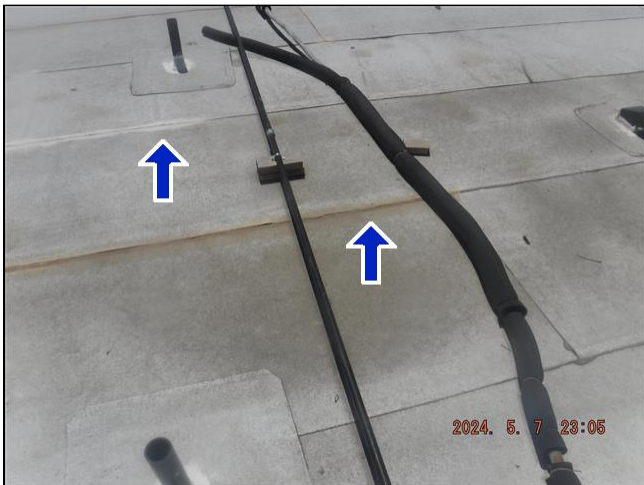
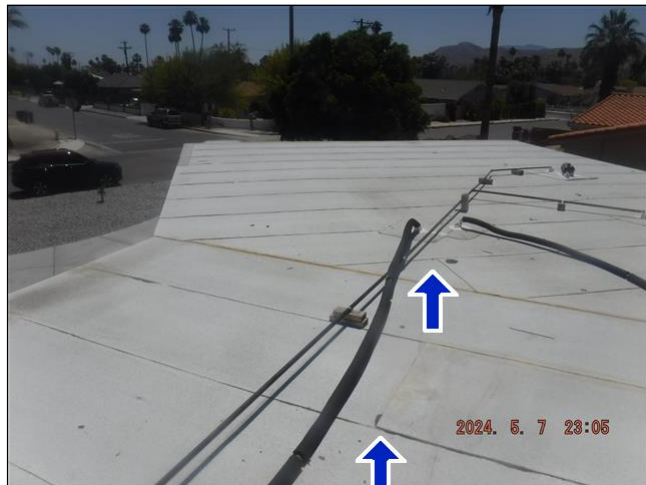
9.0 Item 2(Picture) Seem sealant failing

9.0 Item 3(Picture) Seem sealant failing

9.0 Item 4(Picture) Seem sealant failing

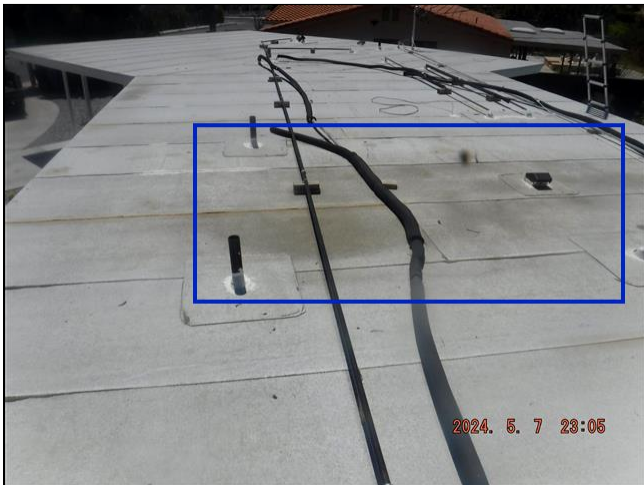
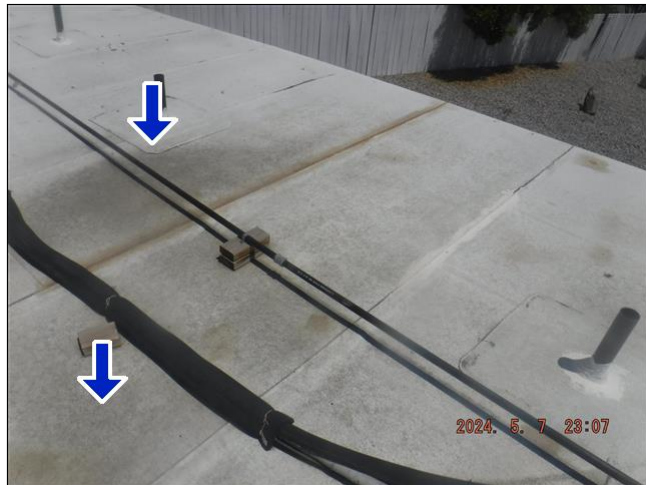
(3) Noted signs of water ponding was observed at various locations of the roof. Water ponding on a flat roof is very common, however, it can cause the roof covering to deteriorate sooner than expected. Leakage from deteriorated roof coverings are more likely to occur if not maintenance periodically. Recommend a license roof contractor further evaluate and repair or advise as desired.

9.0 Item 5(Picture) Water ponding signs on roof

9.0 Item 6(Picture) Water ponding signs on roof

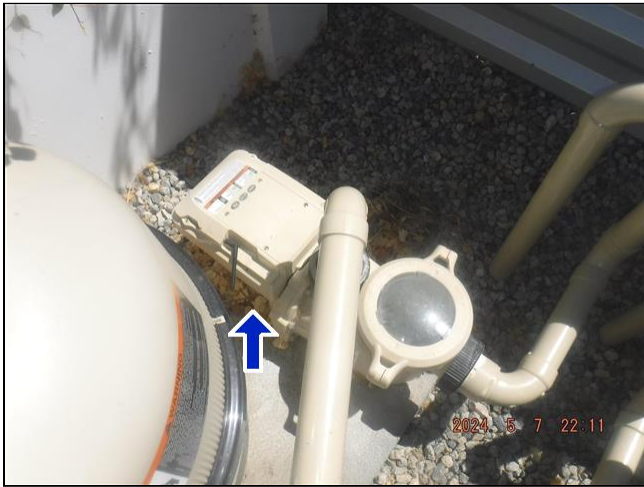
Pump bonded/grounded for safety.

10.5 Item 1(Picture) Pump bonded/grounded for safety

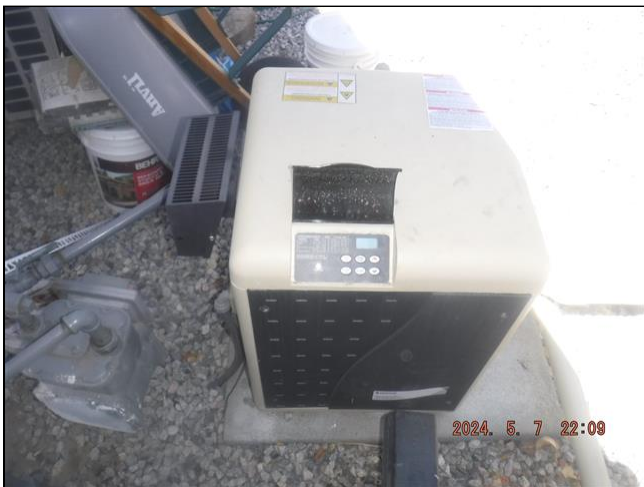
10.8 Item 1(Picture) Pool heating unit

10.8 The pool & spa heating unit(s) was operational at the time of inspection. This is for your information.

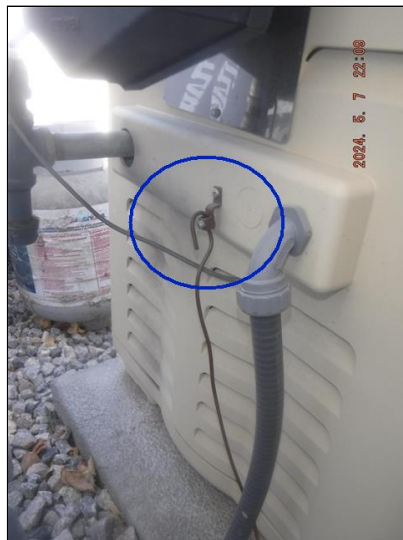
10.8 Item 2(Picture) Heating unit bonded/grounded for safety

Heating unit bonded/grounded for safety.

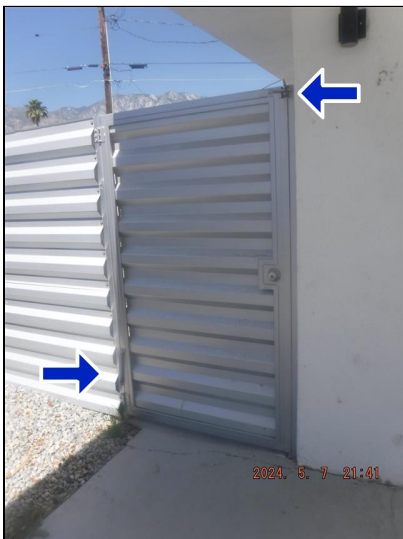
10.19 Item 1(Picture) Gate door

10.19 Note: California pool safety regulations require property fence gate(s) to have certain devices in place. This is required if a pool or spa is present on the property grounds. The gate door(s) leading to the pool or spa should have a self-closing, and self-latching devices installed/in place. After further review of the property gate(s) it was determined that the gate door does comply with the safety pool requirements. This is for your information

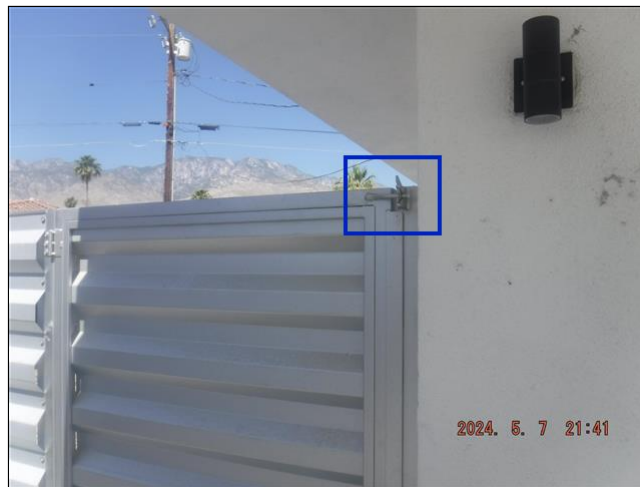
10.19 Item 2(Picture) Self-latching device

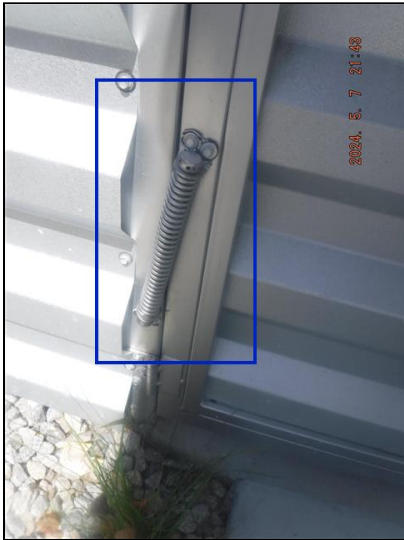
10.19 Item 3(Picture) Self-closing device

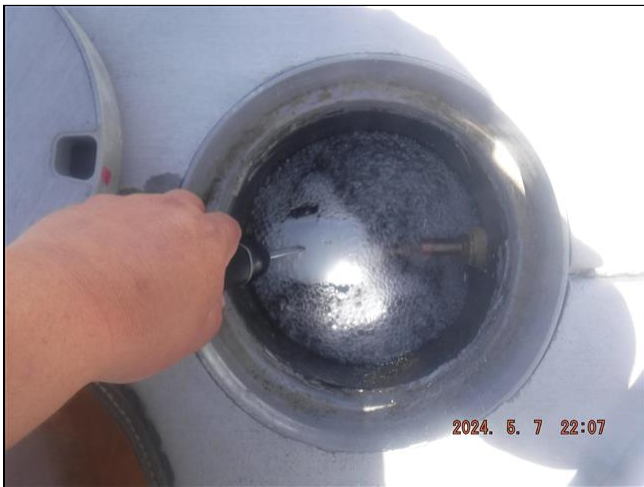
10.23 The pool and spa auto fill was operational at the time of inspection. This is for your information.

10.23 Item 1(Picture) Pool auto fill feature

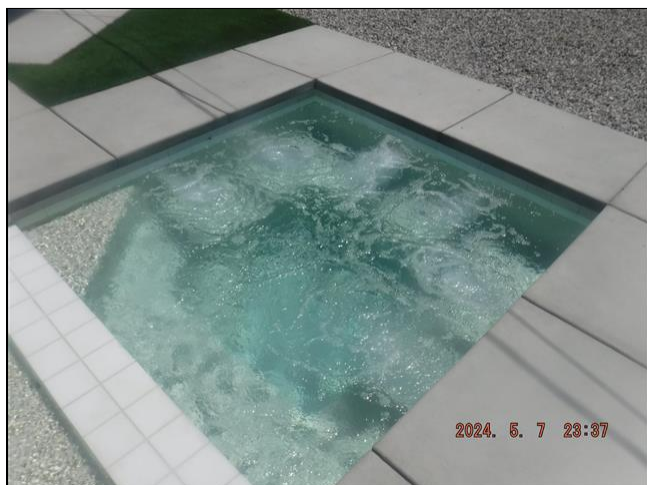
10.27 Noted the spa jets were operational, however, the jets pressure appeared weak, and or not adequate when tested at the time of inspection. This can be a maintenance or a more complex issue. Unable to determine if a possible issue exists. This is for your information. Recommend a license pool contractor further evaluate and repair or advise as desired.

10.27 Item 1(Picture) Spa jets

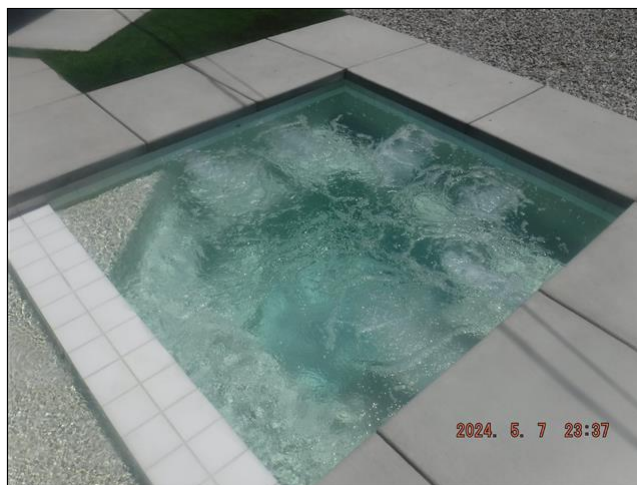
10.27 Item 2(Picture) Jets pressure was weak

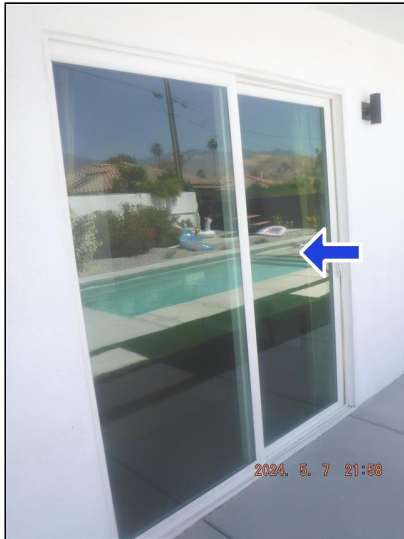
(1) **Note, the sliding glass door(s) are missing the screen(s) at the back of the home. Screen doors help with pest management. This is for your information. Recommend to install door screen(s) as recommended, by a qualified person and company.**

1.1 Item 1(Picture) Screen door missing

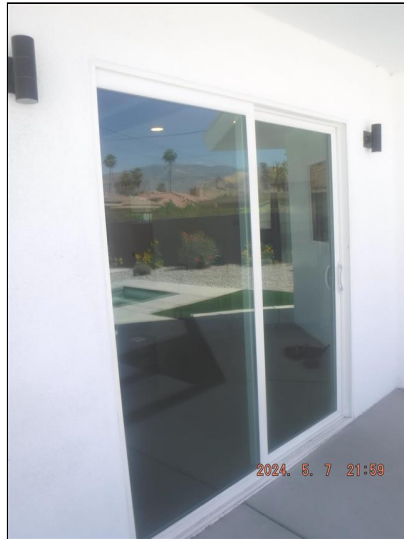
1.1 Item 2(Picture) Screen door missing

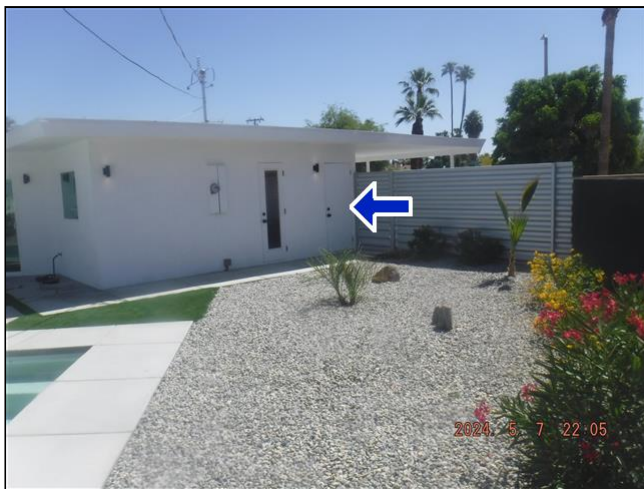
(2) **Note: The exterior door on the left side of the home was locked at the time of inspection. Possible washer and dryer units location. Unable to locate key to unlock, therefore was not able to visually inspect the interior condition of this area or components.**

1.1 Item 3(Picture) Location of lock door

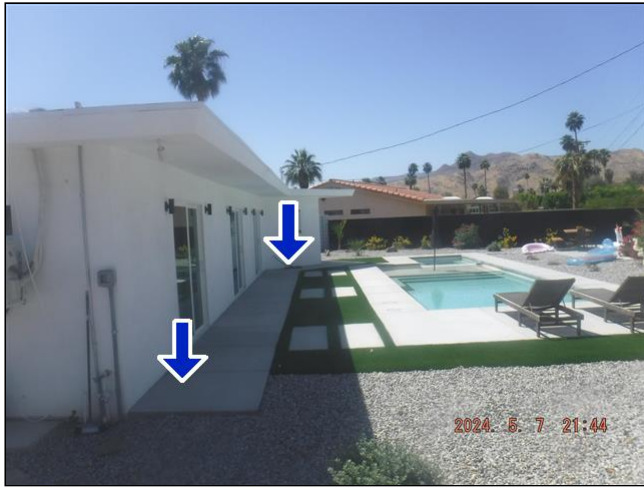
Noted the exterior concrete slab/walkway height, and slope at the front and back of the home perimeter can cause water ponding, water and or termite intrusion. Recommend the slab have a clearance of at least 3 inches and slope away from the home. Recommend a license general or landscape contractor further evaluate and repair or advise as desired.

1.4 Item 1(Picture) Walkway slab slope back of home

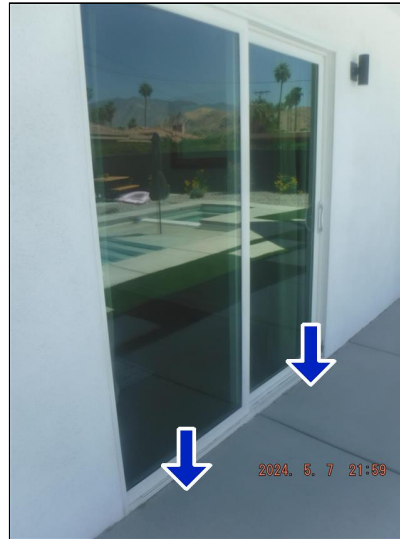
1.4 Item 2(Picture) Walkway height, or near to door threshold

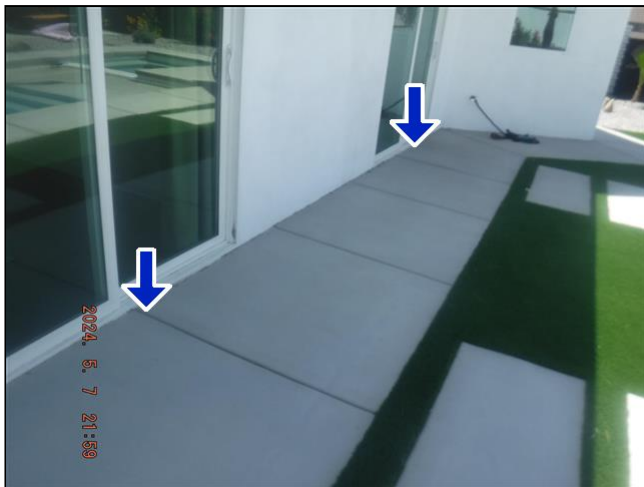
1.4 Item 3(Picture) Walkway slop, or near to door threshold

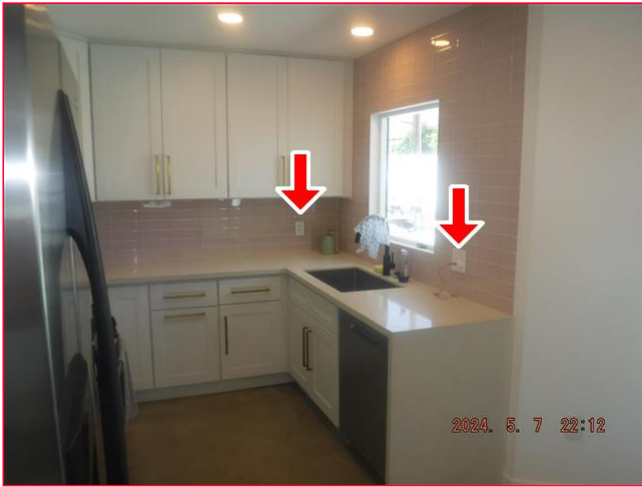
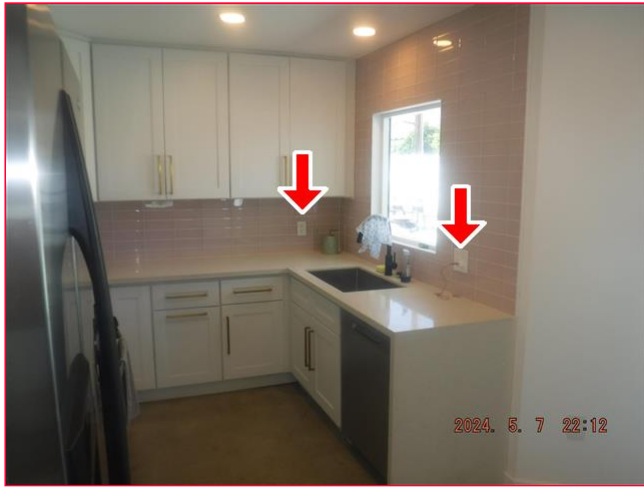
Noted the GFCI (ground fault circuit interrupter) protected electrical outlet(s) is not present in the kitchen. Some of these style outlet(s) may have not been required at the time of construction, however we recommend to update to current electrical standards for safety. A GFCI electrical outlet(s) should be installed within 6 feet of interior plumbing fixtures. Recommend a license electrical contractor further evaluate and correct as required.

2.5 Item 1(Picture) No GFCI electrical outlet

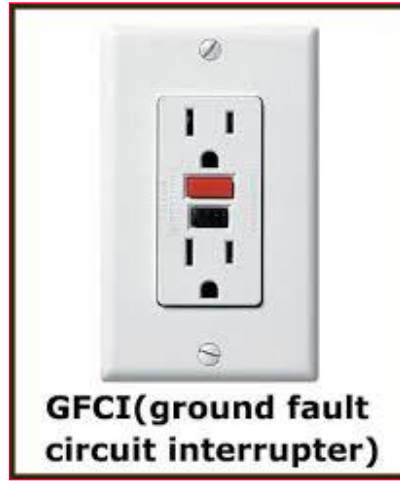
2.5 Item 2(Picture) Example of GFCI outlet

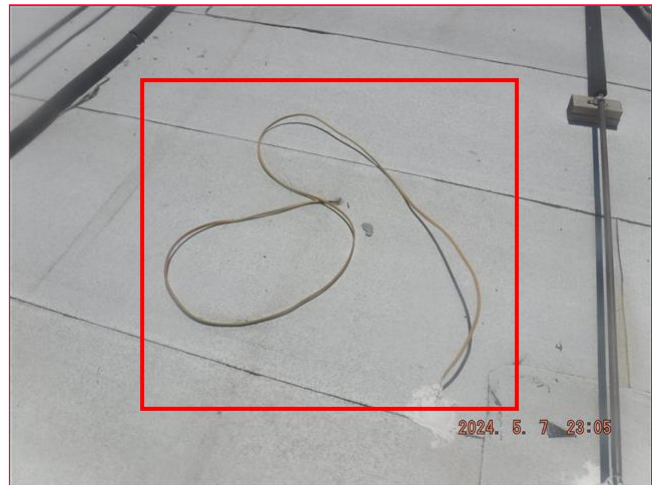
(1) **Noted expose(ed) electrical wiring (open splice) within reach was observed at the exterior right side of the home.**

2.6 Item 2(Picture) Exposed electrical wiring (roof)

The grounding wire at the right side of the home is exposed and not properly connected or concealed. Exposed electrical wiring can be a safety issue if not corrected. Recommend a license electrical contractor further evaluate and repair or correct as needed.

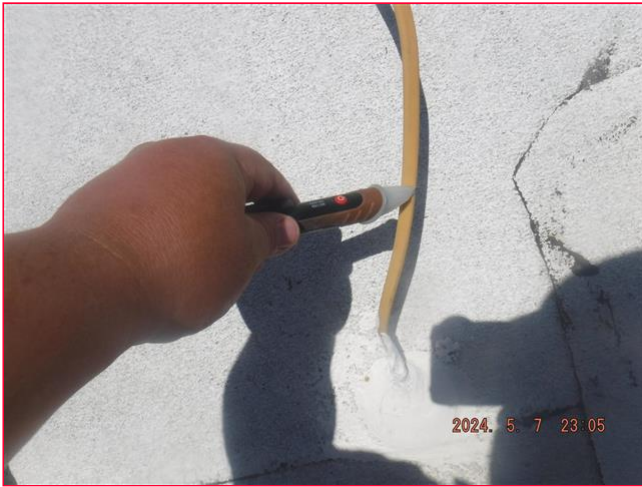
2.6 Item 3(Picture) Exposed electrical wiring (roof)

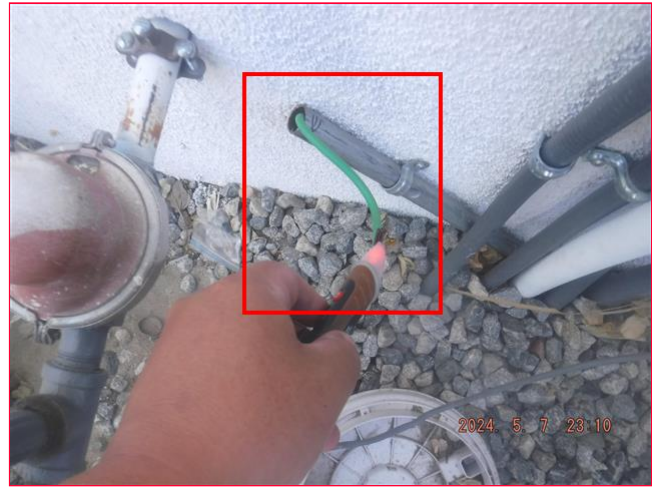
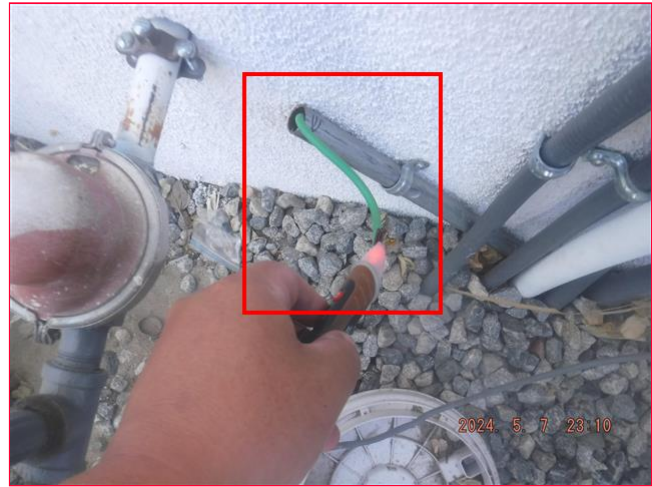
2.6 Item 4(Picture) Grounding wire at right side of home

The grounding wire at the right side of the home is exposed and not properly connected or concealed. Exposed electrical wiring can be a safety issue if not corrected. Recommend a license electrical contractor further evaluate and repair or correct as needed.
