Inspection Report

Sample Report #1

Property Address:
715 El Placer Rd
Palm Springs CA 92264

Dominguez Property Inspections, LLC

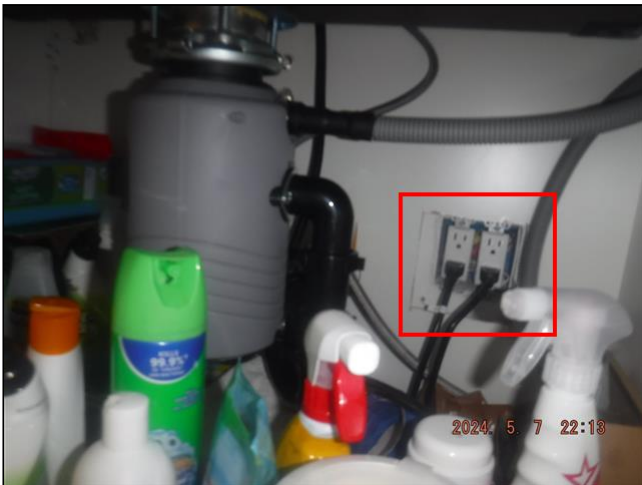
(2) **Noted the electrical outlet(s) is missing a cover plate in the kitchen under the sink. Exposed wiring is considered unsafe until repaired or concealed. Cover plate should be installed. Recommend a license electrical contractor further evaluate and repair or replace as needed.**

2.6 Item 5(Picture) Electrical outlet under kitchen sink

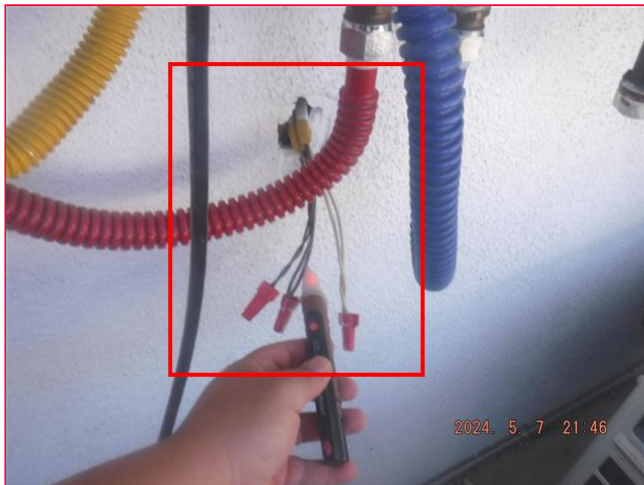
The grounding wire at the right side of the home is exposed and not properly connected or concealed. Exposed electrical wiring can be a safety issue if not corrected. Recommend a license electrical contractor further evaluate and repair or correct as needed.

2.6 Item 1(Picture) Exposed electrical wiring (right of home)

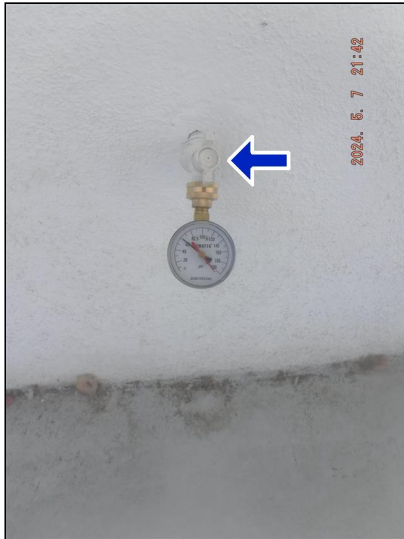
(2) Noted the hose bib/spigot(s) are missing a anti-siphon valve at the front, back and sides of home. Anti-siphon valve(s) on hose bib/spigot(s) are required to prevent water from back flowing into the home, this can possibly cause cross-contamination of the water supply. Installation of anti-siphon valves is a small repair. Recommend a license plumbing contractor further evaluate and repair, replace or advise as needed.

3.3 Item 1(Picture) Hose bib/ spigot (front of home)

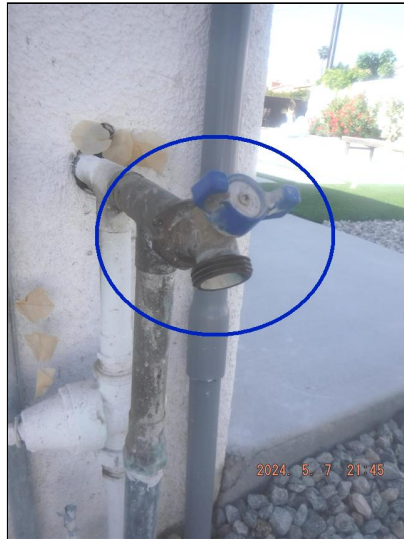
3.3 Item 2(Picture) Hose bib/ spigot (back right of home)

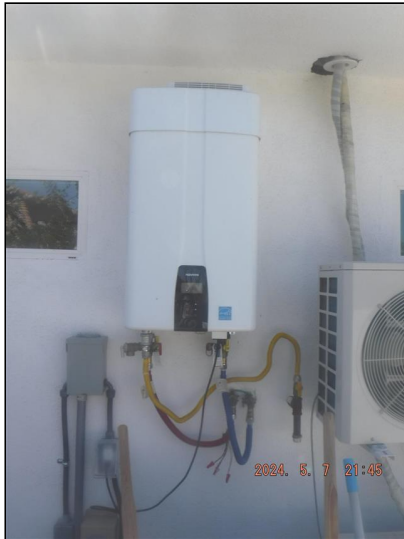
(1) Noted the water heater unit was operational at the time of inspection. Unit condition appeared new. Recommend a qualified license plumbing contractor repair, and or maintenance as/when needed.

3.6 Item 1(Picture) Water Heater Unit

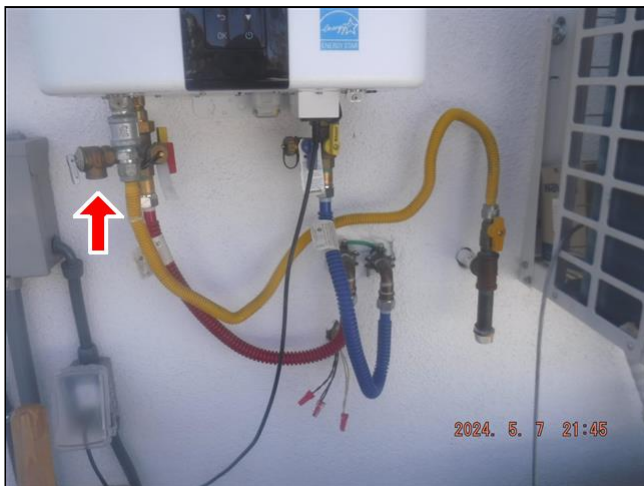
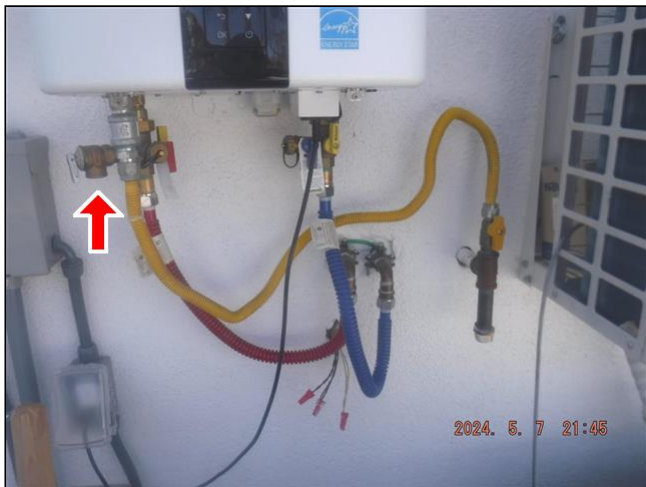
(2) **Noted the T & P (Temperature and Pressure) release valve for the water heater does not have a qualified discharge pipe. This is a safety issue. A discharge pipe should be installed and it should extend to within 6 inches of the floor. (PVC is not approved for hot water use). Discharge pipe should be of copper, galvanize or a rated (high temperature) piping material. Recommend a license plumbing contractor further evaluate and repair as required.**

3.6 Item 2(Picture) T&P valve missing discharge pipe

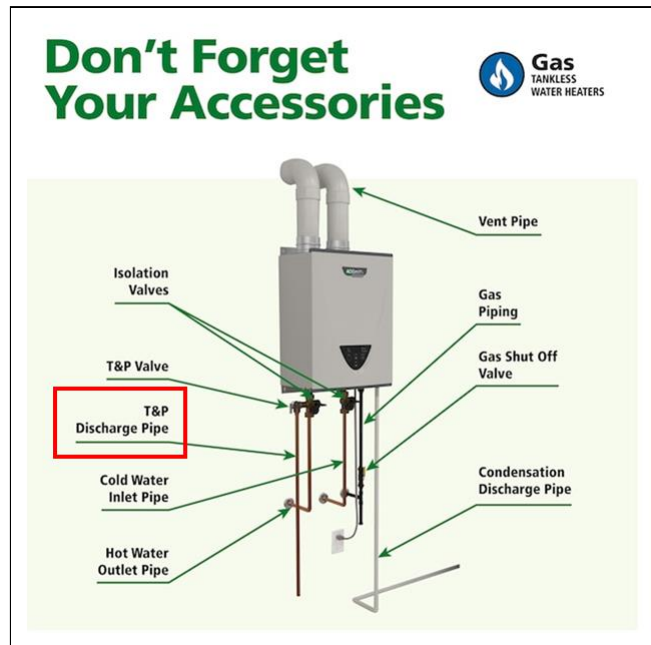
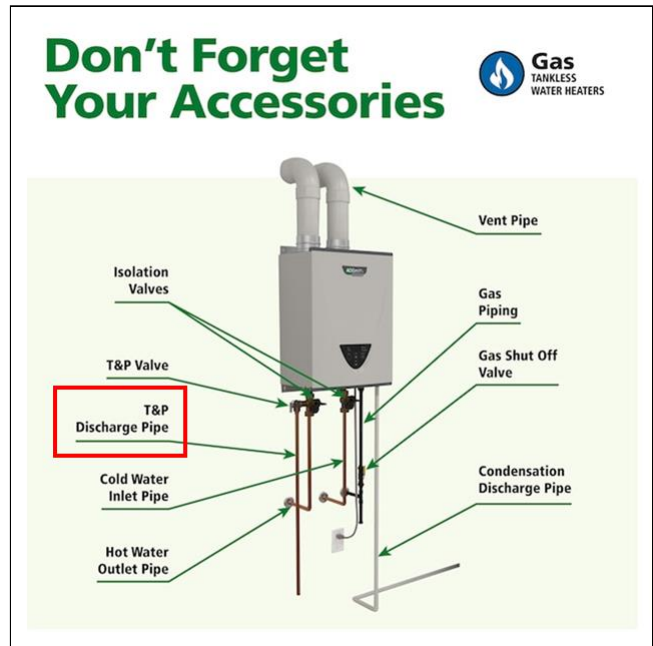
3.6 Item 3(Picture) Example of water heater with discharge pipe

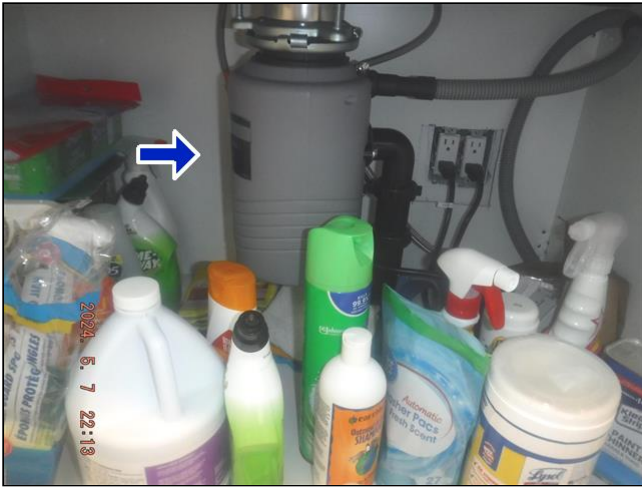
Noted the hot and cold water controls for the sink faucet in the kitchen were reversed. This can lead to confusion and accidental scalding. Recommend a license plumbing contractor evaluate and repair or replace as required.

3.10 Item 1(Picture) Sink water valves location

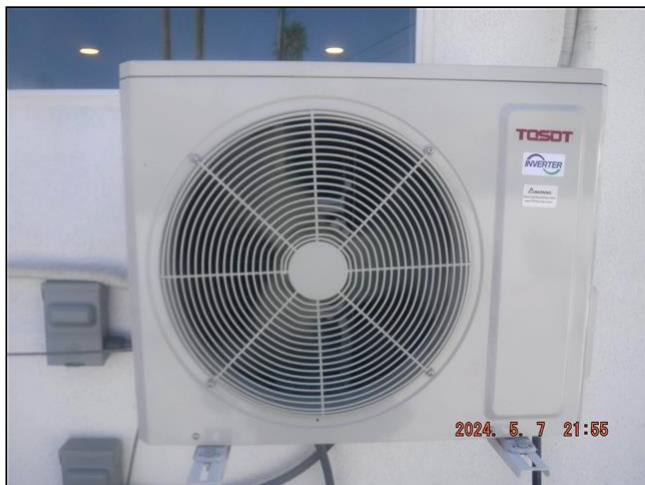
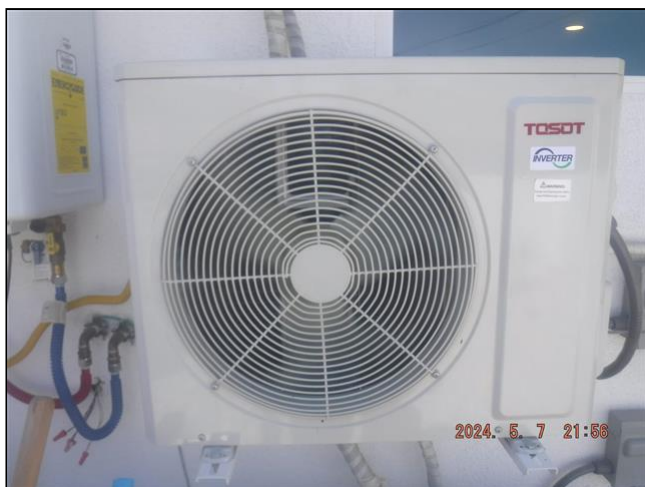
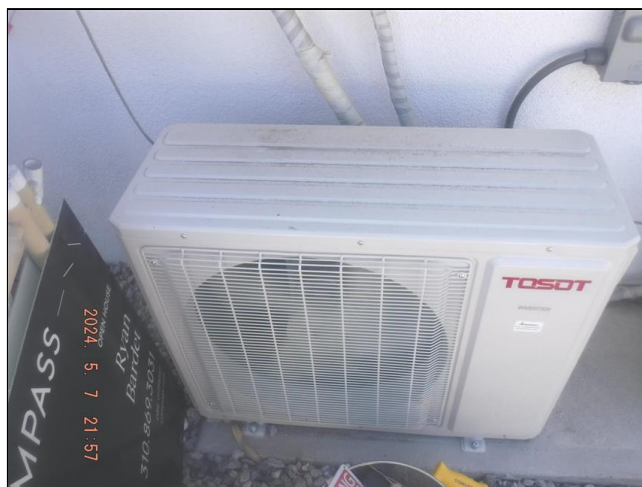
Note, three units are 1 tons, and one unit is a 2 ton.

4.0 Item 1(Picture) Mini air conditioning unit

4.0 Item 3(Picture) Mini air conditioning unit 3

4.0 Item 4(Picture) Mini air conditioning unit 4

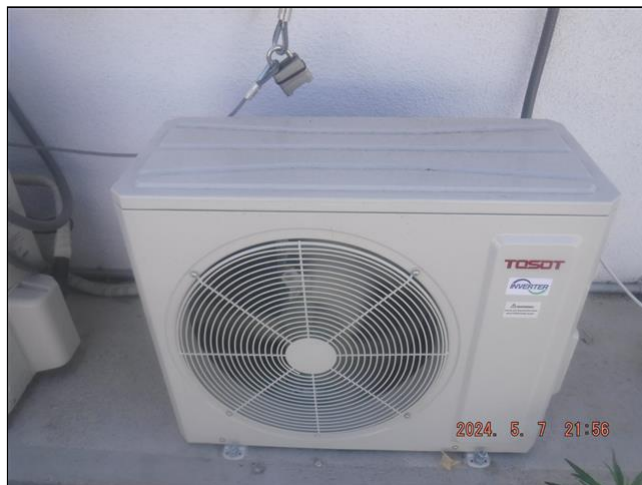
(1) The mini split air conditioning units operated satisfactory at the time of inspection. Condition appeared new. I recommend to service unit system (for example, replacing filters, checking system gas levels and equipment condition) per manufacture guidelines. A certified HVAC contractor should further evaluate internal system components and service as recommended.

4.0 Item 2(Picture) Mini air conditioning unit 2

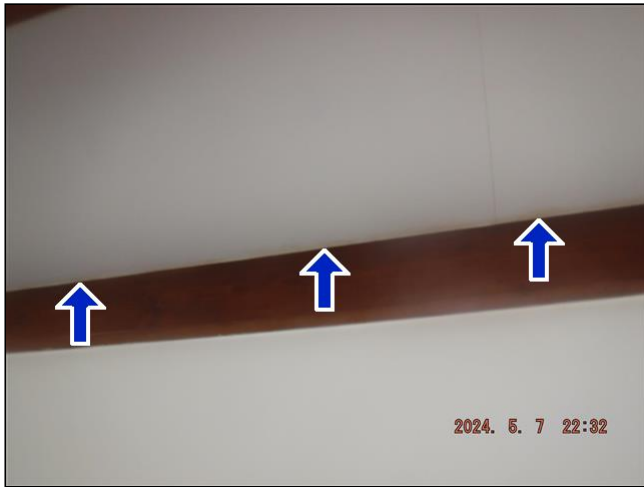
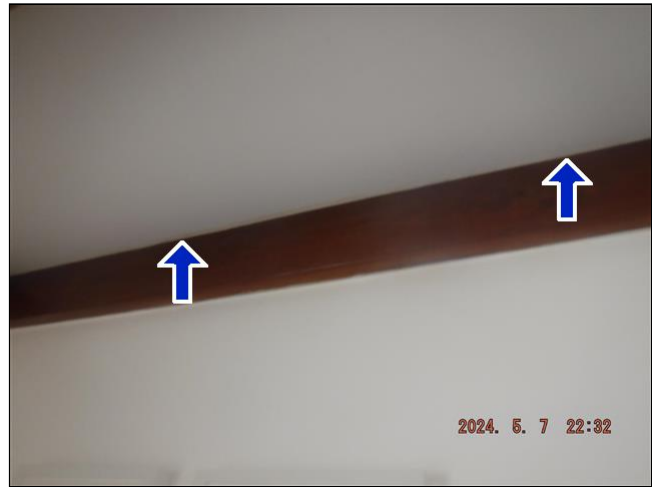
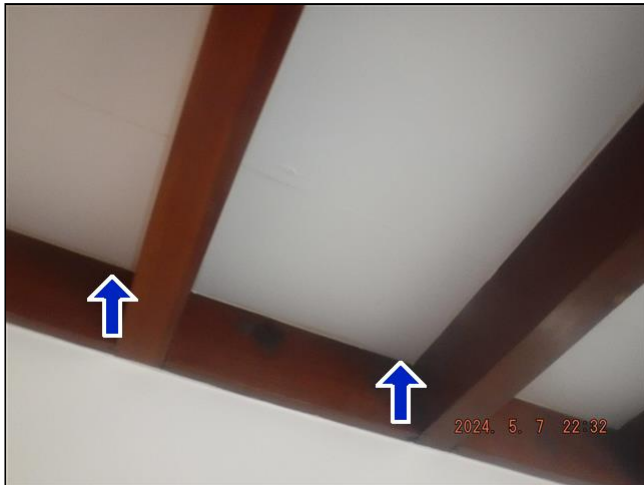
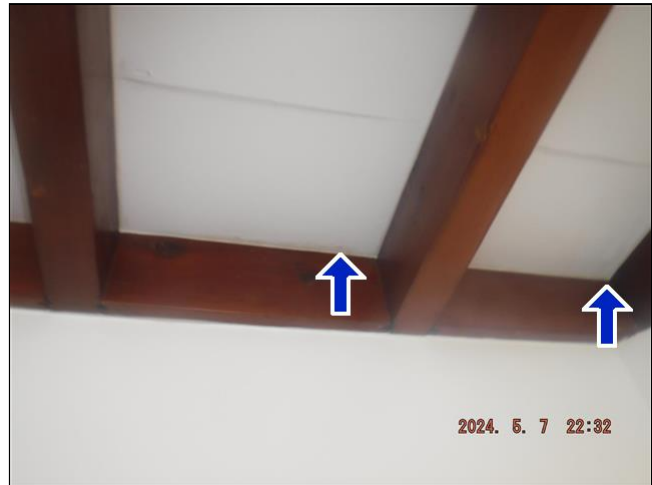
Noted the paneling on the ceiling revealed minor light moisture stains on the edges possibly indicating a leak did, or still may exists at the living room. Due to recent dry weather, I was unable to determine if this stain(s) are from a current or previous leak. Stains were dry at the time of inspection. Recommend a license general contractor further evaluate and repair or replace as needed.

5.0 Item 1(Picture) Ceiling stains

5.0 Item 2(Picture) Ceiling stains

5.0 Item 3(Picture) Ceiling stains

5.0 Item 4(Picture) Ceiling stains

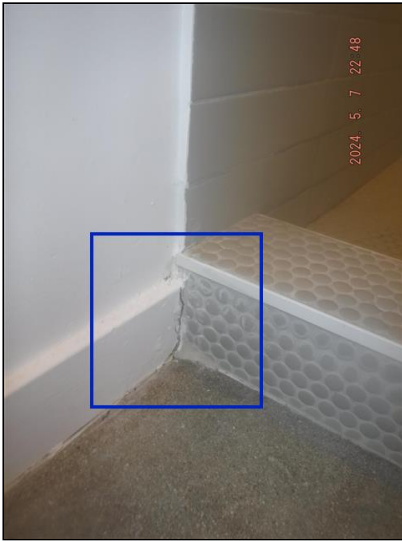
Noted the drywall/baseboard appears to have signs of minor water damage (drywall is peeling, wrapping, and or stained) at the guest bathroom side of shower stall. Unable to determine the source of water damage. This could have occurred from water seeping out of the shower pan when being used. This needs repairing to avoid further deterioration/damage. Recommend installing glass barrier or door to prevent continued damaged. Recommend a license contractor further evaluate and repair or replace as needed.

5.1 Item 1(Picture) Signs of water damage on wall

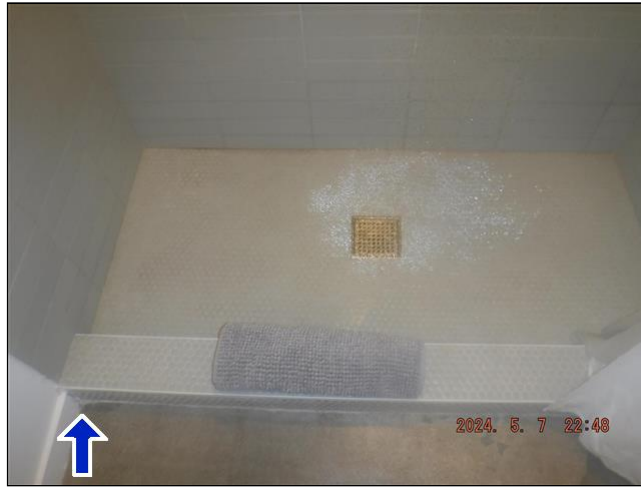
5.1 Item 2(Picture) Signs of water damage on wall

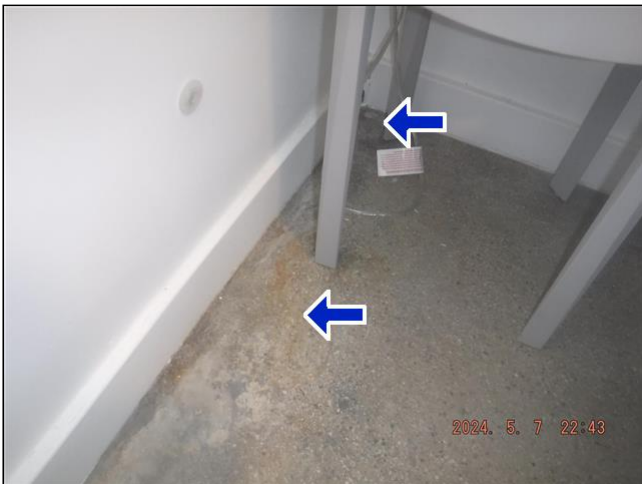
Noted the concrete slab floor is stained at the living room, guest and master bedrooms. Unable to determine source of these stains.

5.2 Item 1(Picture) Stained slab floor (guest bedroom)

The baseboard on the wall is wrapping, and or caulking at the seams is failing around the stained flooring. Recommend to monitor these areas during heavy rain fall for water intrusion. Recommend a license general contractor further evaluate and repair or replace as needed.

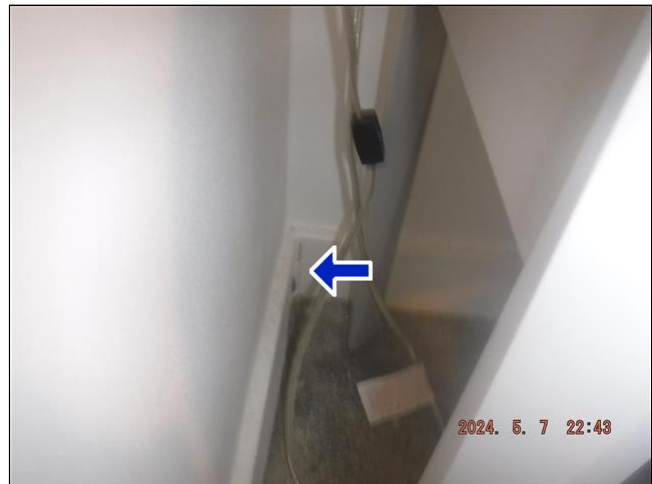
5.2 Item 2(Picture) Baseboard caulking failing

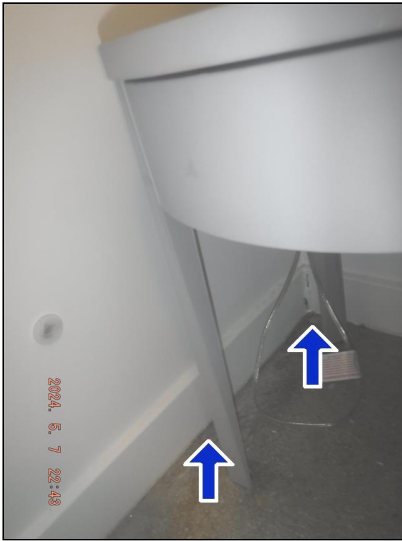
5.2 Item 3(Picture) Baseboard caulking failing

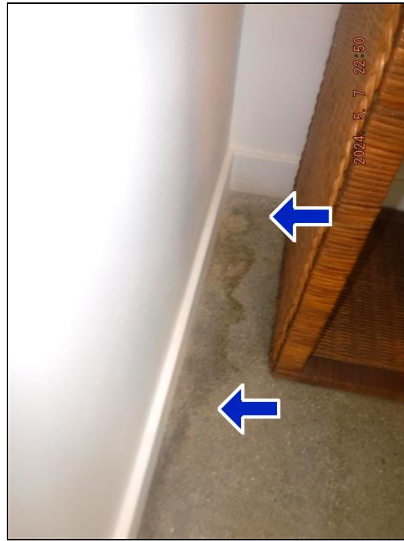
5.2 Item 4(Picture) Stained slab floor (master bedroom)

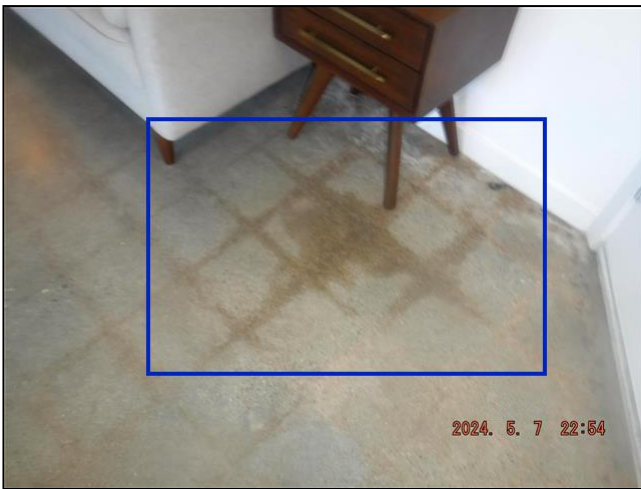
5.2 Item 5(Picture) Stained slab floor (living room)

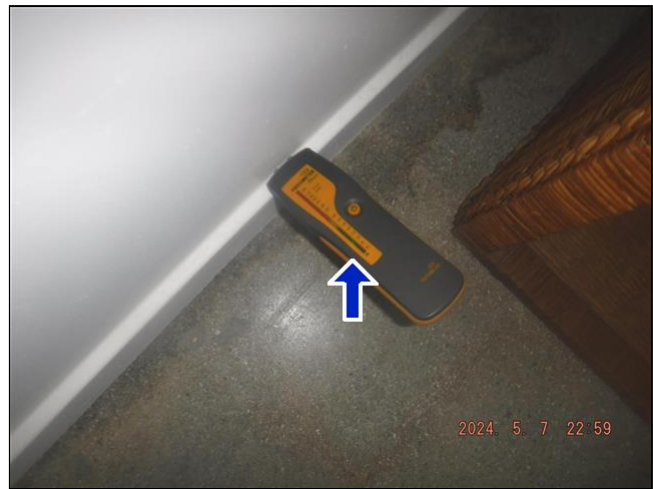
5.2 Item 6(Picture) Moisture meter (device) indicated dry surface

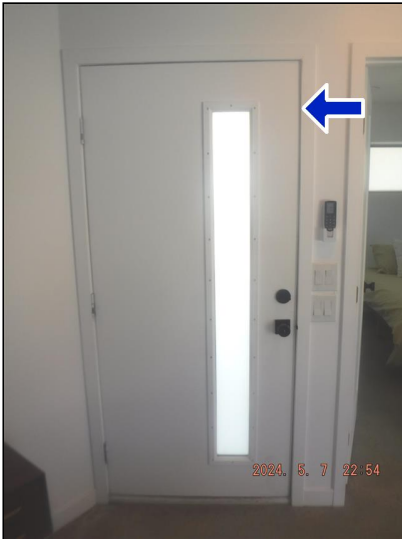
(1) Noted the main entry door rubs at top when closing at the living room. Door may need adjustment or replacement. Recommend a license general contractor further evaluate and repair or replace as needed.

5.4 Item 1(Picture) Main entry door

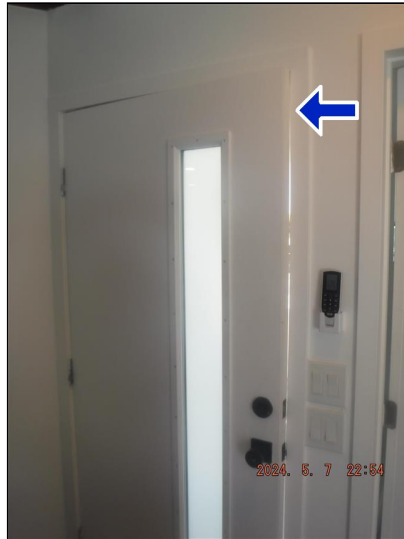
5.4 Item 2(Picture) Door rubs at top

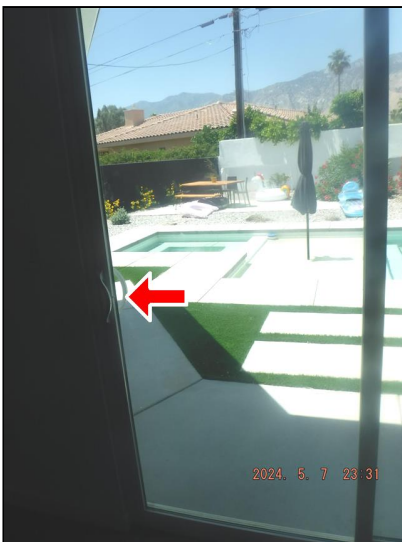
(2) **Noted the sliding glass door(s) did not lock securely when tested at the living room. Door(s), and or sliders should lock for safety. Recommend a window/door specialist/contractor further evaluate and repair or replace as needed.**

5.4 Item 3(Picture) Living room sliding door

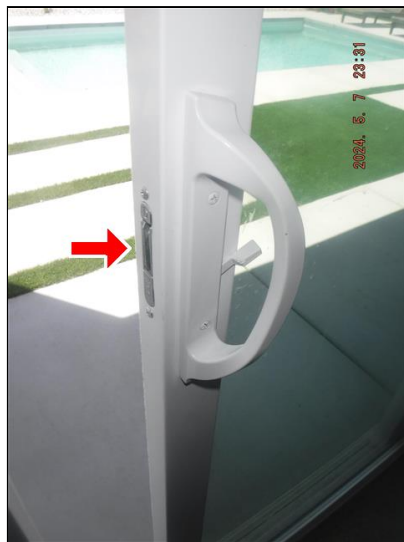
5.4 Item 4(Picture) Door did not lock properly

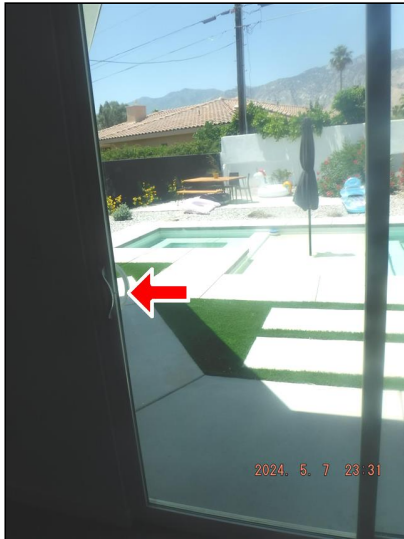
(2) **Noted the sliding glass door(s) did not lock securely when tested at the living room. Door(s), and or sliders should lock for safety. Recommend a window/door specialist/contractor further evaluate and repair or replace as needed.**

5.4 Item 3(Picture) Living room sliding door

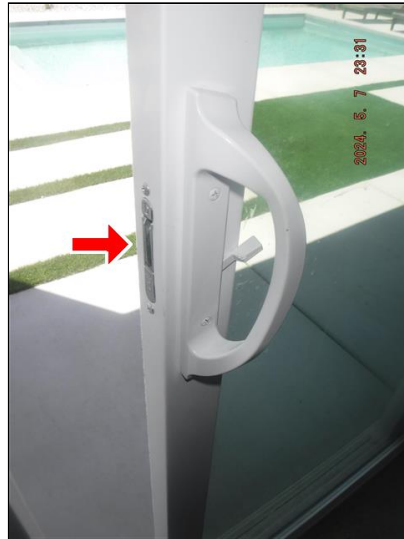
5.4 Item 4(Picture) Door did not lock properly

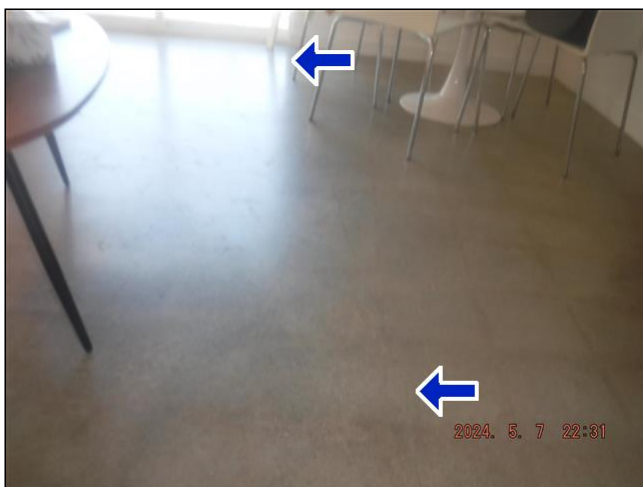
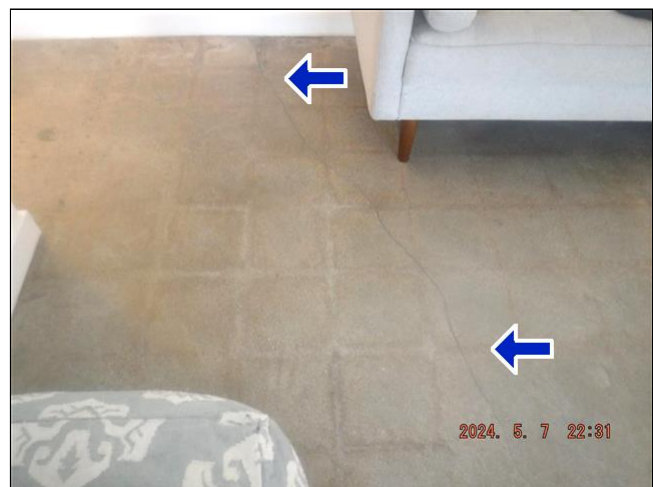
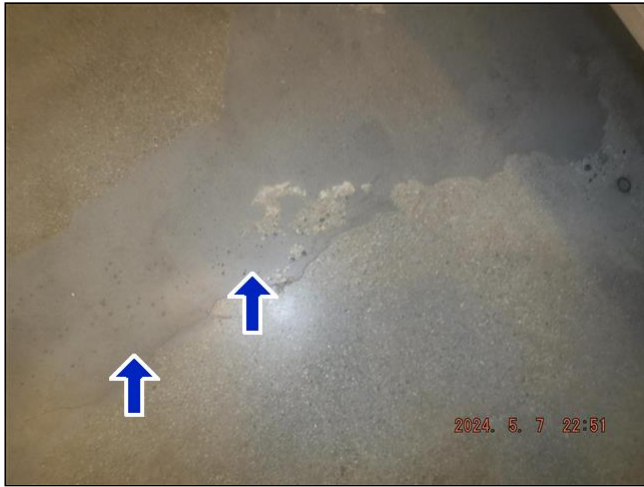
Noted a few settlement crack(s) were observed on the concrete slab (foundation) at the living room and master bathroom. Crack(s) can be a simple to a complex issue, settlements cracks are common. Recommend crack(s) sealed as needed to minimize further deterioration. If this is a concern to buyer recommend a structural engineer further evaluate and advise as desired. Recommend a license contractor repair or advise as desired.

7.0 Item 1(Picture) Slab crack (living room)

7.0 Item 2(Picture) Slab crack (living room)

7.0 Item 3(Picture) Slab crack (master bath)

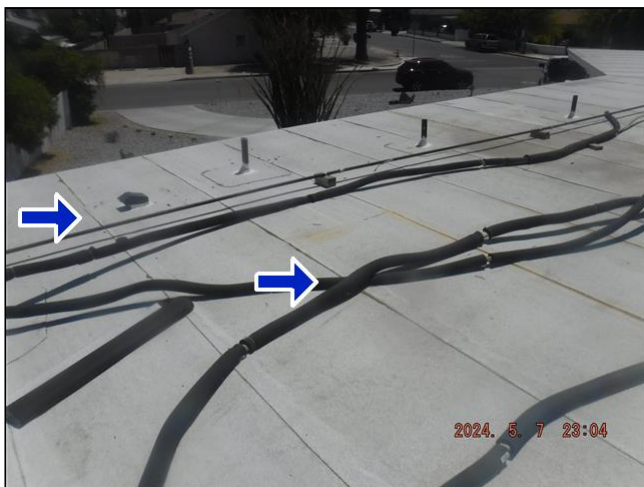
(2) Noted the asphalt rolls sealant at the seams appears to be failing at various locations of the roof. I am unable to determine if this current condition of the sealant will continue to fail. Improper sealant can lead to leaks if not corrected. Recommend a license roof contractor further evaluate and repair or replace as needed.

9.0 Item 1(Picture) Roll seams

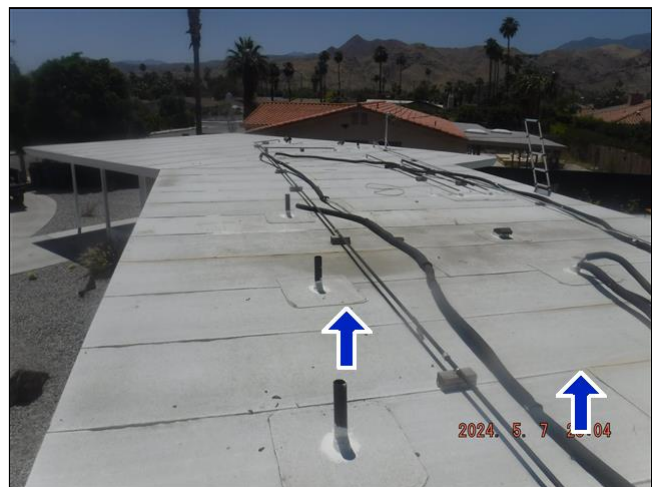
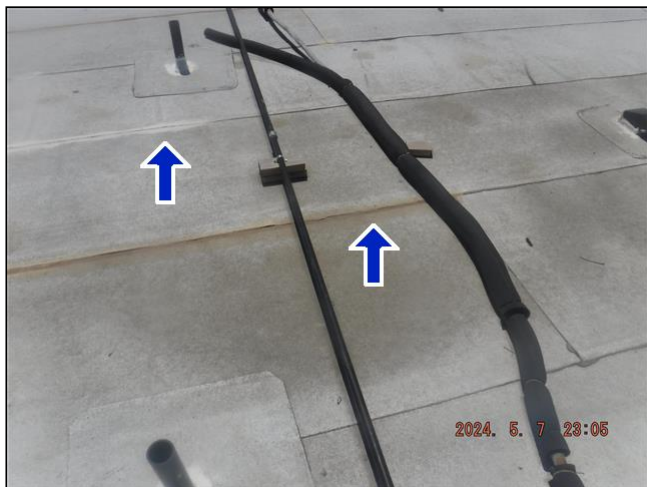
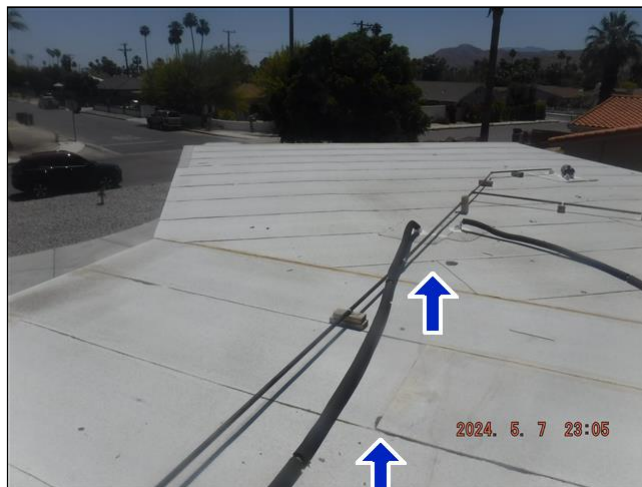
9.0 Item 2(Picture) Seem sealant failing

9.0 Item 3(Picture) Seem sealant failing

9.0 Item 4(Picture) Seem sealant failing

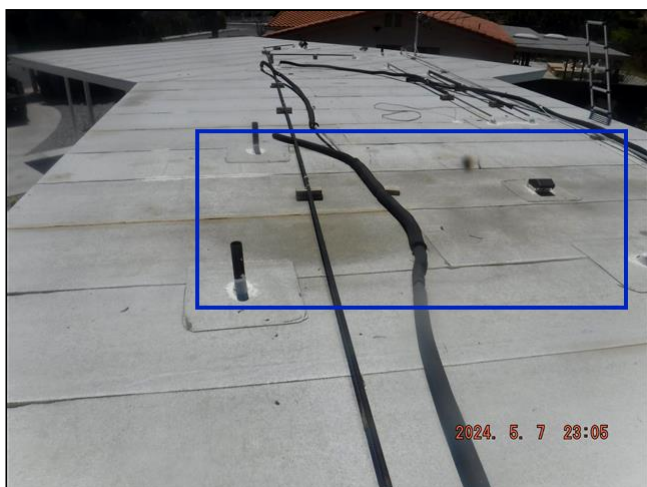
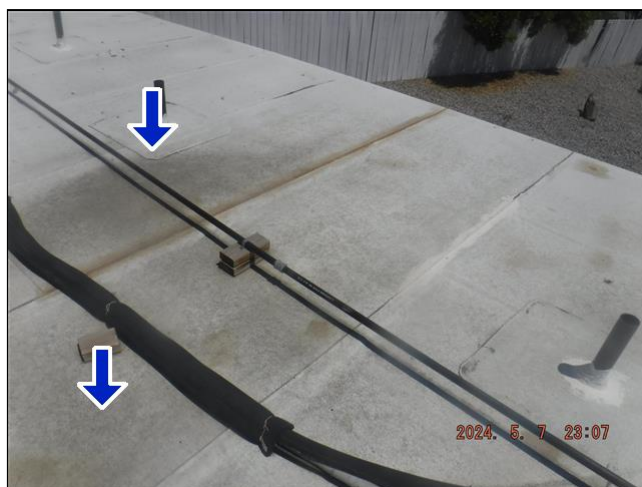
(3) Noted signs of water ponding was observed at various locations of the roof. Water ponding on a flat roof is very common, however, it can cause the roof covering to deteriorate sooner than expected. Leakage from deteriorated roof coverings are more likely to occur if not maintenance periodically. Recommend a license roof contractor further evaluate and repair or advise as desired.

9.0 Item 5(Picture) Water ponding signs on roof

9.0 Item 6(Picture) Water ponding signs on roof
