Inspection Report

Sample Report #3

Property Address:
61715 Topaz Drive
La Quinta CA 92253

Dominguez Property Inspections, LLC

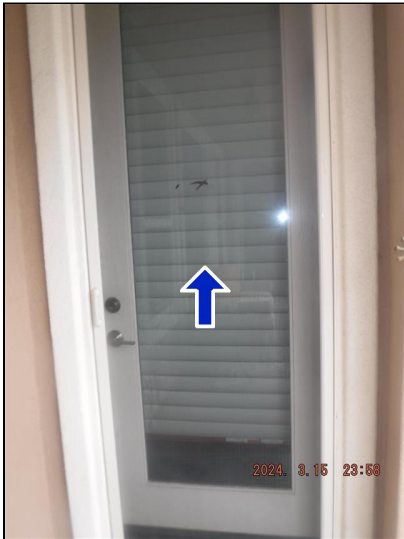
1.1 Item 1(Picture) Retractable door screen

1.1 The retractable door screens were operational at the time of the inspection. Recommend to maintain for proper operation. This is for your information. Recommend a window/door specialist/contractor further evaluate and maintain as needed.

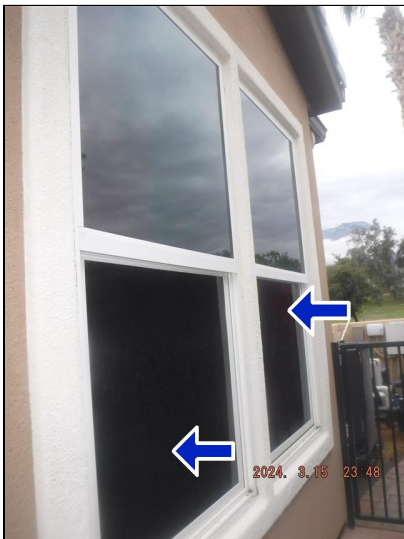
1.2 Item 1(Picture) Missing screens (right side of home)

1.2 (1) Noted a few window screen(s) are beginning to deteriorate, damaged, and or missing at various locations around the home. Window screens are important, they help prevent pest intrusion. Recommend a qualified contractor evaluate and repair or replace as needed.

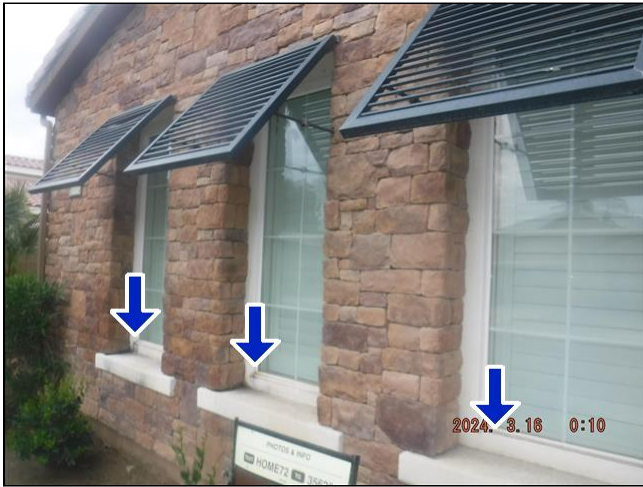
1.2 Item 3(Picture) Windows front of home

(2) Noted the window(s) appeared stained on the sill and frame at the front of home. This appeared to be a maintenance issue and is for your information. Recommend a license general contractor further evaluate and repair or maintain as needed.

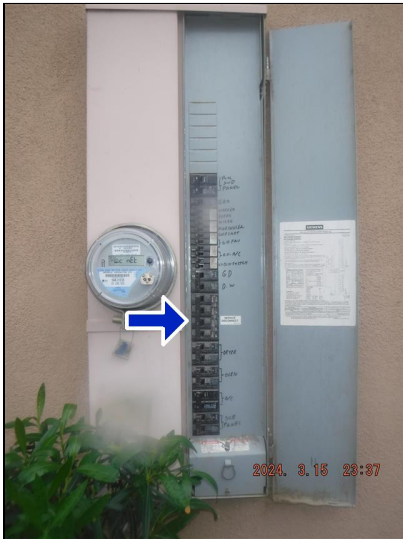
2.3 Item 1(Picture) Main electrical shut off (at panel)

2.3 (1) The MAIN electrical panel box is located at the right side front of home. Main electrical disconnect.

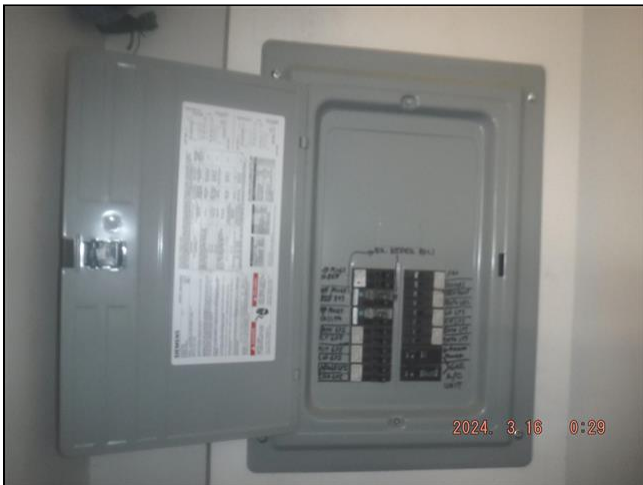
2.3 Item 3(Picture) Sub Electrical Panel

(2) The sub electrical panel box is located at the garage.

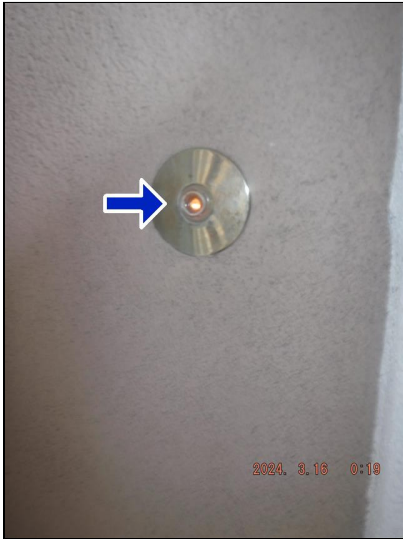
2.6 Item 1(Picture) Door bell

2.6 Noted the door bell was operational when tested, however, button appeared damaged near the main entrance door. This is for your information, small repair. **RECOMMEND** a electrical contractor further evaluate and repair or replace as needed.

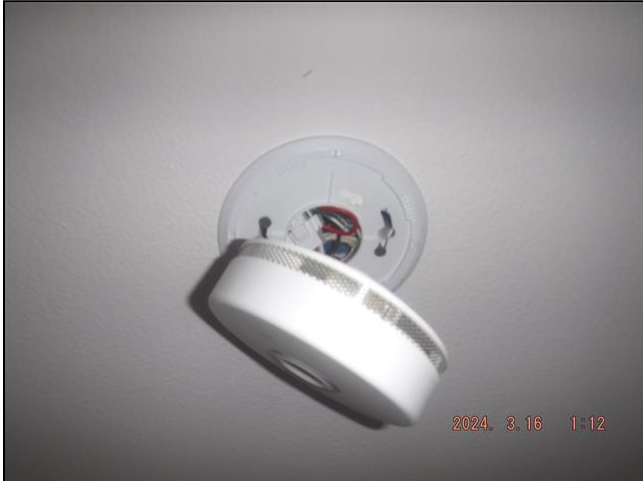
2.8 Item 1(Picture) Hallway

+ 2.8 The smoke detector is missing, and or loose at the common hallway to the master bedroom. Without a proper working smoke detector in your home you have no first alert to a possible fire Small repair. Recommend a licensed electrical contractor further evaluate and repair or replace as needed.

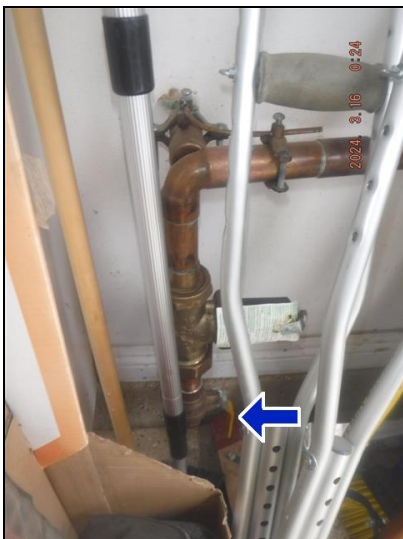
3.2 Item 1(Picture) Quick access water shut off valve location

3.2 The home quick access water shut off valve is located at the garage right wall. Note: This valve will ONLY shut off the water supply going into home/dwelling. This is for your information.

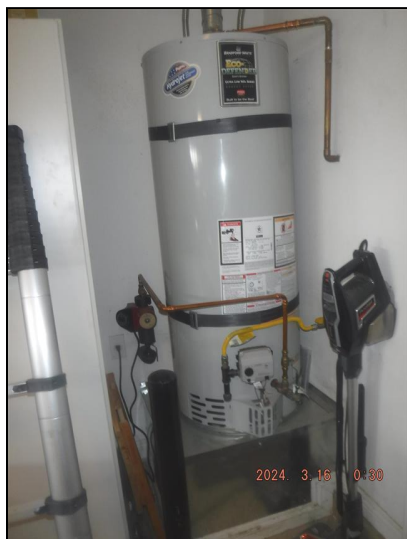
3.4 Item 1(Picture) Water Heater Unit

3.4 Note the water heater unit operated satisfactory at the time of inspection. Unit condition appeared good. Verified that seismic straps were installed. Recommend a license plumbing contractor repair, and or maintenance when needed.

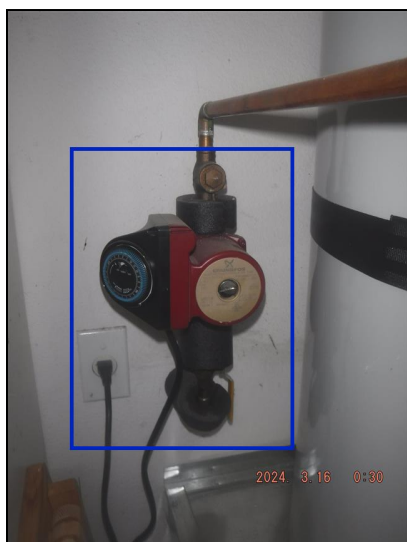
3.5 Item 1(Picture) Recirculating pump

3.5 Noted the water heater(s) recirculating pump(s) was not inspected for operation during the inspection. No visual leaks observed at pump. Recommend a license plumbing contractor evaluate this item and advise as desired.

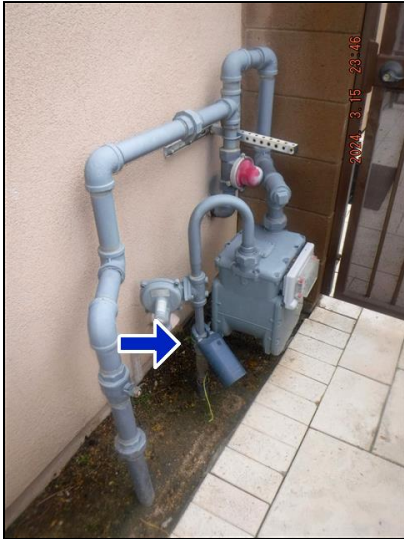
3.7 Item 1(Picture) Main Gas Shut Off (At Meter)

Gas meter is a public utility component and therefore inspected for leaks only.

Recommend to store a qualified wrench and or tool near the gas shut off valve for quick shut off access, in the event a emergency occurs.

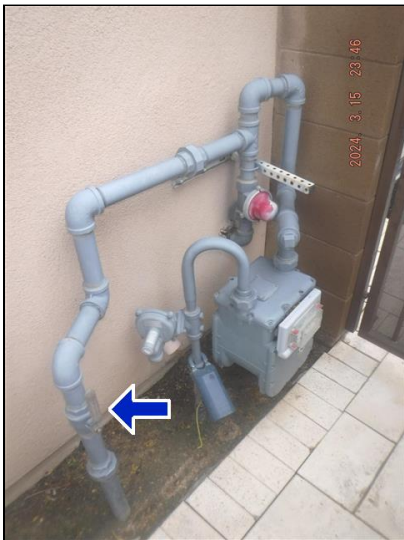
3.7 Item 2(Picture) Pool heater gas valve

(2) The pool heater main fuel shut off valve is located at the meter.

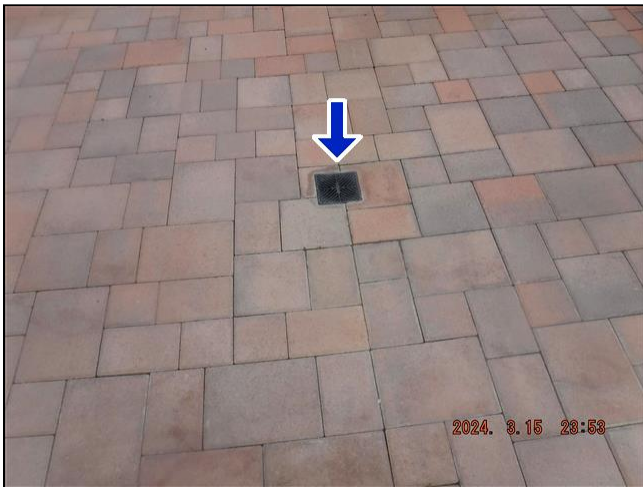
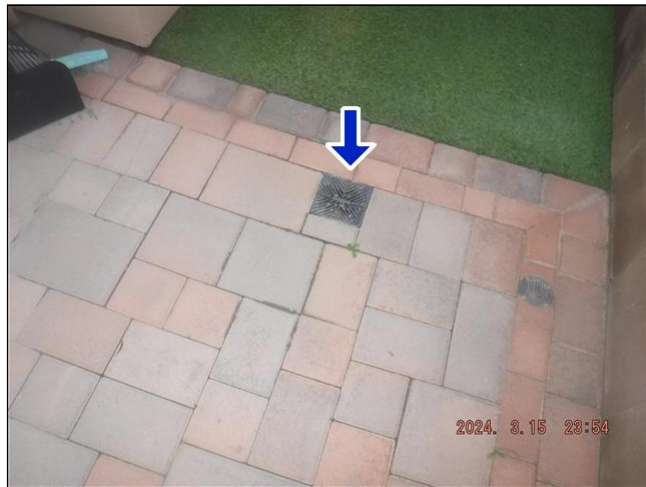
3.11 Item 1(Picture) Exterior plumbing drain

3.11 Noted, the home property is equipped with exterior plumbing drains. Neither the condition nor adequacy of any underground piping or site drainage systems for the home/property can be determined as part of a standard home inspection. All exterior drains around the home/property must be regularly cleared, and maintained periodically in order to ensure adequate water run-off, discharge and to protect the home from possible water damage/intrusion. A qualified license plumbing contractor should evaluate the condition or maintenance as needed.

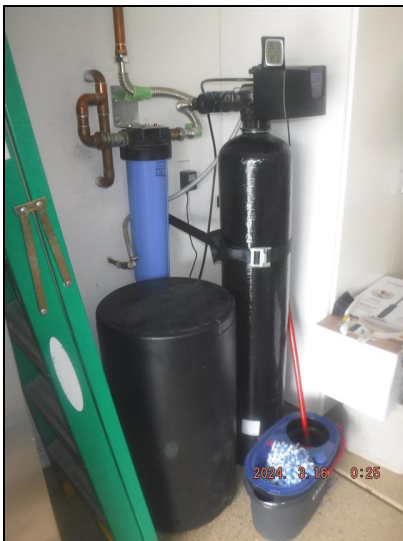
3.12 Item 1(Picture) water softener/filtration system

3.12 Note: This home is equipped with a water softener/filtration system. This type of system is not a part of a standard home inspection, therefore, we did not inspect the system for condition or operation. No water leaks were observed at the time of inspection when the plumbing evaluate was performed for this system. RECOMMEND a water softener/filtration system specialist evaluate and advise as desired.

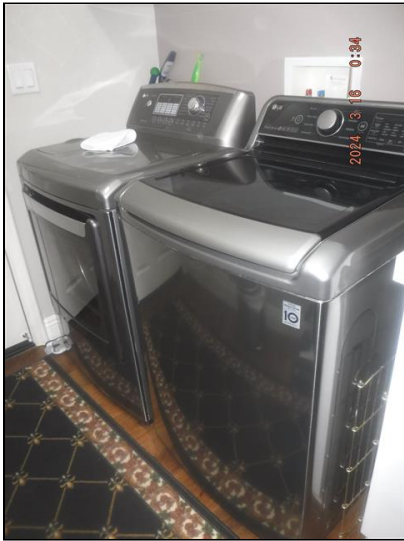
3.13 Item 1(Picture) Washer & Dryer Units

3.13 The laundry room washing machine and dryer are not a required inspection appliance, and are therefore not inspected. No moisture or leakage noted/signs from the hot and cold water supply valves for the washing machine. Recommend further evaluation for proper operation for the washer and dryer as desired.

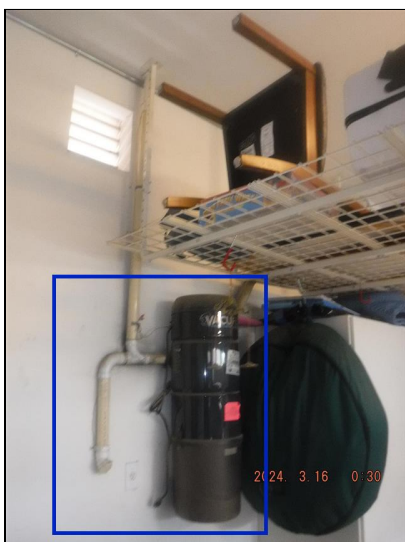
3.16 Item 1(Picture) Central vacuum system

3.16 Noted this home is equiped with a central vacuum system. This type of system is not a part of the standard home inspection, therefore, we did was not inspect the system for condition or operation. This is for your information. If this is a concern to buyer, recommend a evaluation of the vacuum system completed by the company who installed the system or a specialist.

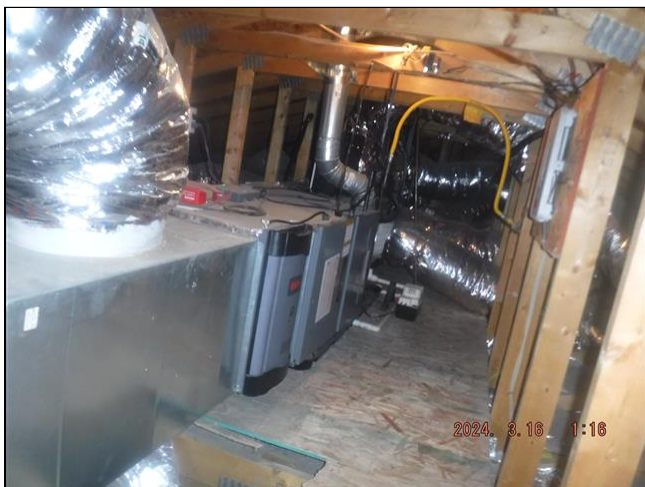
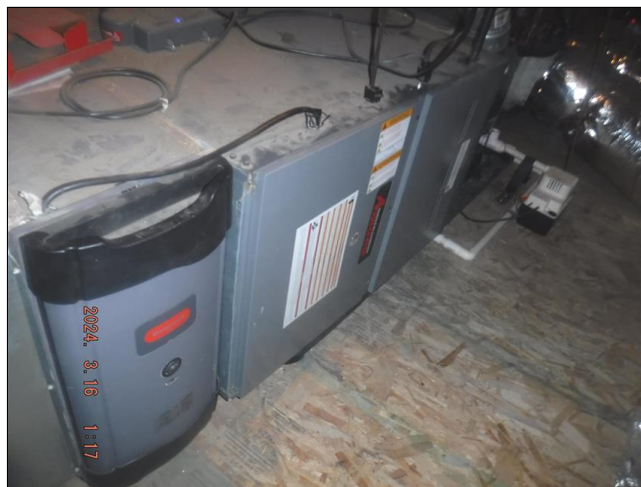
4.0 Item 1(Picture) Air Heating Unit

4.0 The furnace unit operated satisfactory at the time of inspection. Unit condition appeared good. I recommend to service the HVAC system (i.e, replacing filters, checking gas piping and equipment condition) at least once a year. A certified HVAC contractor should further evaluate internal system components and service as recommended.

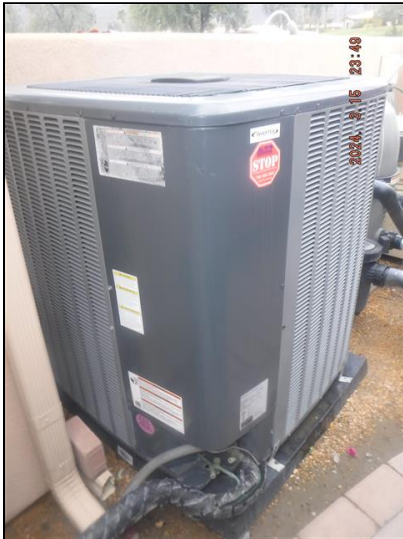
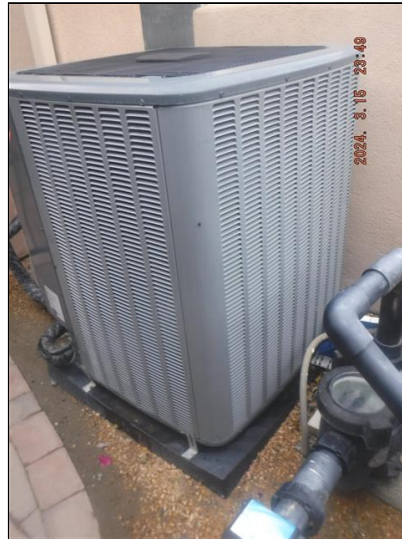
4.5 Item 1(Picture) Air Cooling Unit

4.5 The cooling unit was operating satisfactory at the time of inspection. Condition appeared good. I recommend to service HVAC system (for example, replacing filters, checking system gas levels and equipment condition) at least once a year. A certified HVAC contractor should further evaluate internal system components and service as recommended.

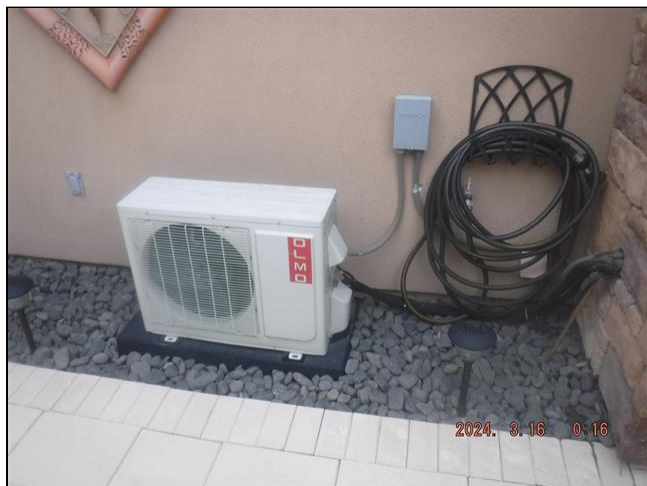
4.9 Item 1(Picture) Mini split A/C unit

4.9 The mini air conditioning unit was functional at the time of inspection. Unit condition appeared fair. I recommend to service the HVAC system (i.e, replacing filters, checking gas piping and equipment condition) at least once a year. I cannot determine how long your AC will last before a replacement is necessary. A certified HVAC contractor should further evaluate internal system components and service as recommended.

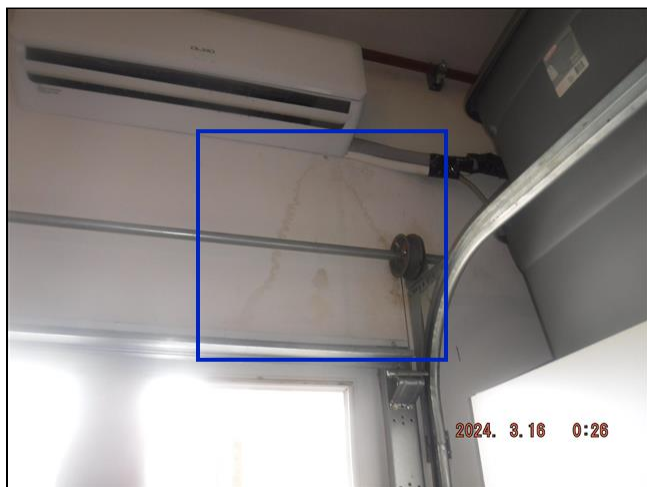
5.1 Item 1(Picture) Wall stains under a/c unit

5.1 Noted the drywall above the garage door is stained. Stains appear to be of moisture. After further review, these stains could be a result from the mini air conditioning unit leaking. Recommend to repair or further water damage can occur. Recommend a license HVAC contractor evaluate and repair or advise as desired.

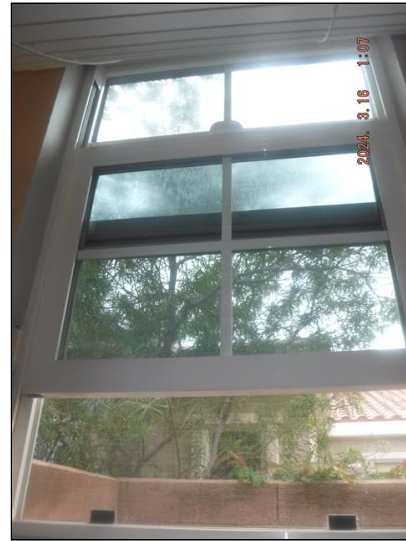
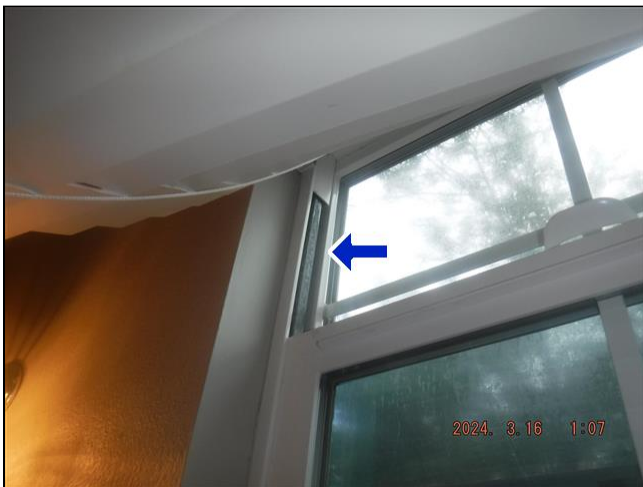
6.5 Item 3(Picture) Casita bath window

6.5 Noted the single hung window (opens up vertically) spring is loose at the master bedroom and casita bathroom. This is a small repair. Recommend a window/door specialist/contractor further evaluate and repair or replace as needed.

6.5 Item 4(Picture) Window spring loose

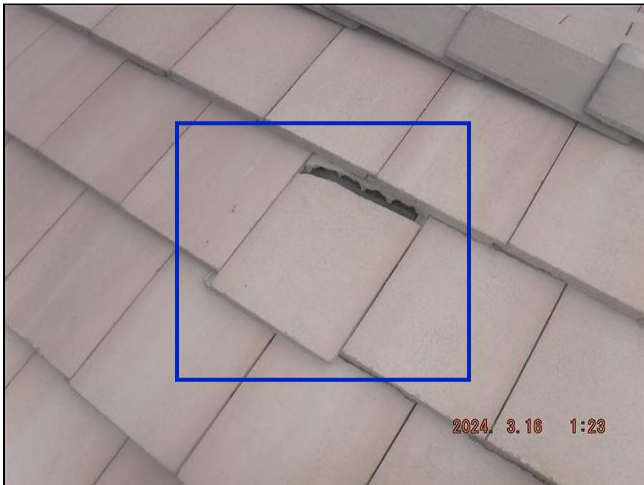
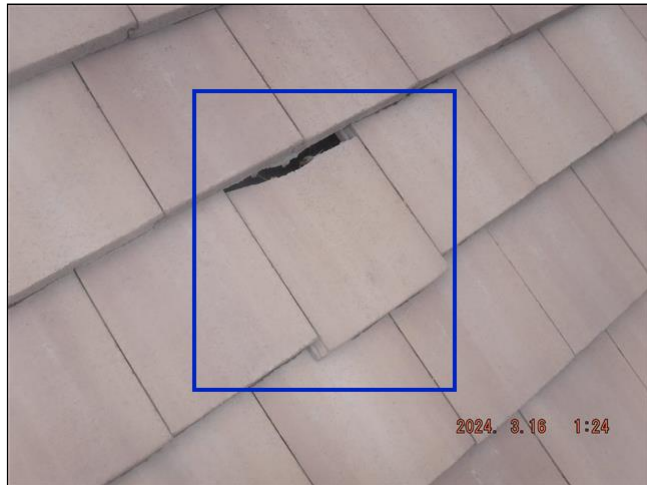
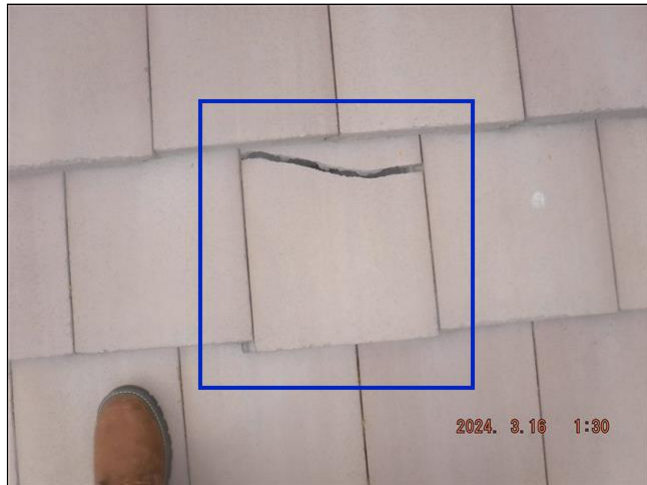
10.0 Noted 7 to 8 cracked/damaged roof tile(s) were observed at various location(s) of the roof. Recommend damaged/cracked roof tile(s) be replaced as soon as possible. Recommend a license roof contractor further evaluate and repair or advise as required.

10.0 Item 1(Picture) Cracked/damage tile

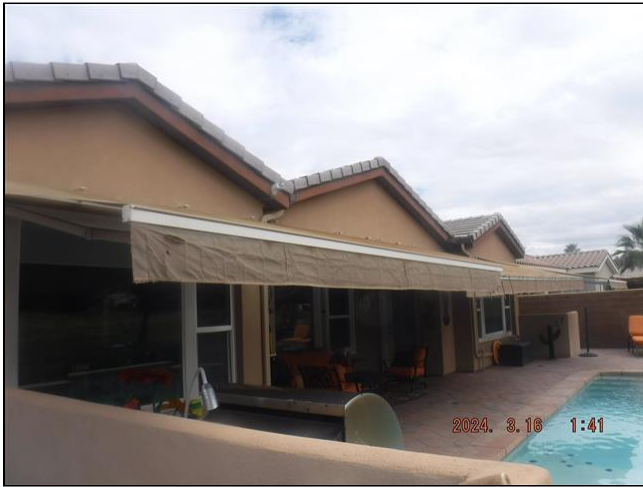
10.5 Item 1(Picture) Awning

10.5 The electrical awning(s) at the patio were functional at the time of inspection. Awnings(s) appeared to have minor damage (torn flap). This is a cosmetic issue, and is for your information. Recommend a awning specialist further evaluate and repair or replace as desired.

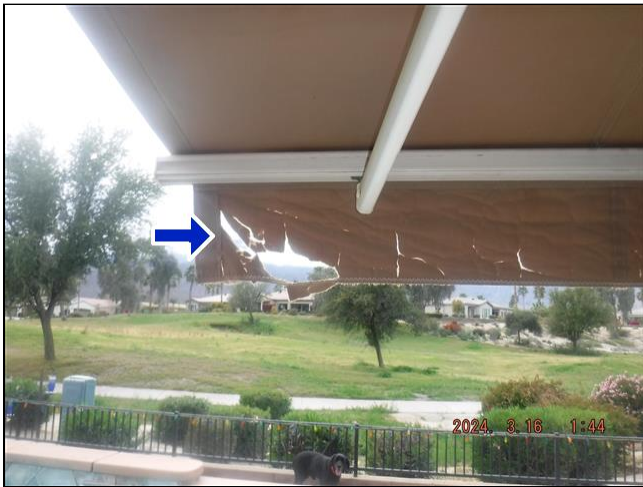
10.5 Item 3(Picture) Torn flaps

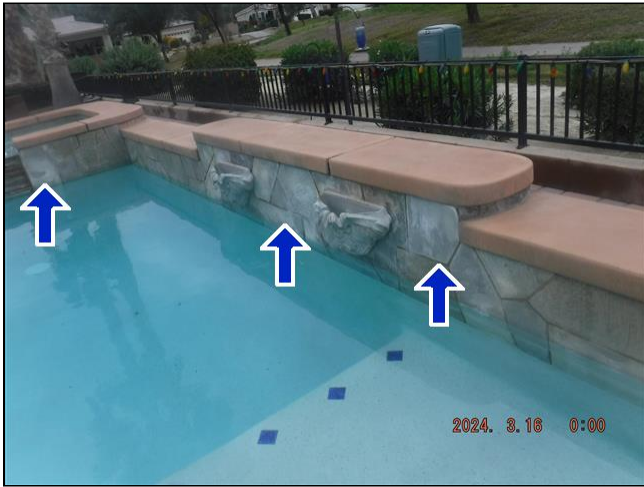
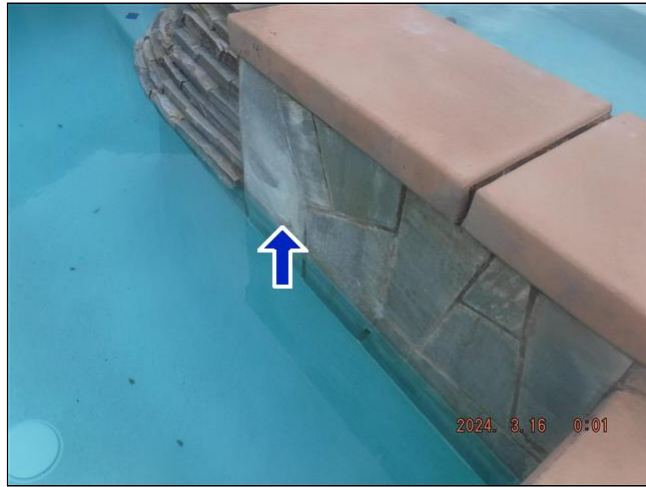
11.1 Noted the stone tile(s) appear to have calcium build up at various wall locations around the pool and spa, this can cause deterioration or staining of the stones if not removed/cleaned. This is a maintenance issue. Recommend a license pool contractor further evaluate and repair or clear as needed.

11.1 Item 1(Picture) Calcium build up on walls

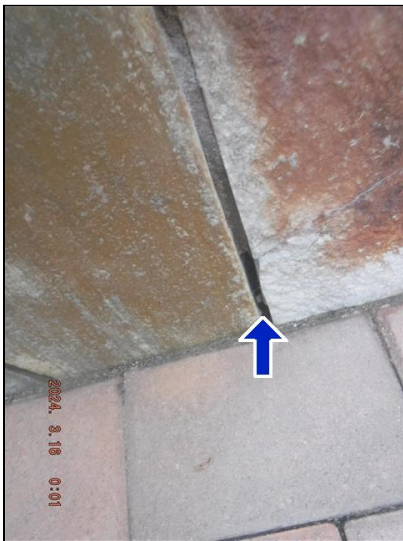
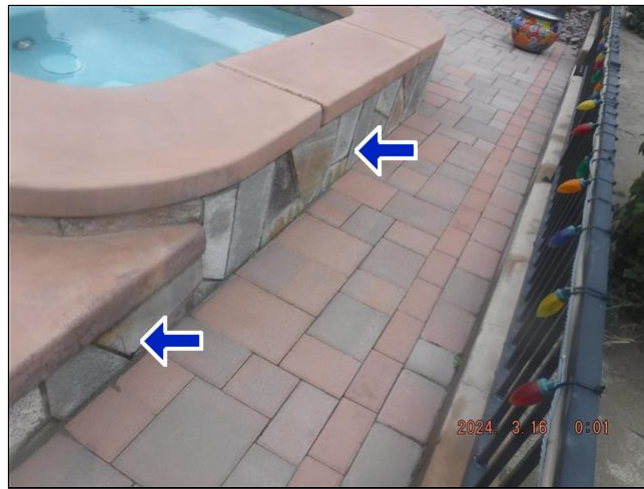
11.2 Noted the tile mortar is failing, deteriorating at various locations of the wall on the back of pool and spa. This is a very common. However, recommend to repair and re-mortar as needed. This is a repair/maintenance issue. Recommend a license pool contractor further evaluate and repair or replace as needed.

11.2 Item 1(Picture) Tile mortar failing

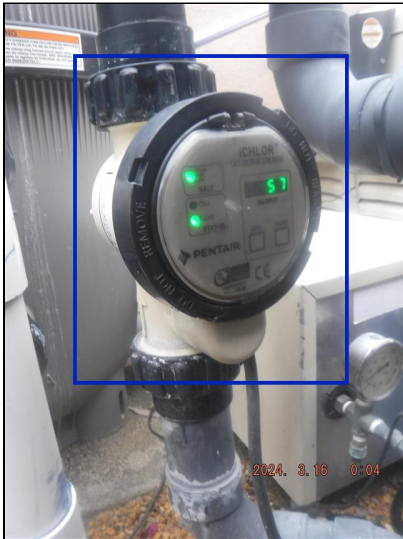
11.3 Item 1(Picture) Pool chlorine generator unit

11.3 Noted the pool and spa chlorine generator unit was operational at the time of inspection. This particular feature requires proper maintenance to operate efficiently as intended. Recommend a license pool service company, or contractor maintain as needed.

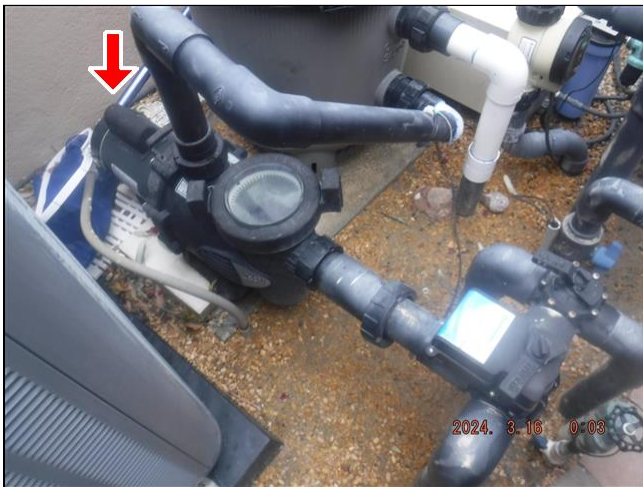
11.5 Item 1(Picture) Pump

⚠ 11.5 Noted the pool and spa pump(s) is currently not bonded (grounded) for safety. Pool pumps should be bonded with a grounding wire as required by the pool california safety code. Recommend safety measures corrected, a license pool contractor should further evaluate and repair as required.

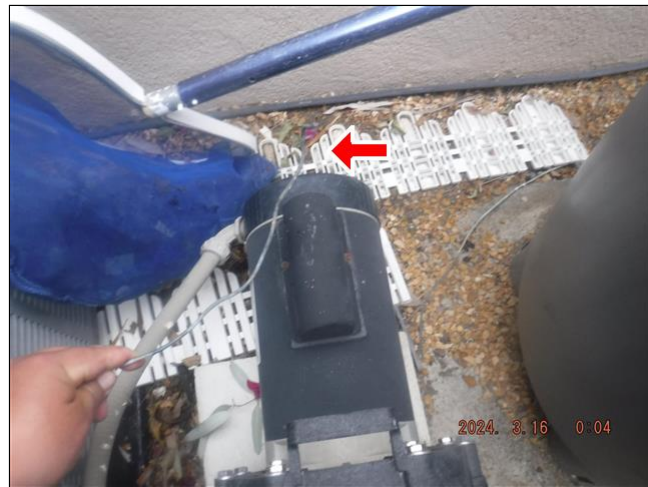
11.5 Item 2(Picture) Pump not grounded

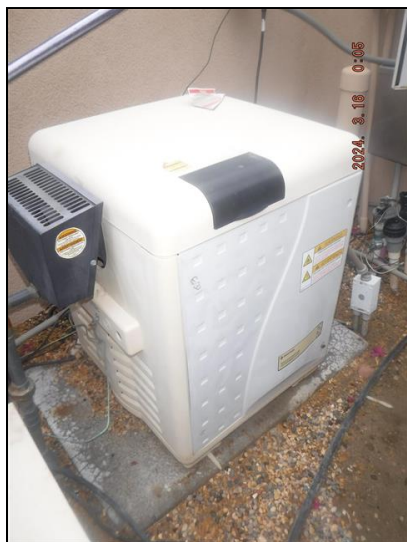
11.8 Item 1(Picture) Pool heating unit

11.8 The pool & spa heater(s) was/were functional at the time of inspection.

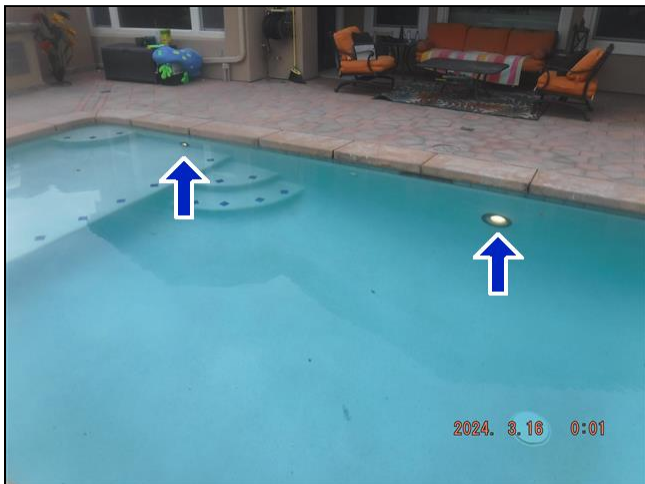
11.11 Item 1(Picture) Pool lights

11.11 Pool and spa light(s) were operational at the time of inspection.

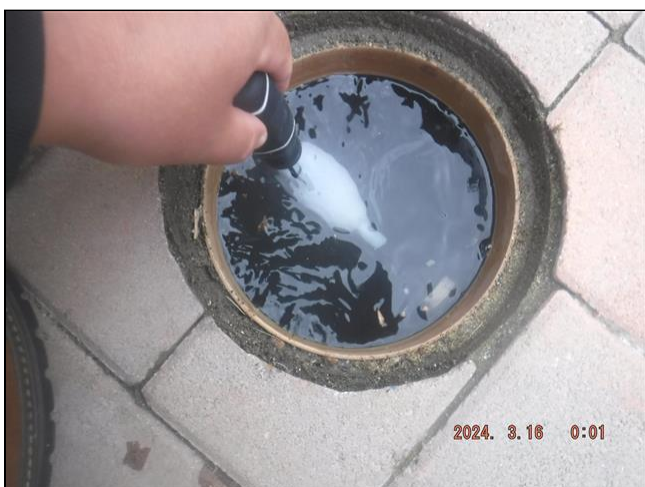
11.23 Item 1(Picture) Pool auto fill

11.23 The pool and spa auto fill was operational at the time of inspection.

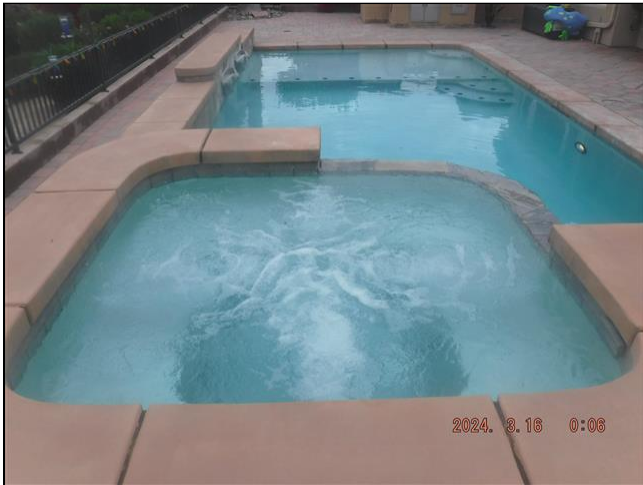
11.27 Item 1(Picture) Spa jets

11.27 The spa jets were operational at the time of inspection.

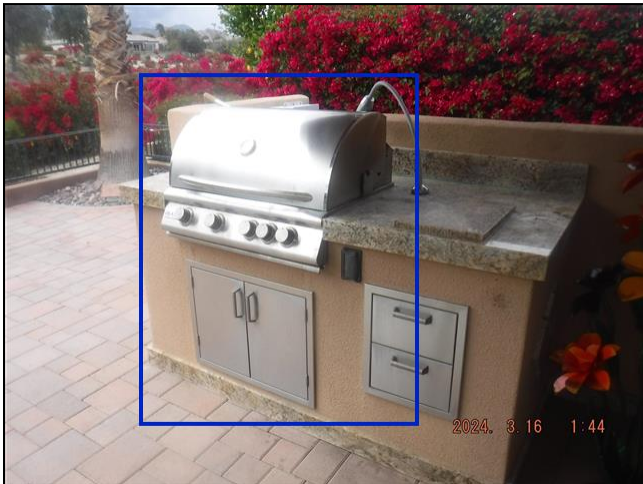
12.0 Item 1(Picture) Bar-Bee-Que Unit

12.0 Note, exterior bar-bee-que unit(s) are not included during a standard home inspection, and therefore was not inspected for operation or condition. However, unit components such as, electrical wiring and gas piping were visually inspected for proper installation, issues, and or possible leakage. Only visible electrical wiring and gas lines were evaluated during the inspection. Recommend further evaluation by a bar-bee-que specialist as client desires.

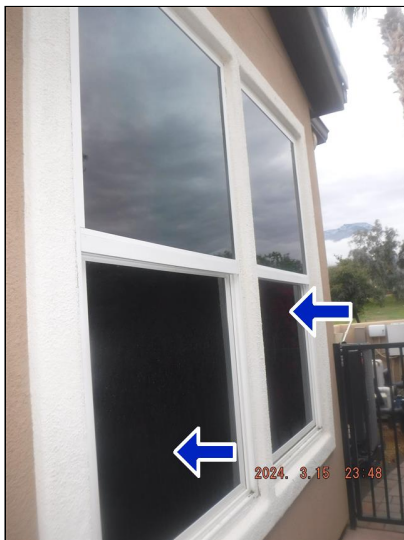
1.2 Item 1(Picture) Missing screens (right side of home)

(1) Noted a few window screen(s) are beginning to deteriorate, damaged, and or missing at various locations around the home. Window screens are important, they help prevent pest intrusion. Recommend a qualified contractor evaluate and repair or replace as needed.

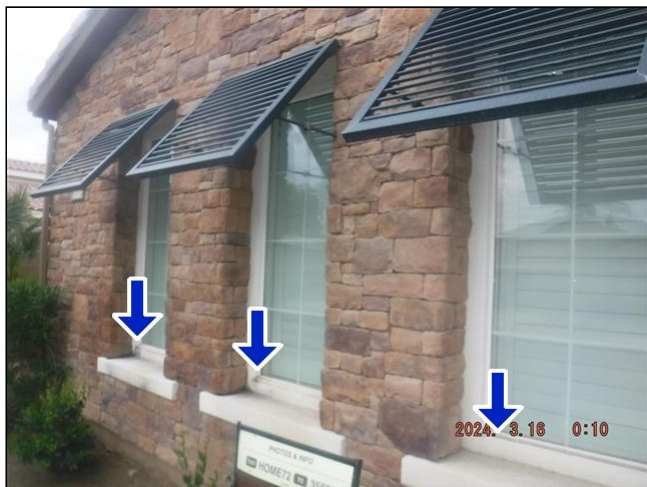
1.2 Item 3(Picture) Windows front of home

(2) Noted the window(s) appeared stained on the sill and frame at the front of home. This appeared to be a maintenance issue and is for your information. Recommend a license general contractor further evaluate and repair or maintain as needed.

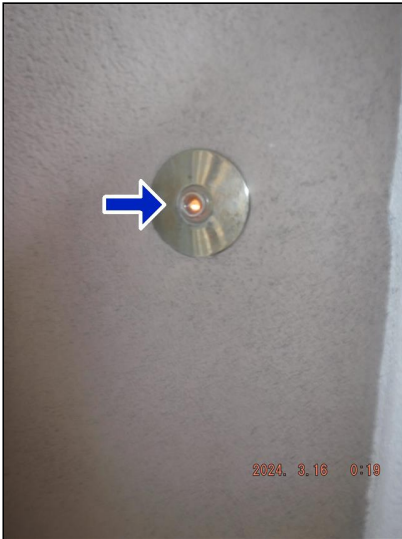
2.6 Item 1(Picture) Door bell

Noted the door bell was operational when tested, however, button appeared damaged near the main entrance door. This is for your information, small repair. **RECOMMEND** a electrical contractor further evaluate and repair or replace as needed.

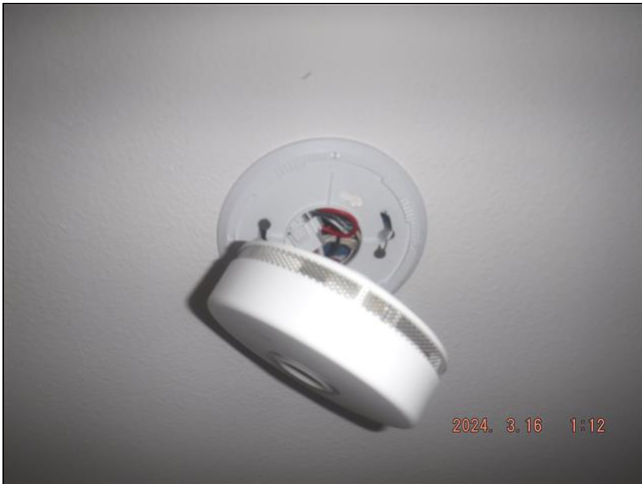
2.8 Item 1(Picture) Hallway

The smoke detector is missing, and or loose at the common hallway to the master bedroom. Without a proper working smoke detector in your home you have no first alert to a possible fire Small repair. Recommend a licensed electrical contractor further evaluate and repair or replace as needed.

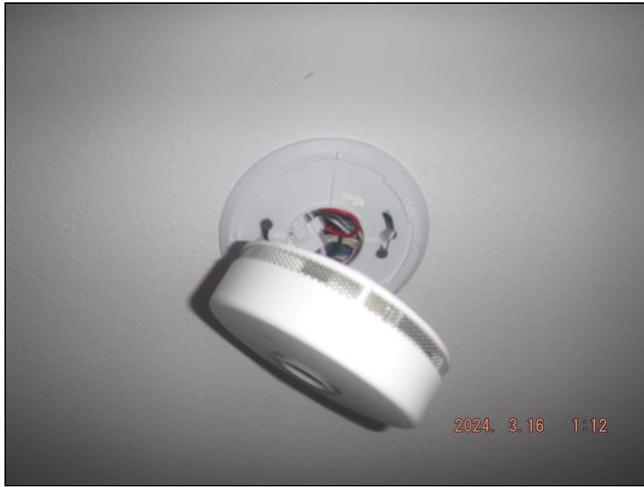
2.8 Item 1(Picture) Hallway

The smoke detector is missing, and or loose at the common hallway to the master bedroom. Without a proper working smoke detector in your home you have no first alert to a possible fire Small repair. Recommend a licensed electrical contractor further evaluate and repair or replace as needed.

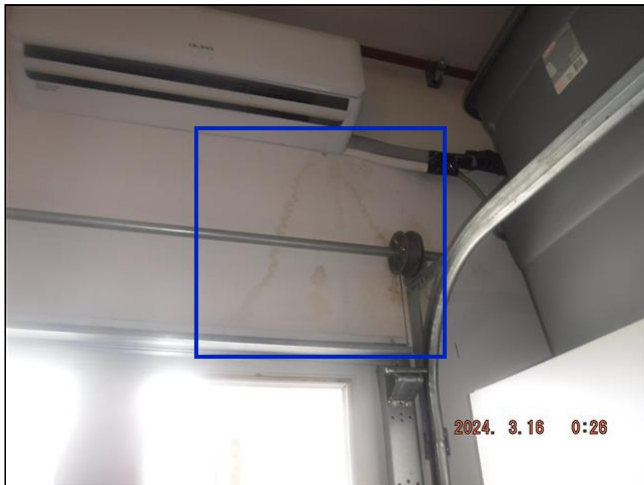
5.1 Item 1(Picture) Wall stains under a/c unit

Noted the drywall above the garage door is stained. Stains appear to be of moisture. After further review, these stains could be a result from the mini air conditioning unit leaking. Recommend to repair or further water damage can occur. Recommend a license HVAC contractor evaluate and repair or advise as desired.

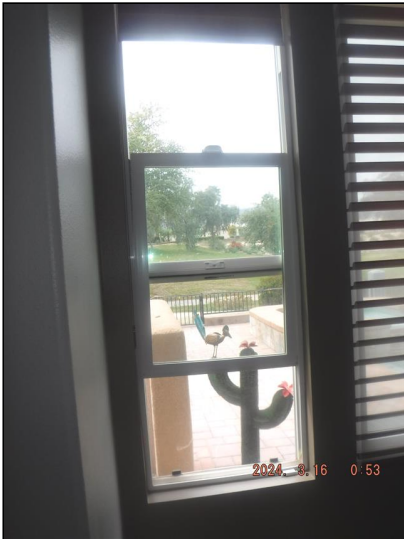
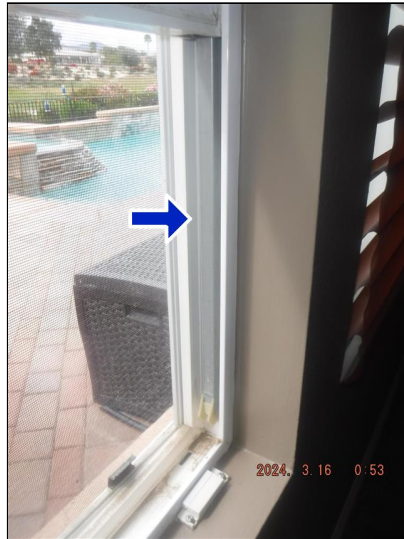
6.5 Item 1(Picture) Master bedroom window

Noted the single hung window (opens up vertically) spring is loose at the master bedroom and casita bathroom. This is a small repair. Recommend a window/door specialist/contractor further evaluate and repair or replace as needed.

6.5 Item 2(Picture) Window spring loose

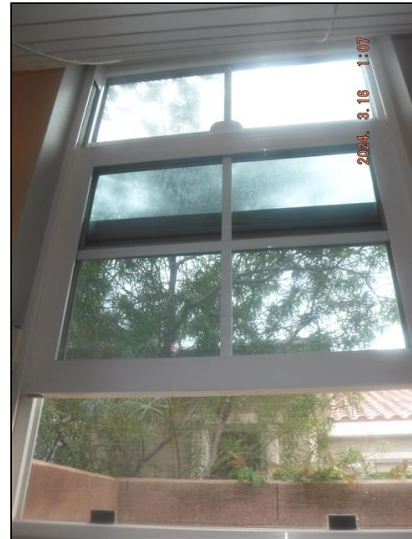
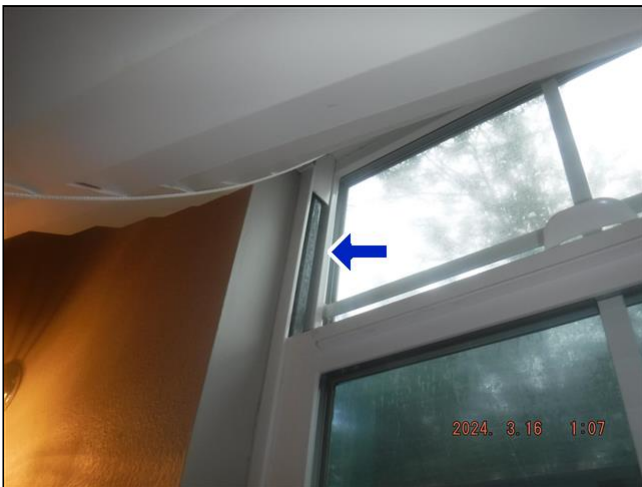
6.5 Item 3(Picture) Casita bath window

6.5 Item 4(Picture) Window spring loose

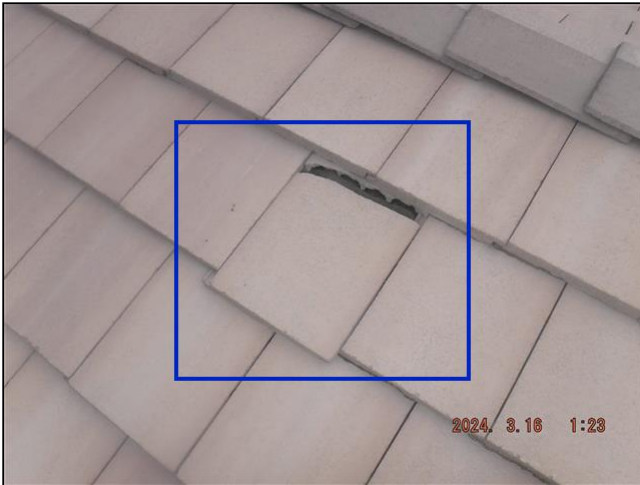
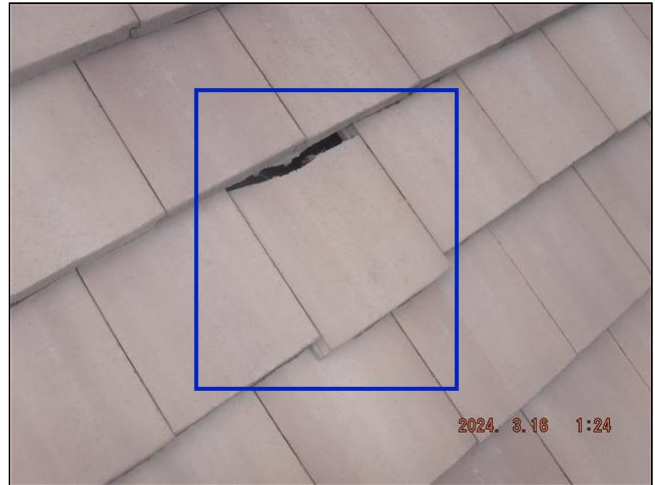
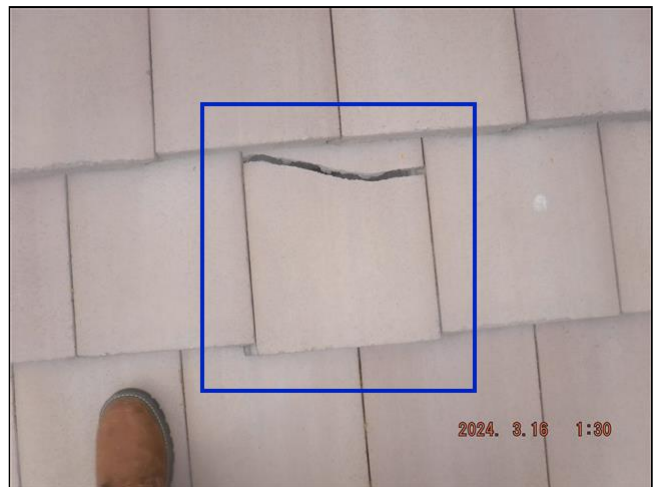
Noted 7 to 8 cracked/damaged roof tile(s) were observed at various location(s) of the roof. Recommend damaged/cracked roof tile(s) be replaced as soon as possible. Recommend a license roof contractor further evaluate and repair or advise as required.

10.0 Item 1(Picture) Cracked/damage tile

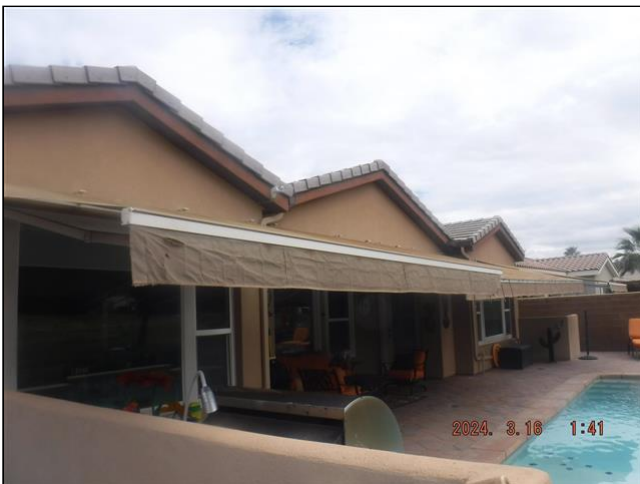
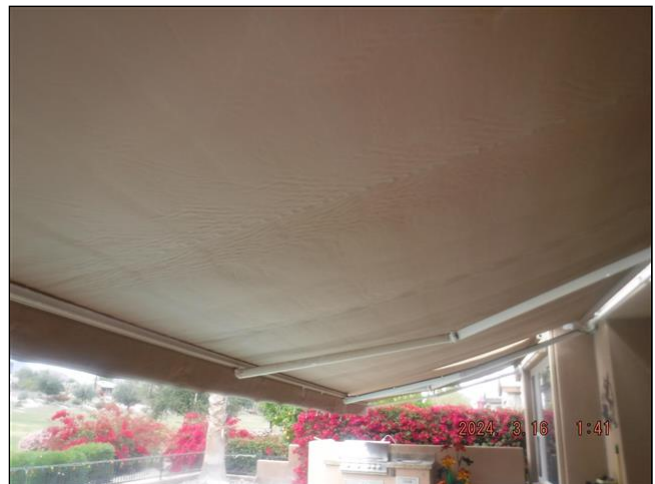
The electrical awning(s) at the patio were functional at the time of inspection. Awnings(s) appeared to have minor damage (torn flap). This is a cosmetic issue, and is for your information. Recommend a awning specialist further evaluate and repair or replace as desired.

10.5 Item 1(Picture) Awning

10.5 Item 2(Picture) Awning

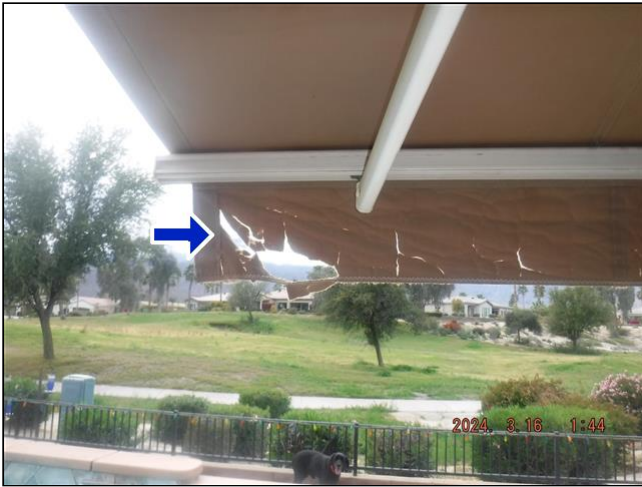
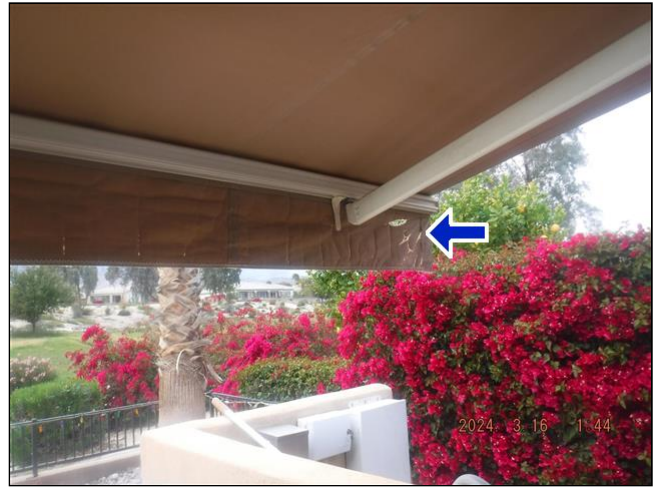
10.5 Item 3(Picture) Torn flaps

10.5 Item 4(Picture) Torn flaps

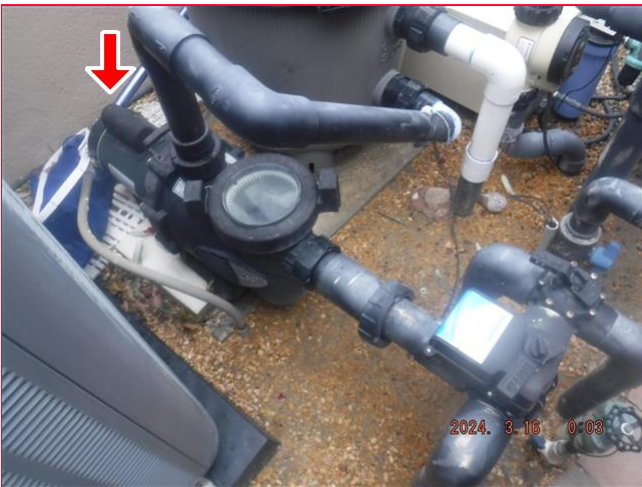
11.5 Item 1(Picture) Pump

Noted the pool and spa pump(s) is currently not bonded (grounded) for safety. Pool pumps should be bonded with a grounding wire as required by the pool california safety code. Recommend safety measures corrected, a license pool contractor should further evaluate and repair as required.

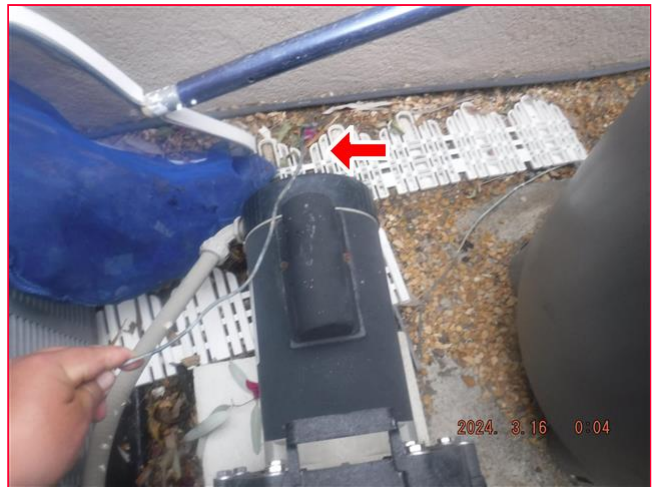
11.5 Item 2(Picture) Pump not grounded

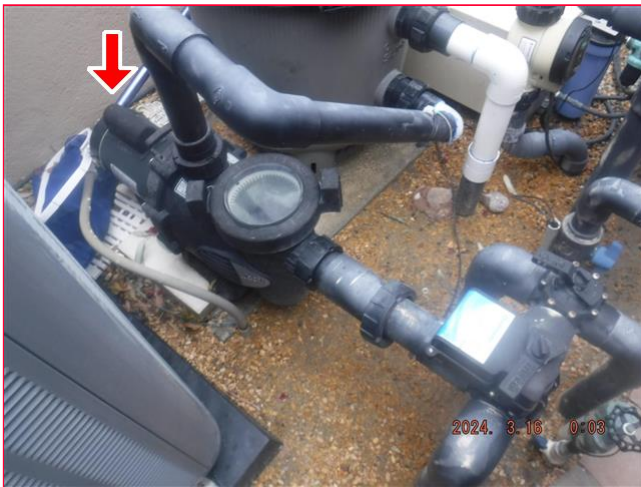
11.5 Item 1(Picture) Pump

Noted the pool and spa pump(s) is currently not bonded (grounded) for safety. Pool pumps should be bonded with a grounding wire as required by the pool california safety code. Recommend safety measures corrected, a license pool contractor should further evaluate and repair as required.

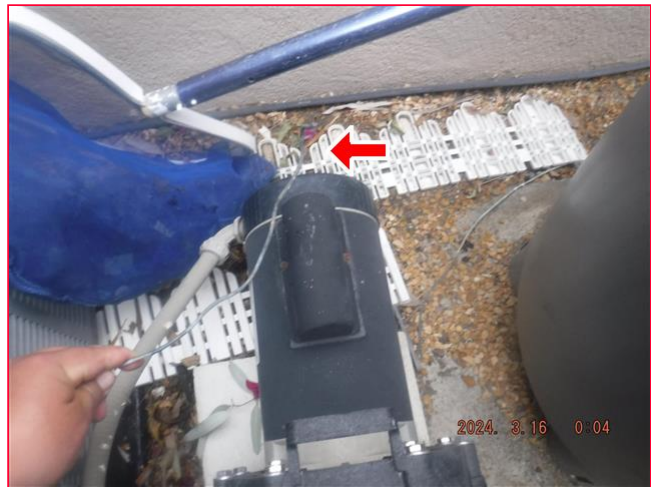
11.5 Item 2(Picture) Pump not grounded
