Inspection Report

Property Address:
42381 Sultan Ave
Palm Desert CA 92211

Dominguez Property Inspections, LLC

Date: 3/27/2024	Time: 10:00 AM	Report ID: 014 - 2024
Property: 42381 Sultan Ave Palm Desert CA 92211	Customer: Sample Repor #2 Sample Report #2	Real Estate Professional: Danny Schmitz Keller Williams

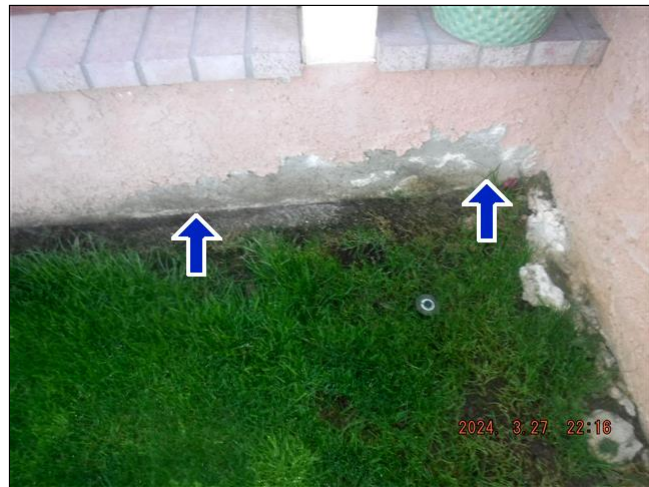
1.4 Item 2(Picture) Stucco coating peeled off

1.4 The block wall stucco coating is failing (peeling) at the patio back of home. This is a maintenance issue and is for your information. Further deterioration may occur if not repaired. Recommend a licensed general contractor further evaluate and repair or replace as needed.

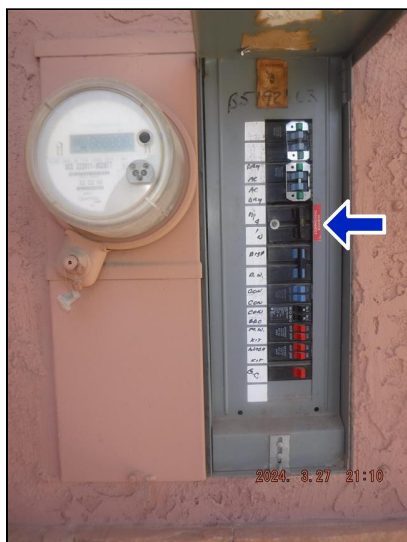
2.3 Item 1(Picture) Main electrical shut off (at panel)

2.3 The MAIN electrical panel box is located at the front of home. Main electrical disconnect.

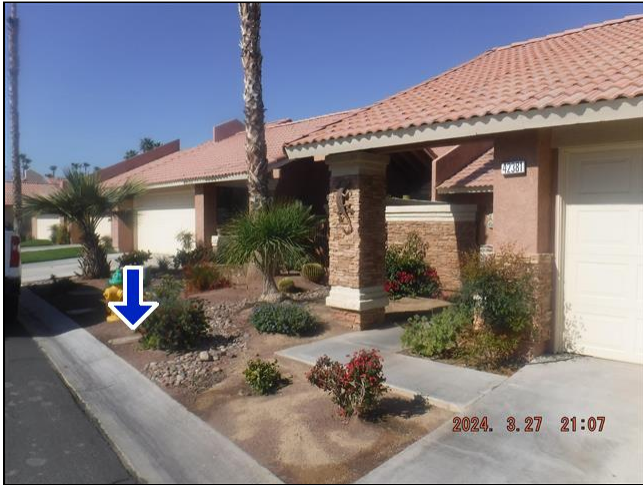
3.2 Item 1(Picture) Main Water Shut Off Valve and Meter

3.2 (1) The property MAIN water meter and shut off valve is located outside in the ground at the front of home/ property. This is for your information.

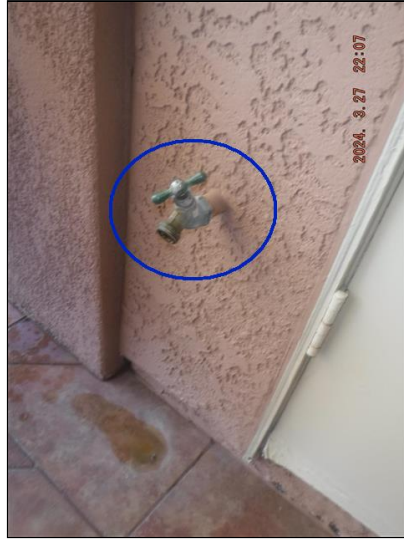
3.3 Item 2(Picture) Plumbing hose bib (patio)

cross-contamination of the water supply. Installation of anti-siphon valves is a small repair. Recommend a license plumbing contractor further evaluate and repair, replace or advise as needed.

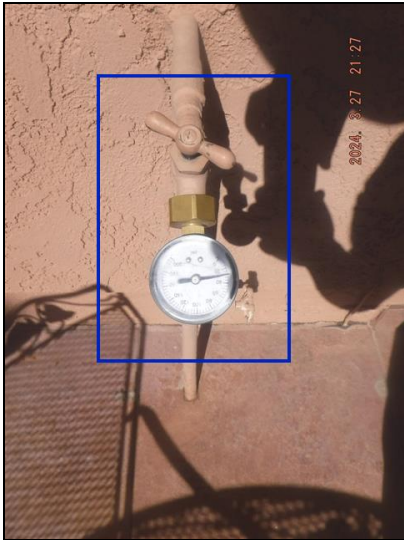
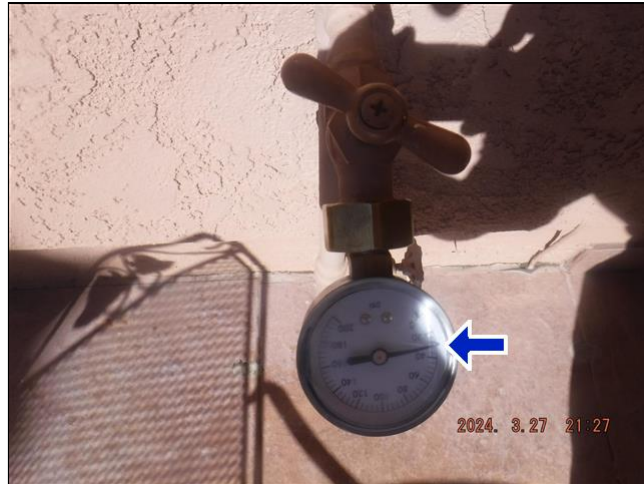
3.4 Item 1(Picture) Water Pressure Test

3.4 Noted water pressure should be between 40 - 80 (PSI) in a residential home. The water pressure tested lower than 40 pounds per square inch (PSI) considered inadequate by generally-accepted current plumbing standards. Plumbing professionals recommend water pressure be within the recommended range. Recommends a qualified plumbing contractor further evaluate and correct as desired.

Water pressure tested at 30 PSI.

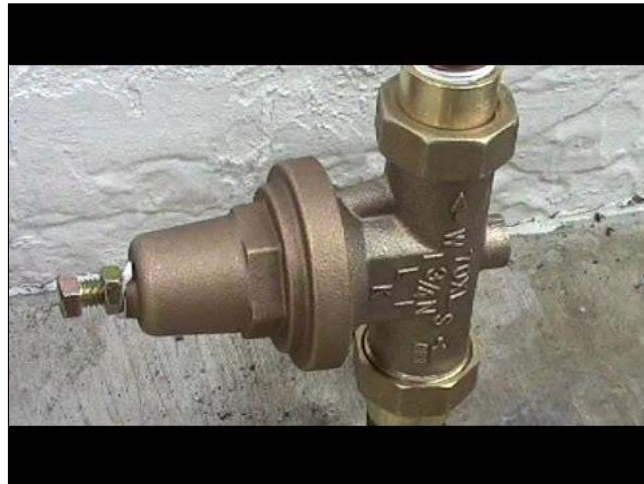
3.5 Item 2(Picture) Example of a water pressure regulator

3.5 Note, there is NO water pressure regulator currently installed on the main water line for the home. Without a water pressure regulator you can't adjust the water pressure to a recommended range. Recommend a license plumbing contractor further evaluate and repair or install as needed.

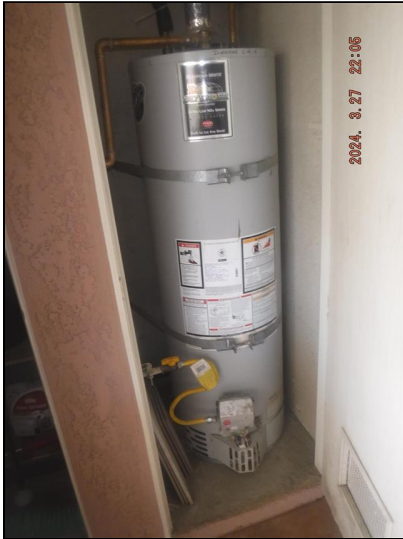
3.6 Item 1(Picture) Water Heater Unit

3.6 Noted the water heater unit was operational at the time of inspection. Unit condition appeared fair. Verified that seismic straps were installed.

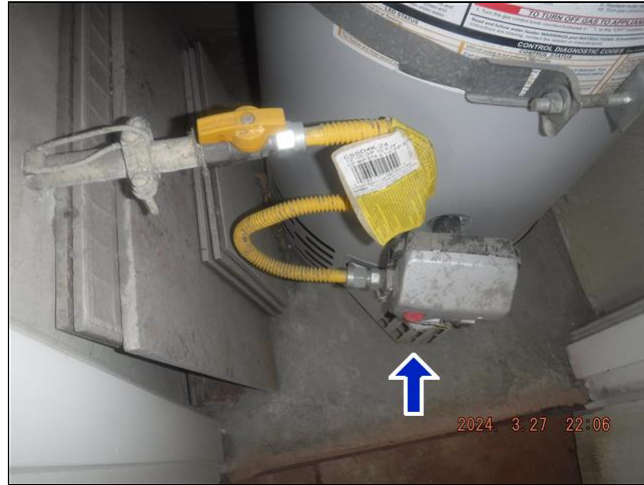
3.6 Item 2(Picture) No drain pan

Note, the unit did not have a drain pan in place underneath. Without a drain pan, leaks can cause water damage to surrounding walls, and or mold growth. Due to water heater(s) location a drain pan is RECOMMENDED to prevent any future damage. Recommend a qualified license plumbing contractor maintain and correct as needed.

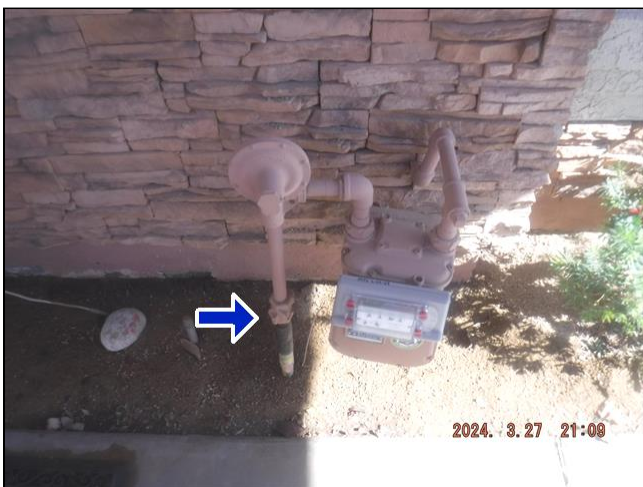
3.8 Item 1(Picture) Main Gas Shut Off (At Meter)

3.8 (1) The main gas shut off valve is located at gas meter outside.

Gas meter is a public utility component and therefore inspected for leaks only.

+ (2) Noted a possible gas odor/smell was detected near, or around the gas meter location at the time of inspection. If a gas leak is present, this can be a safety issue. Recommend a license plumbing contractor or gas company technician further evaluate and repair, replace or advise as needed.

Recommend to store a qualified wrench, and or tool near the gas shut off valve for quick shut off access.

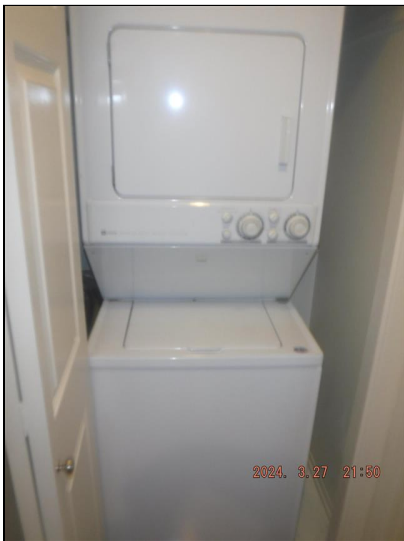
3.12 Item 1(Picture) Washer & Dryer Units

3.12 The laundry room washing machine and dryer are not a required inspection appliance, and are therefore not inspected. No moisture or leakage noted/signs from the hot and cold water supply valves for the washing machine. Recommend further evaluation for proper operation for the washer and dryer as desired.

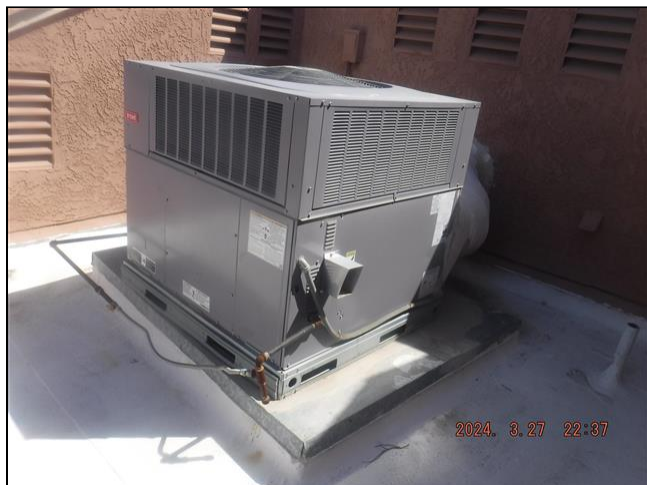
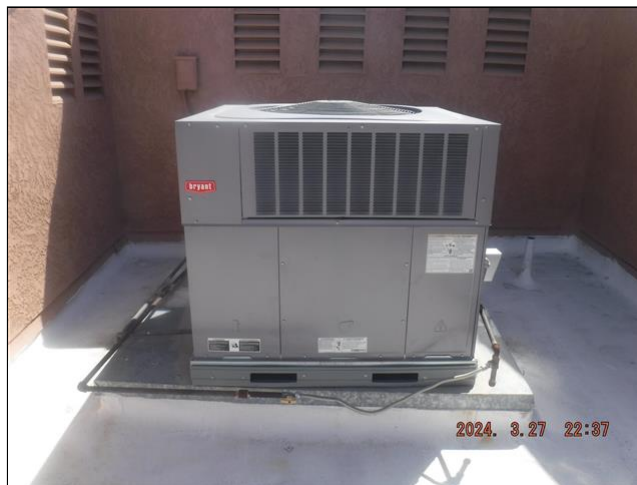
4.7 Item 1(Picture) Air Cooling Unit

4.7 The cooling unit was operational at the time of inspection. Unit condition appeared good. I recommend to service the HVAC system (for example, replacing filters, checking gas piping and equipment condition) at least once a year. I cannot determine how long your AC will last before a replacement is necessary. A certified HVAC contractor should further evaluate internal system components and service as recommended.

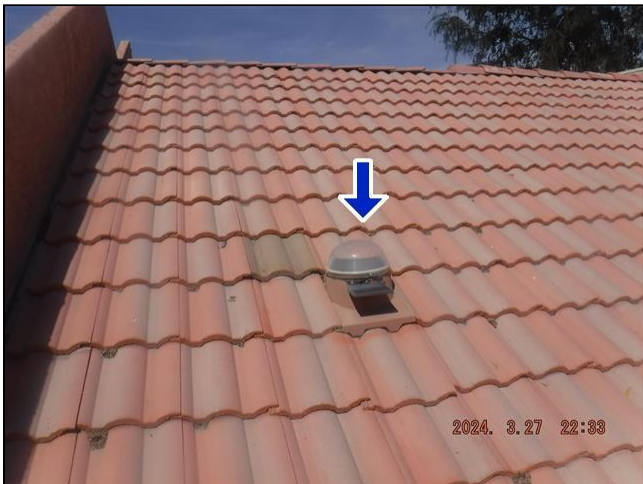
10.3 Note, skylights are particularly prone to leakage and may need periodic repair and or re-sealing around the flashing. The integrity of the flashings is generally the first point to consider when leakage occurs. Surface damage or loss of the seal on insulated glazing can occur, but such a defect may not be readily apparent during an inspection. The skylight(s) condition appeared fair at the time of inspection. Recommend to monitor/inspect skylight(s) from time to time, and maintain as needed by a qualified roof contractor. Recommend to schedule a annual roof inspections with Dominguez Property Inspections, LLC to ensure the condition and integrity of the roof. This is for your information.

10.3 Item 1(Picture) Skylight

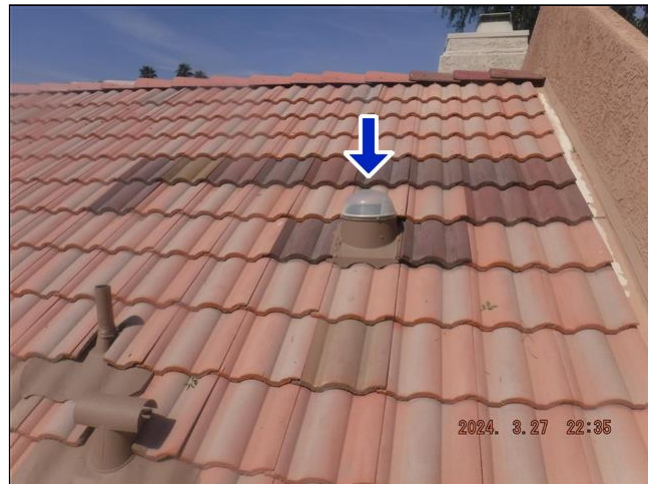
10.3 Item 2(Picture) Skylight

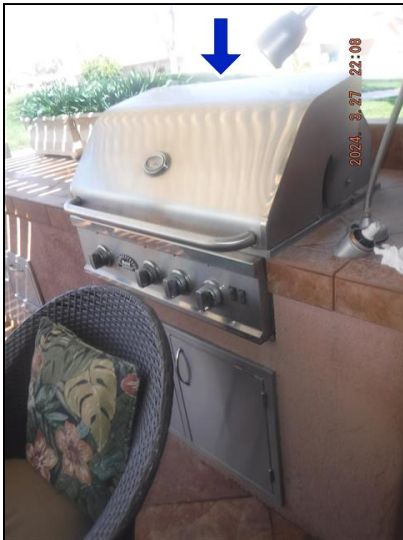
11.0 Note, exterior bar-bee-que unit(s) are not included during a standard home inspection, and therefore was not inspected for operation or condition. However, unit components such as, electrical wiring and gas piping were visually inspected for proper installation, issues, and or possible leakage. Only visible electrical wiring and gas lines were evaluated during the inspection. Recommend further evaluation by a bar-bee-que specialist as client desires.

11.0 Item 1(Picture) Bar-Bee-Que Unit

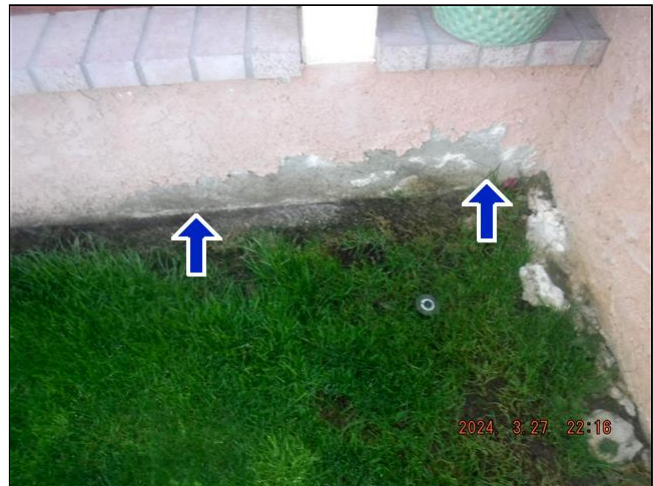
The block wall stucco coating is failing (peeling) at the patio back of home. This is a maintenance issue and is for your information. Further deterioration may occur if not repaired. Recommend a licensed general contractor further evaluate and repair or replace as needed.

1.4 Item 2(Picture) Stucco coating peeled off

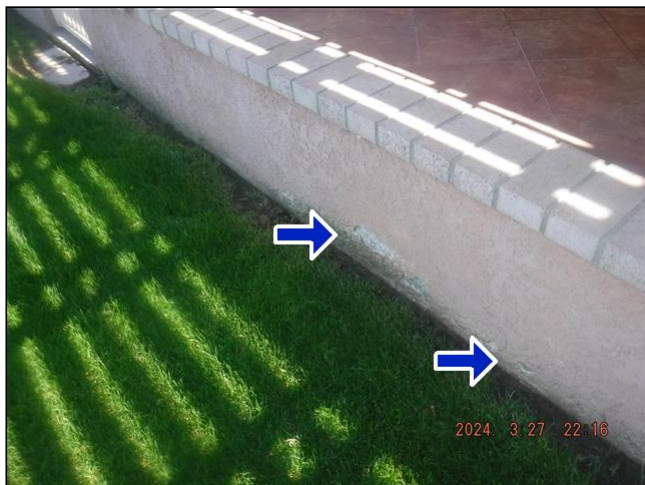
1.4 Item 3(Picture) Stucco coating peeling

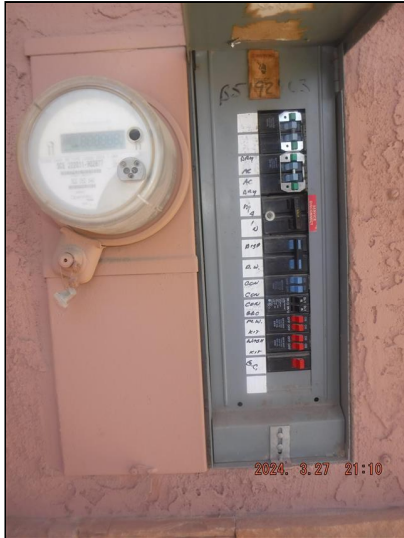
(2) **Noted the potential issue(s) discovered in the panel such as missing AFCI (Arc Fault Circuit Interrupters) breakers, and any other problems that an electrical contractor may discover while performing repairs needs correcting. An arc fault circuit interrupter is designed to detect a dangerous electrical arc and promptly**

interrupt the circuit before a fire can ignites. When an arc fault occurs, it creates a sharp spike and drop that is easily detectible by an AFCI electrical breaker. Not having AFCI breakers in a panels can be a safety issue.

2.1 Item 1(Picture) No AFCI breakers in panel

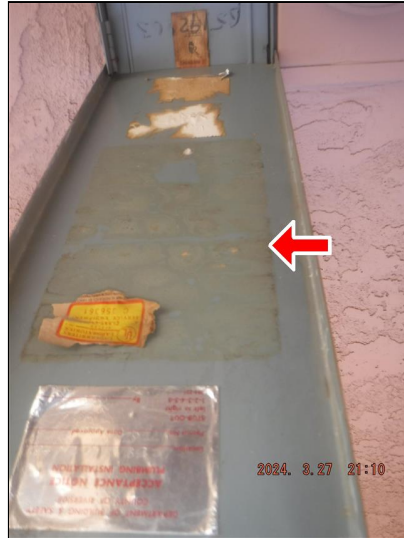
Note, the panel manufactures label (sticker) is missing and or damaged. Its important for the electrical panel boxes to have the label for maintenance and or emergency purposes. A license electrical contractor should evaluate panel to determine brand and label that is needed. Recommend a licensed electrical contractor inspect further and correct as needed.

2.1 Item 2(Picture) Missing panel label

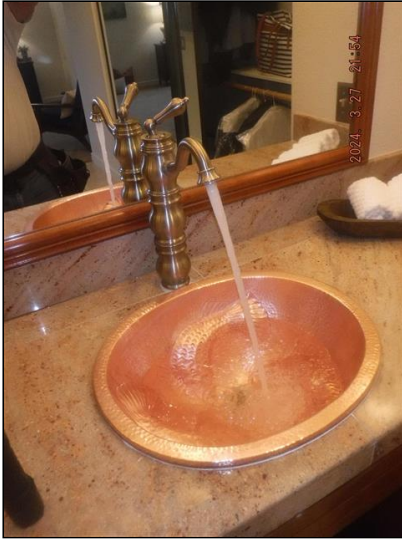
(2) The plumbing sink drains slowly at the master bathroom. A cause of a slow drain can range from a simple cleaning at stop valve or at the trap under sink. Sometimes the drain can be partially clogged down the line. I am unable to determine the cause of the slow drain. Recommend a license plumbing contractor further evaluate and repair or replace as needed.

3.0 Item 1(Picture) Master bathroom sink

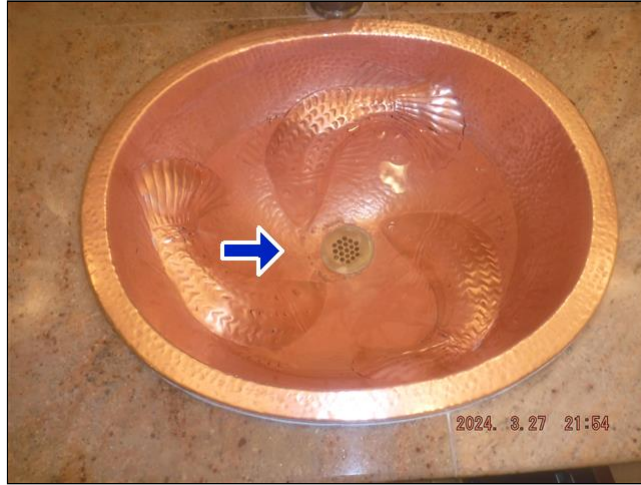
3.0 Item 2(Picture) Sink drains slow

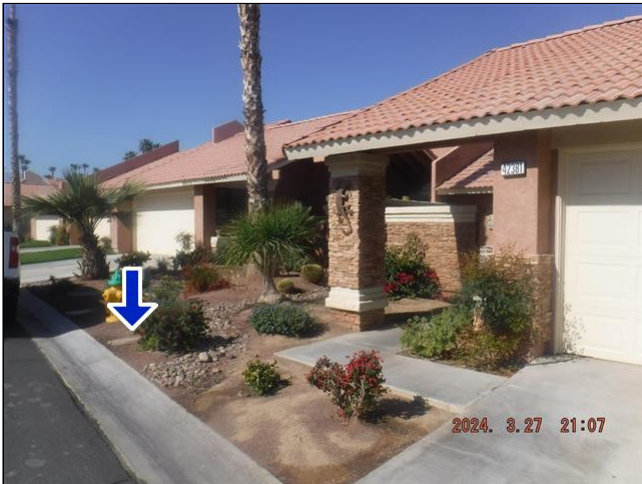
(1) The property MAIN water meter and shut off valve is located outside in the ground at the front of home/property. This is for your information.

3.2 Item 1(Picture) Main Water Shut Off Valve and Meter

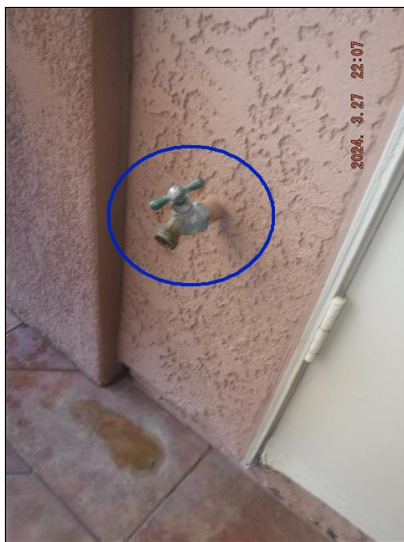
(2) Noted the hose bib/spigot(s) is/are missing a anti-siphon valve at the front and back of home. Anti-siphon valve(s) on hose bib/spigot(s) are required to prevent water from backflow into the home, this can possibly cause cross-contamination of the water supply. Installation of anti-siphon valves is a small repair. Recommend a license plumbing contractor further evaluate and repair, replace or advise as needed.

3.3 Item 2(Picture) Plumbing hose bib (patio)

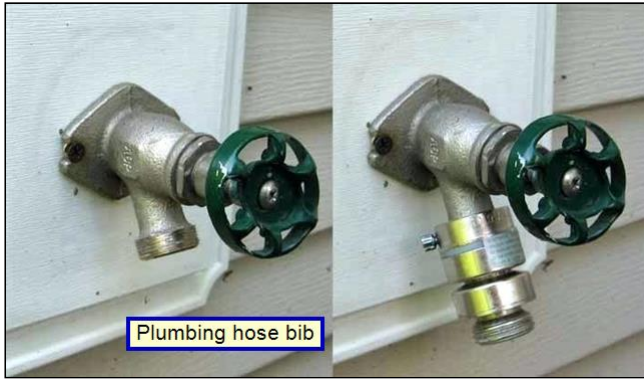
3.3 Item 3(Picture) Example of hose bib with a anti-siphon valve

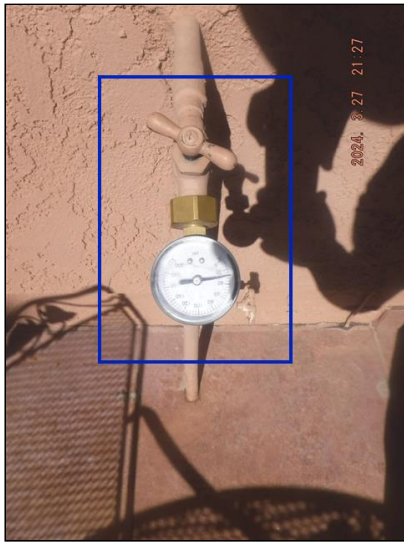
Noted water pressure should be between 40 - 80 (PSI) in a residential home. The water pressure tested lower then 40 pounds per square inch (PSI) considered inadequate by generally-accepted current plumbing standards. Plumbing professionals recommend water pressure be within the recommended range. Recommends a qualified plumbing contractor further evaluate and correct as desired.

Water pressure tested at 30 PSI.

3.4 Item 1(Picture) Water Pressure Test

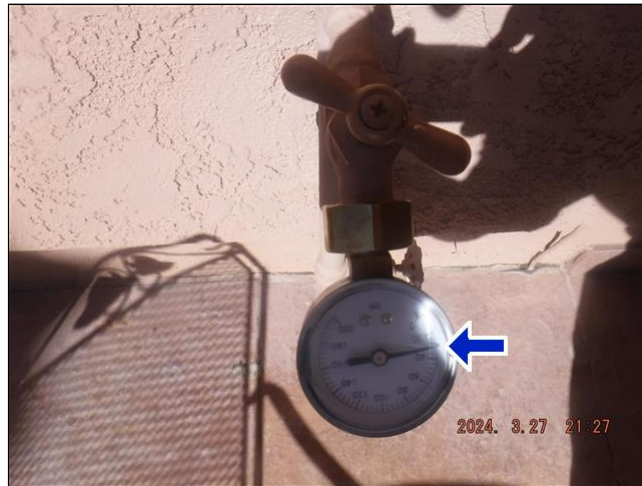
3.4 Item 2(Picture) 30 PSI

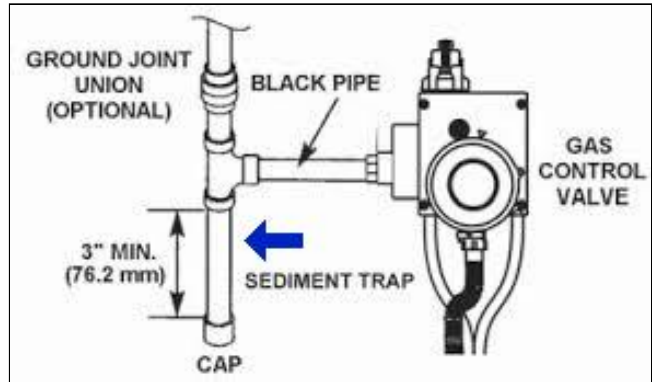
(2) **Note:** Sediment traps are missing on the gas line(s) for the furnace unit(s) and water heater unit(s). Sediment traps may have not been required at the time of construction, recommend to install as recommended by today's plumbing standards. Missing sediments straps may prevent, and or void manufacturers and or home warranties. According to the 2016 California Plumbing Code (CPC), sediment traps are required for all gas appliances except: illuminating appliances, ranges, clothes dryers, decorative appliances for installation in

3.7 Item 2(Picture) Example of a gas line with a sediment trap

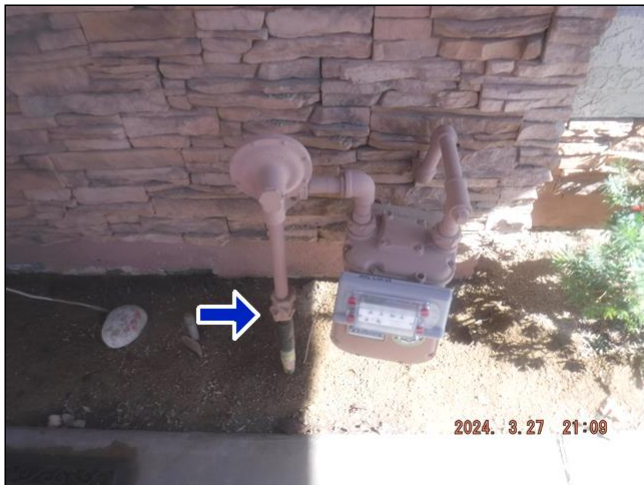
3.8 Item 1(Picture) Main Gas Shut Off (At Meter)

Recommend to store a qualified wrench, and or tool near the gas shut off valve for quick shut off access.

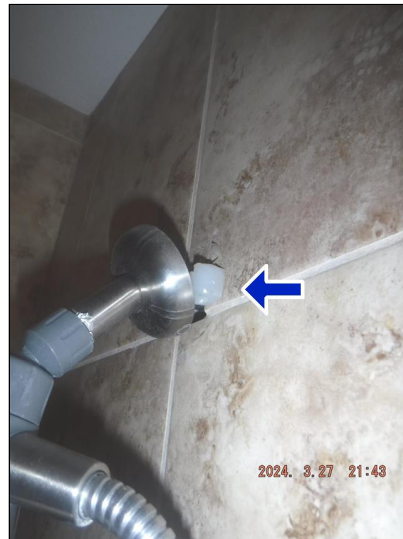
Noted the shower plumbing fixture(s) (shower head and valve) are loose at the wall, and or not properly sealed/water proofed with silicone/caulking at the guest bathroom. This can allow moisture to seep/penetrate behind wall causing water damage or mold growth. This is a maintenances issue. Recommend a plumbing contractor or a qualified person evaluate further and repair as needed.

3.10 Item 2(Picture) Loose shower head

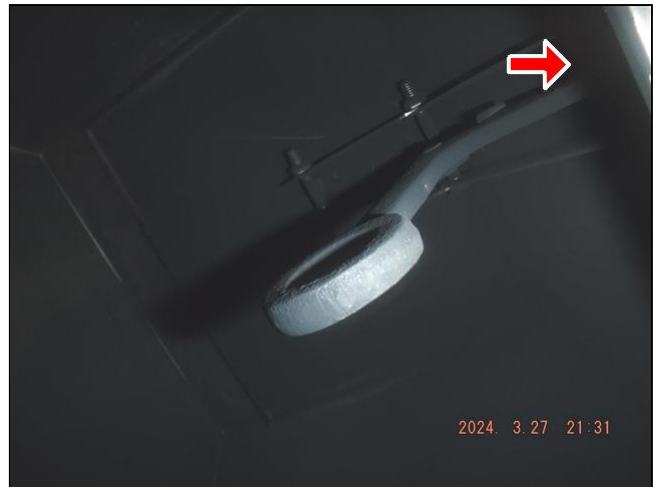
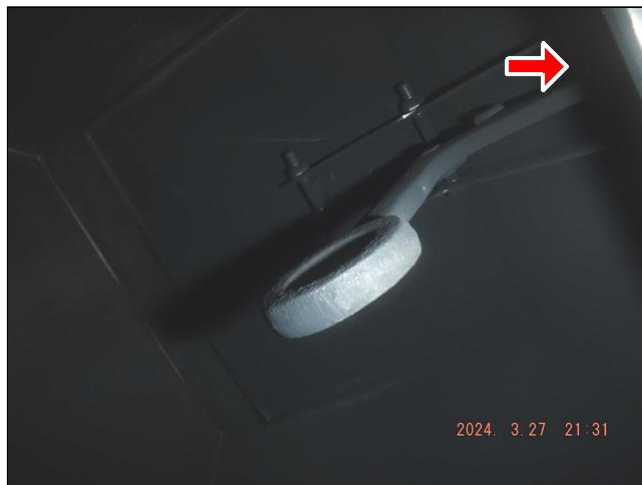
The fireplace unit is missing a C-Clamp at the flue damper inside the firebox. Although the C-Clamp is commonly removed so that the flue damper may be closed. It is recommended that the C-Clamp be installed

4.6 Item 2(Picture) Fireplace damper

The fireplace unit is missing a C-Clamp at the flue damper inside the firebox. Although the C-Clamp is commonly removed so that the flue damper may be closed. It is recommended that the C-Clamp be installed per the Gas Company in order to keep the flue damper open at all times for safety. Recommend to install c-clamp on damper. A qualified person should correct as needed.

per the Gas Company in order to keep the flue damper open at all times for safety. Recommend to install c-clamp on damper. A qualified person should correct as needed.

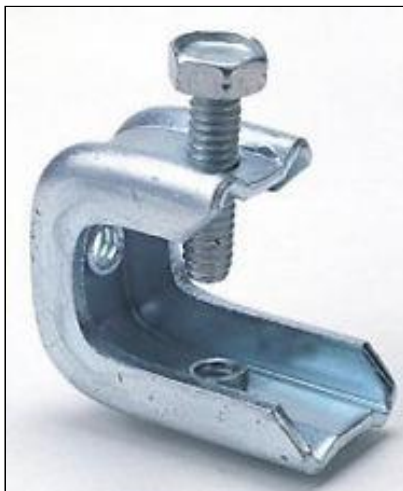
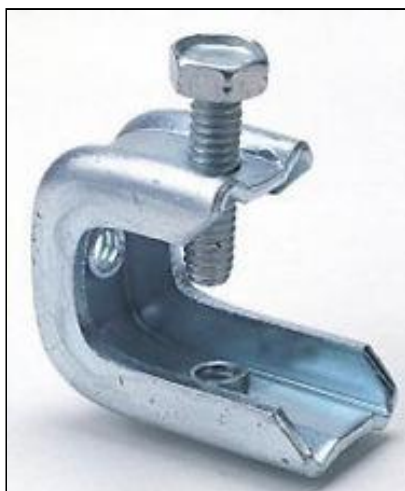
4.6 Item 3(Picture) Example of damper c-clamp

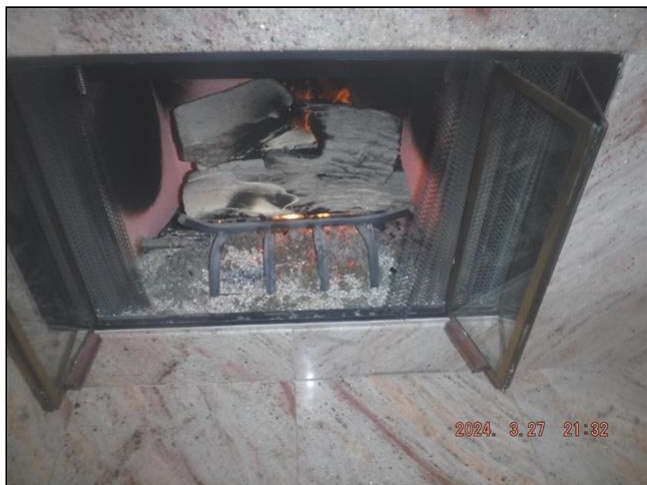
Noted the fireplace unit(s) at the living room was operational at the time of inspection.

4.6 Item 1(Picture) Fireplace Unit

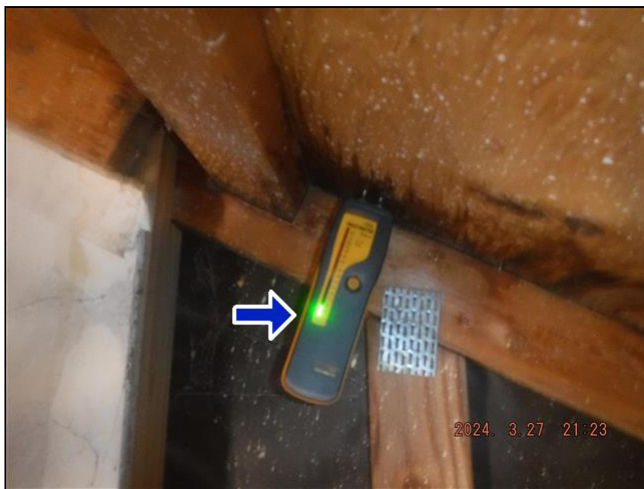
Noted water stains were observed at the garage ceiling on the right side. Stains were viewed on the sub roof (plywood sheathing and joists). Due to recent dry weather, was unable to determine if these stains are from a previous or correct leak (plumbing or roof). Stains were dry at the time of inspection. Recommend a license general or roof contractor further evaluate and repair or advise as desired.

5.0 Item 3(Picture) Moisture meter (device) indicated dry surface

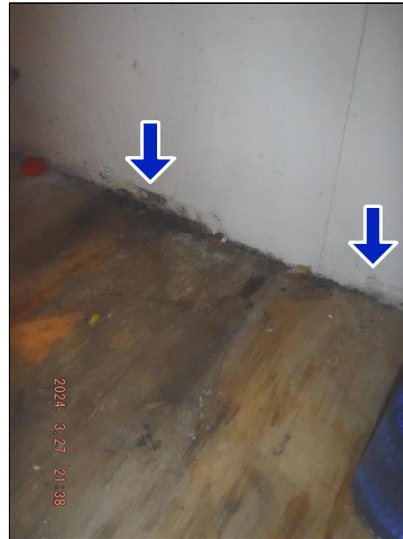
Noted sign(s) of a black substance is present at the kitchen under the sink. Black substance on a wall can be caused by various factors (dirt, paint, moisture, and or mold). We did not test to determine if this black substance is or is not a health concern. No leaks present at the time of inspection at this location. However, moisture stains were present in the area possibly from a previous leak (The only way to determine if this black substance is or is not a health concern, is to obtain surface samples, and have a lab analysis them). If this is a concern you may contact us for a re-evaluation and testing, or contact a certified mold inspector for further evaluation.

6.1 Item 2(Picture) Black substance on wall

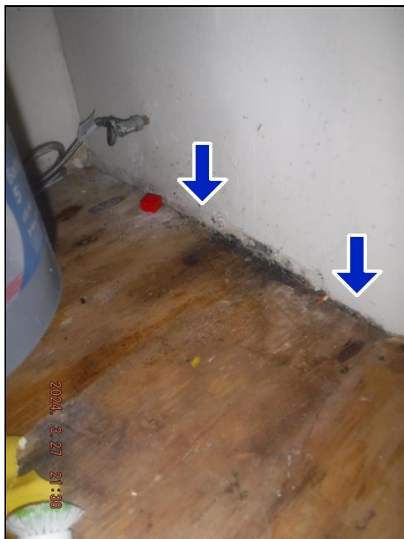
6.1 Item 3(Picture) Black substance on wall

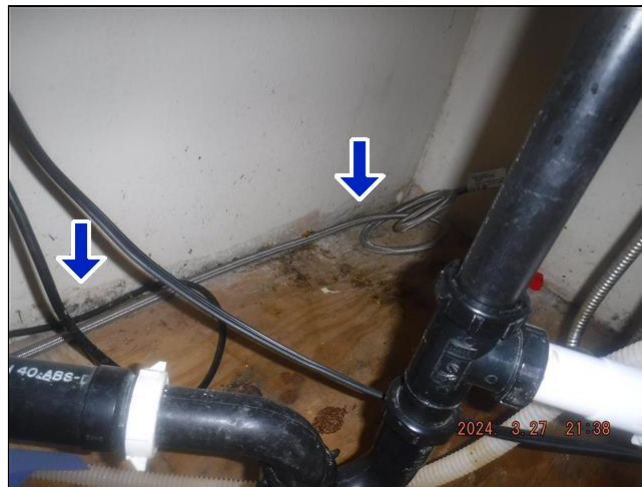
6.1 Item 4(Picture) Black substance on wall
